08-06-2019

UCSF Building Seismic Ratings
Aldea San Miguel 7

CAAN #3025
95 Behr Avenue, San Francisco, CA 94131
UCSF Campus: Parnassus

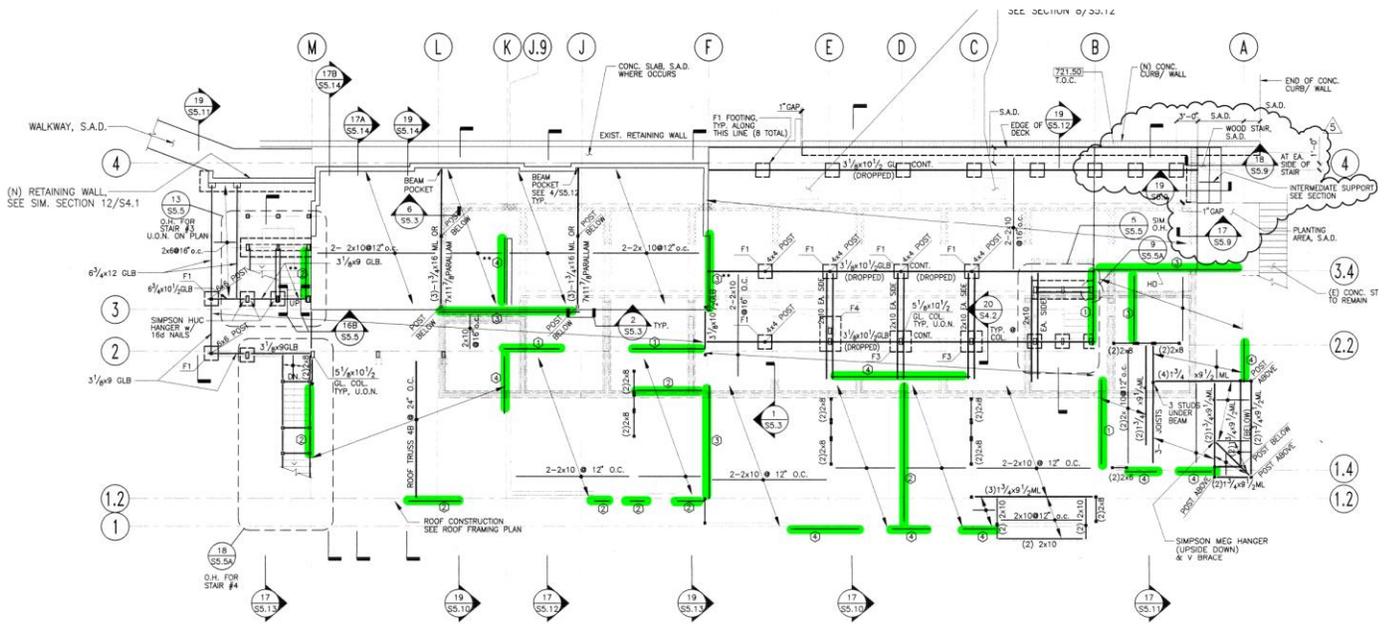
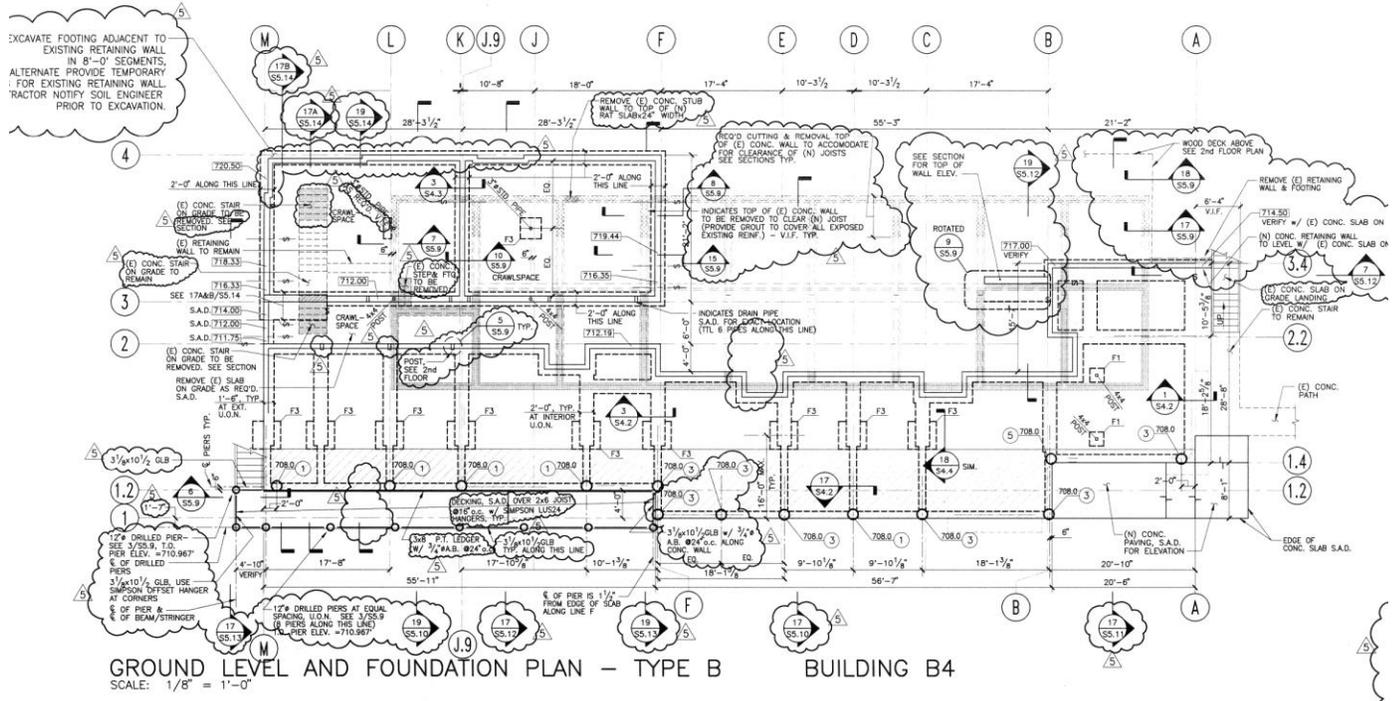
Figure 3. – Structural Foundation, Ground Level, and Second Level Plan

- In a quick check of the lateral-force-resisting system, the shear walls do not have adequate shear capacity at the second level in the transverse direction based on wall layout shown on the structural drawings. When wood shear walls are included as shown on the architectural drawings there is sufficient wall to pass the quick check.
- On the downhill slope of the building, the exterior longitudinal walls have aspect ratios greater than 1:1 due to window openings. There is significant wall along the south side of the crawl space, which resists torsion due to the hillside site.

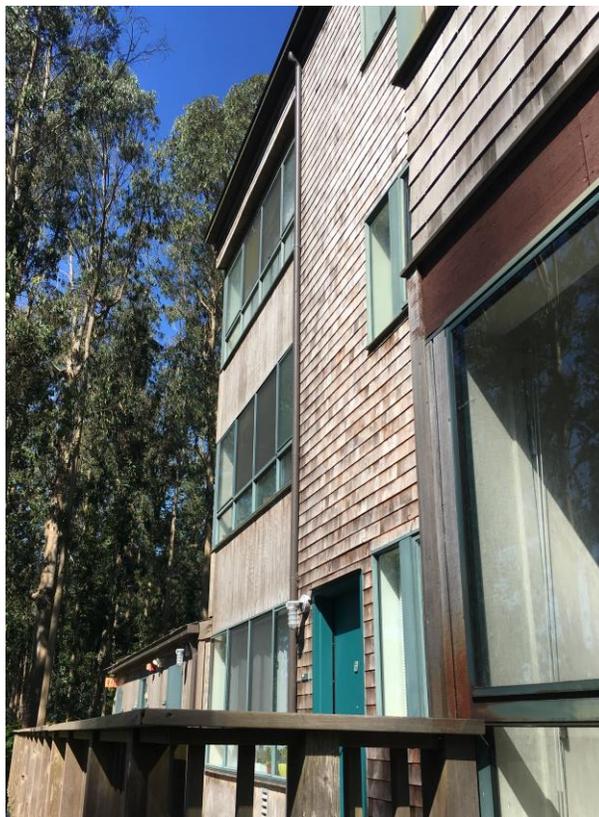
Figure 6. – South elvation

Building Condition: Good. Minor deterioration was observed in the existing siding at the south-east corner of the building.

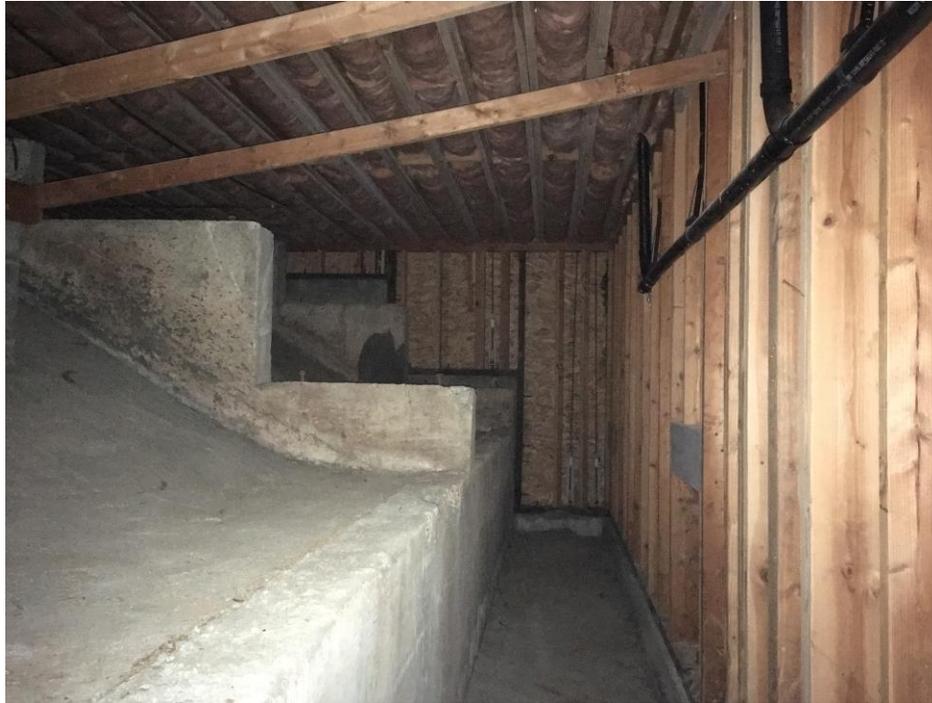
Figure 8. – Crawlspace

Structural system for lateral forces: The roof diaphragm consists of ½" plywood sheathing. The floor diaphragm consists of ¾" T&G plywood. Vertical elements of the lateral-force-resisting system consists of OSB shear walls. The drawings call for plywood or OSB shear walls; OSB was observed in the crawl space.
