UCSF building seismic ratings

Hunters Point Research Facility

CAAN #3011

75 Crisp Road (830 & 831 Palou Avenue), San Francisco, CA 94124

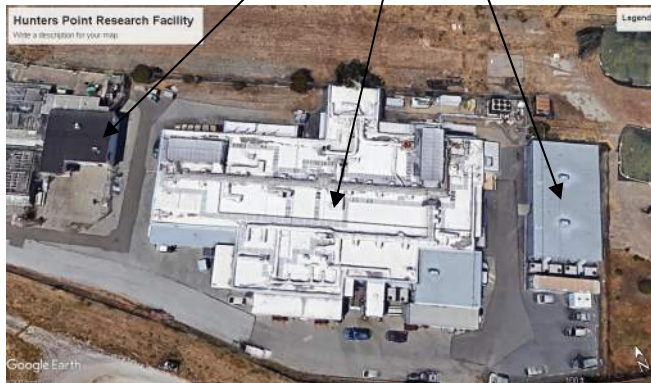
Plan (831 Palou, 830 Palou, Annex)

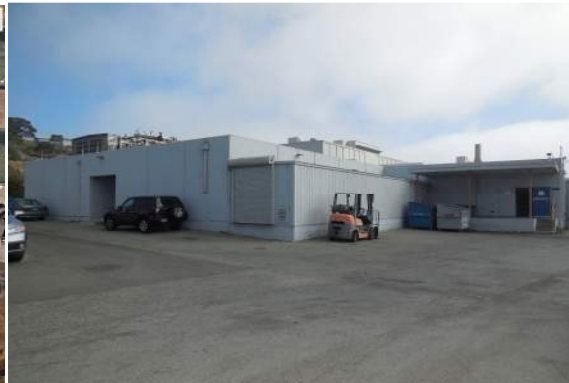
West elevation (looking northeast)
