12-3-2019

UCSF Building Seismic Ratings
1322-24 3RD AVENUE

CAAN #2003
1322-24 3RD AVENUE, SAN FRANCISCO, CA 94122
UCSF Campus: Parnassus

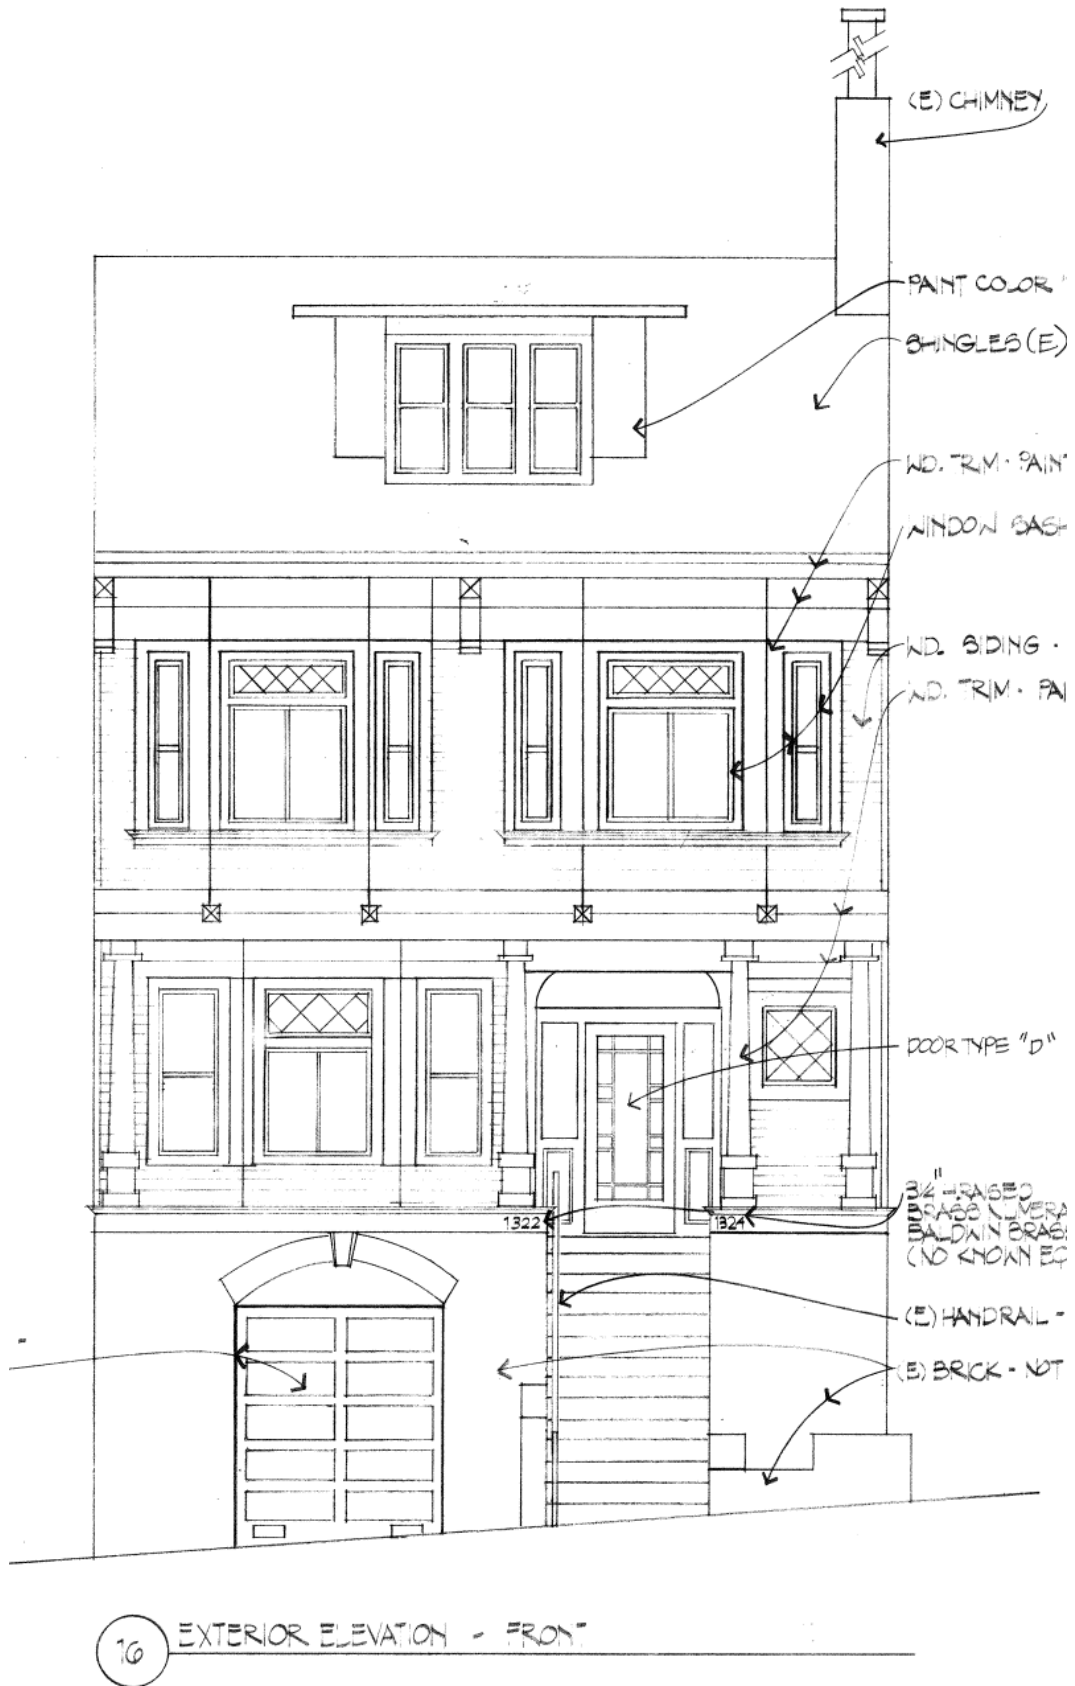
Figure 4 - Exterior Elevation (West Elevation)

The existing drawings exterior elevation (Figure 4) show a chimney, as does satellite imagery. During the site visit, it appeared the chimney had been replaced with a sheet metal flue. The facilities maintenance technician assisting with the site visit noted that the units have fireplaces, but they had been blocked off.

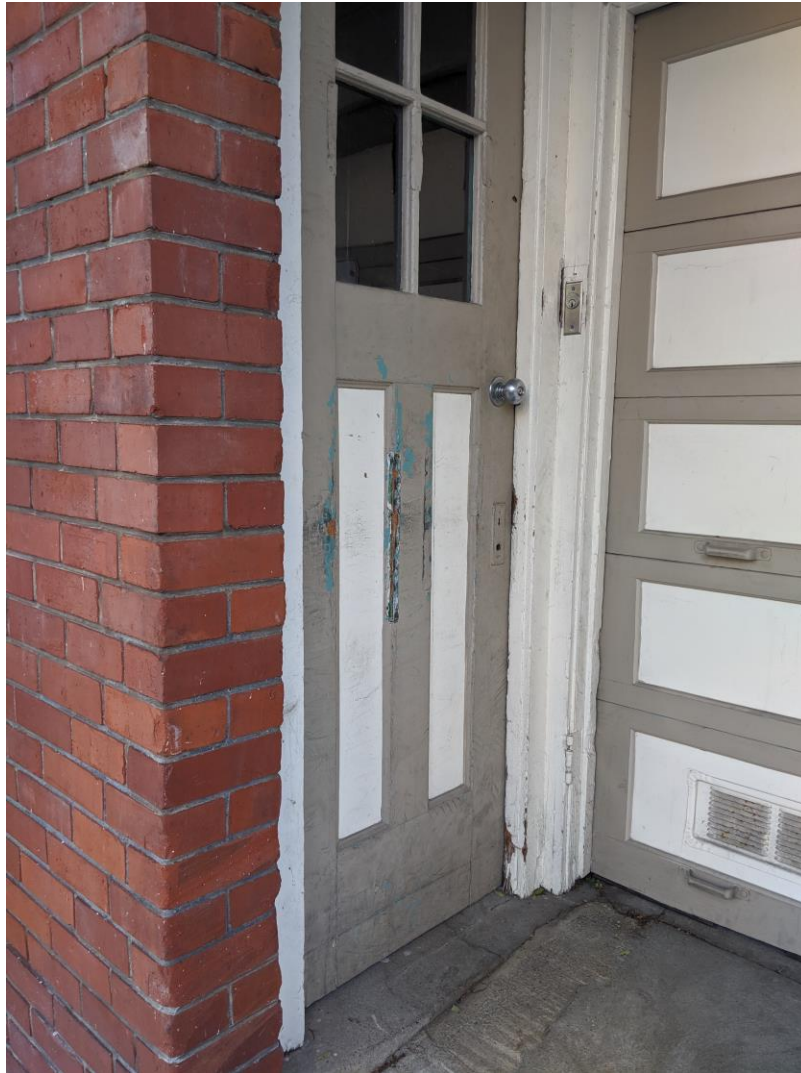
Figure 5 - Wood Deterioration at Garage Door

Building Condition: What could be observed of the structure of the building appeared to be in fair condition; however, most of the structure was concealed behind architectural finishes. The wood around the door frame to the garage has degraded. The exterior patio and stair on the south side of the house appeared to be in need of maintenance. Metal brackets for the elevated wood walkway and stair were rusting in some places. The concrete stairs exiting the ground floor at the back of the house appeared to have moved over time under lateral soil pressure from the hillside behind the property. There is a water pipe exiting the back of the building and passing under the elevated wood walkway. The braces of the pipe were corroded and one was unattached to the structure. The vertical hanger for the pipe was also corroded, and unattached to the structure above.

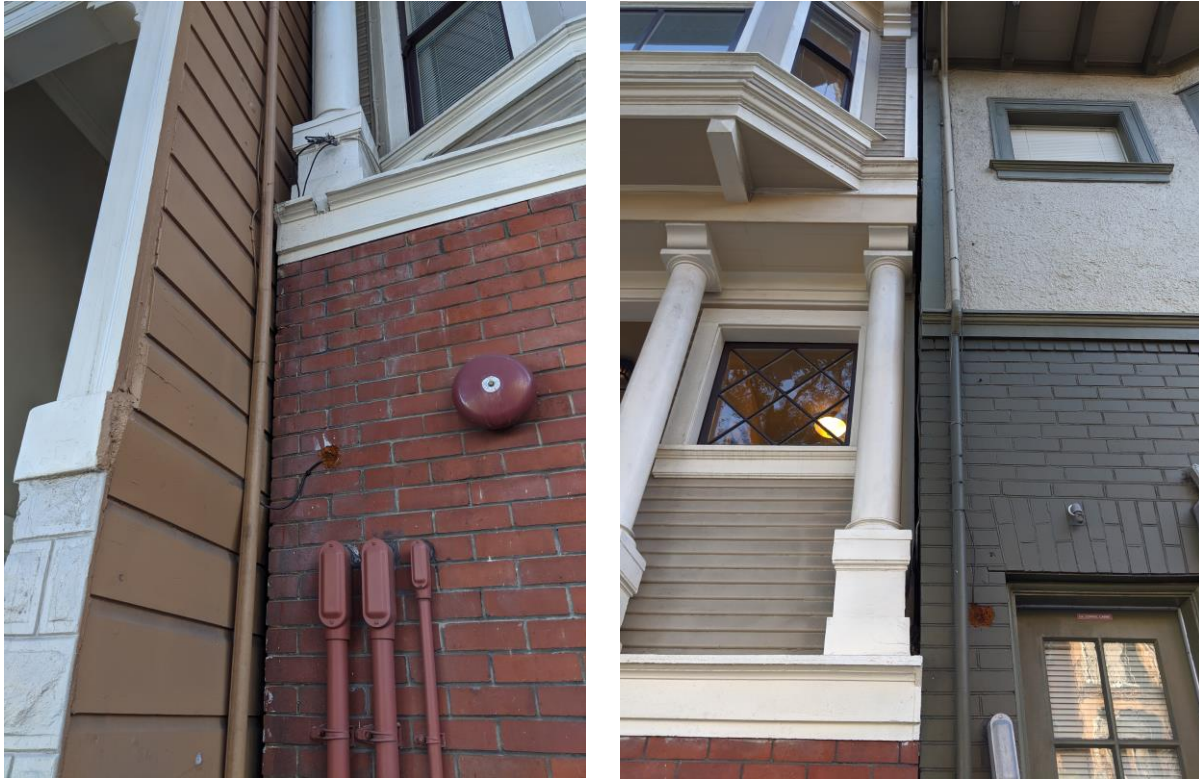
Figure 6 - Building Separation to the North (Left) and South (Right)

- Based on the age of construction, the walls between levels are not expected to be detailed to transfer shear and overturning forces between levels.
- The building is located on a sloped site. However, there is a significant length of wall on the downhill side of the building.
- The building is built to the property line with virtually no separation between the neighboring buildings to the north and south. The floor levels do not align with the adjacent buildings due to the steeply sloped site.
- The garage cripple walls were primarily sheathed with plaster and gypsum board, but they appeared to have straight sheathing where some of the plaster was missing. Based on the age of construction, it is assumed the anchor bolts for the sill plate are not adequate.

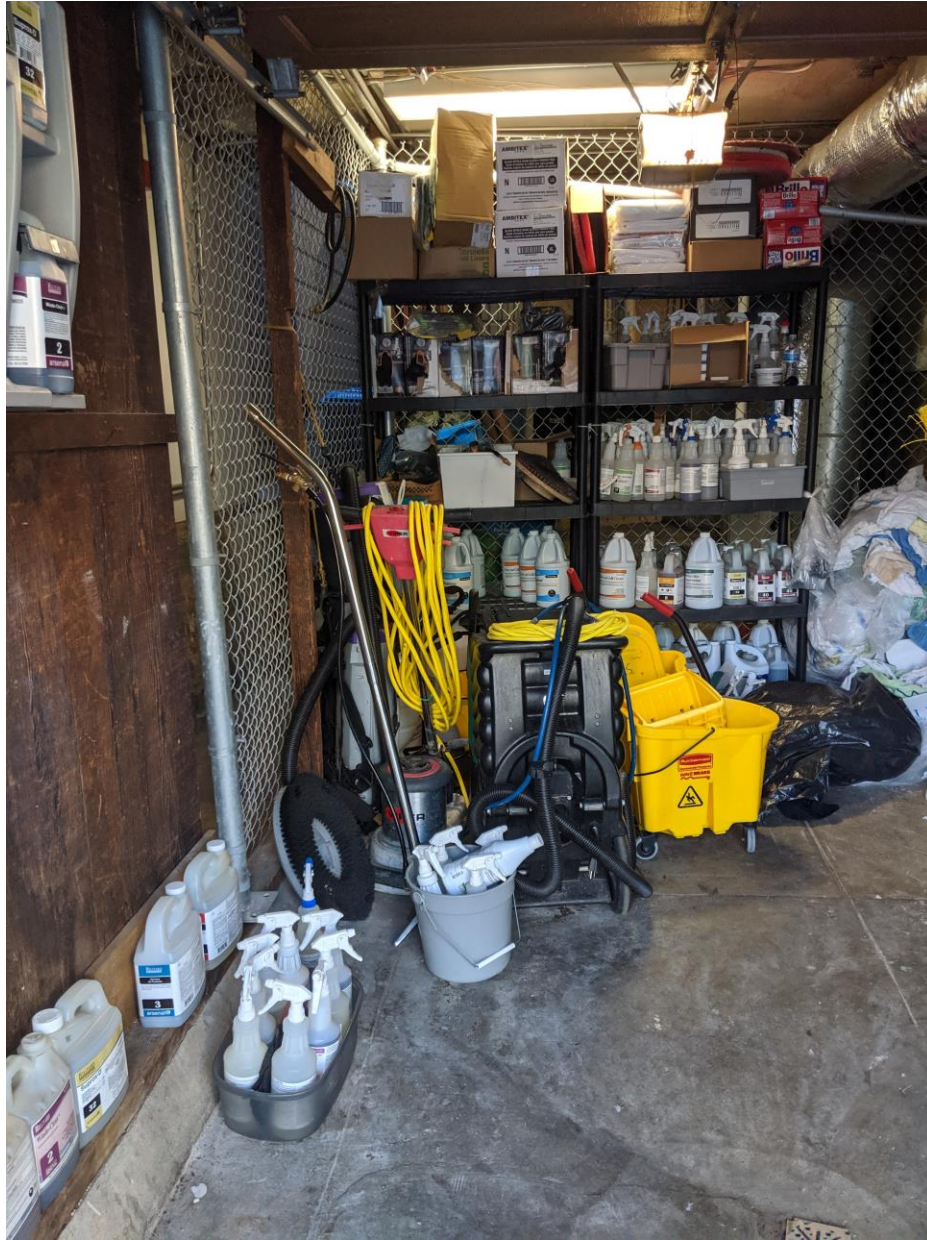
Figure 7 - Cleaning Product Storage in Garage

The garage partially functions as storage for cleaning products. None of the products appeared to pose a life safety concern if dislodged from the shelving unit.

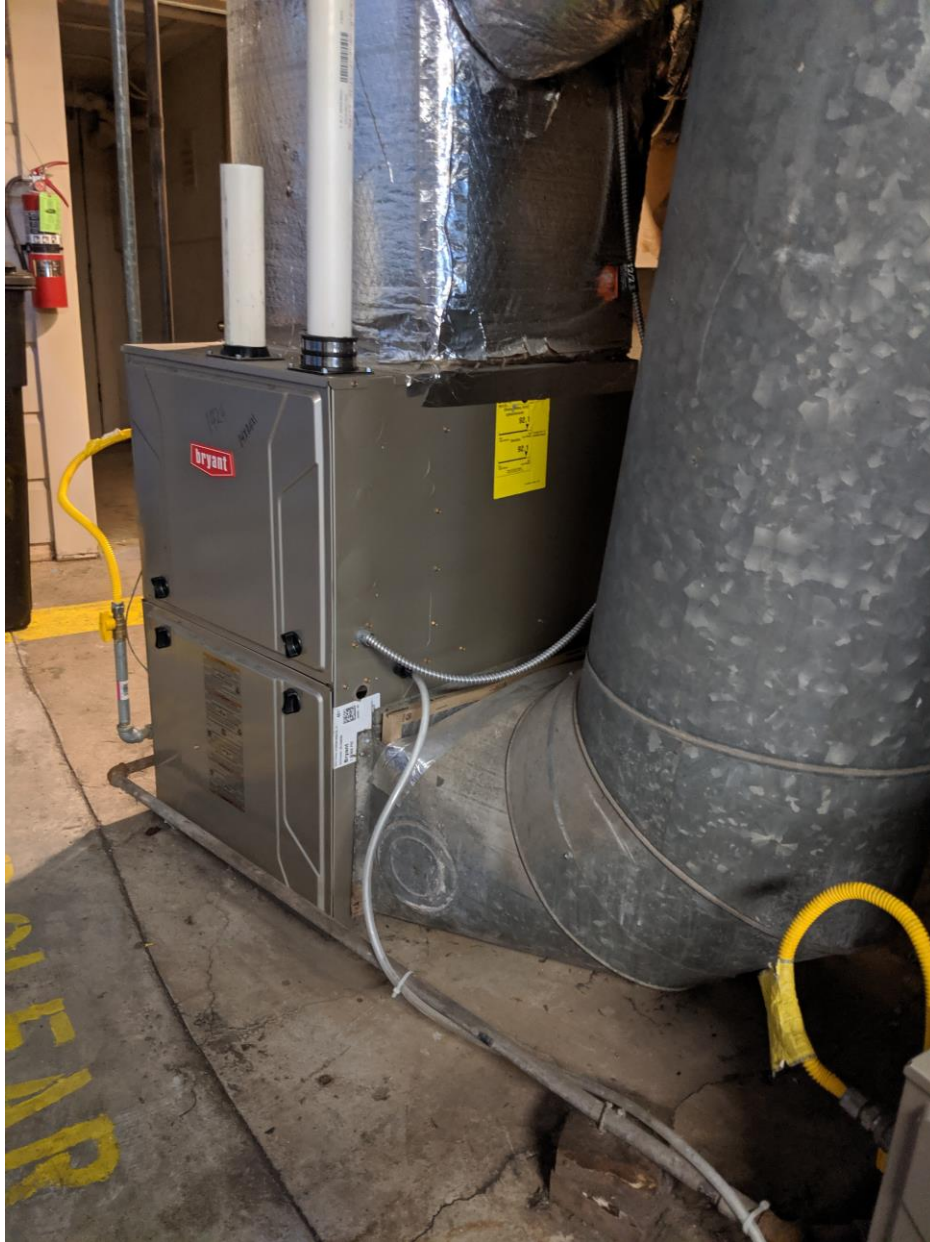
Figure 8 - Gas Furnace in Garage

The facilities maintenance technician also noted the water heaters were in the units and located within a closed off closet. Two gas-fueled furnaces were located in the basement garage space. Positive attachment could not be identified from the furnace to the structure; however, the units also appeared squat enough that overturning did not appear to be a concern. The furnaces had flexible connections with the gas line.

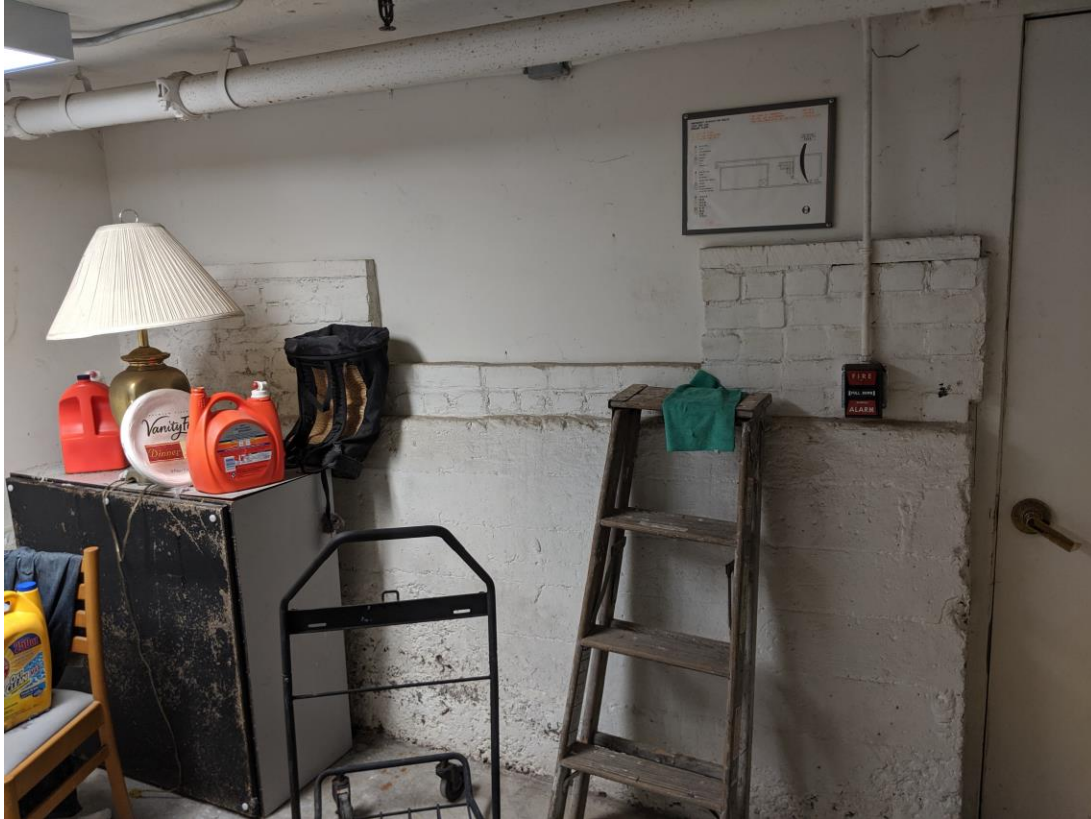
Figure 9 - Area of Brick Wall Over Concrete Stem Wall in Basement

Foundation system: Existing foundation drawings are not available. It is presumed there are continuous footings below bearing walls. During the site visit on October 31, 2019 continuous concrete stem wall footings were observed around the ground floor level. At the exterior east side of the building, there was a small section of brick over the concrete stem wall.
