**UCSF building seismic ratings**

**1320 3<sup>rd</sup> Avenue – Single Family Residence**

CAAN #2005

1320 3<sup>rd</sup> Avenue, San Francisco, CA 94122

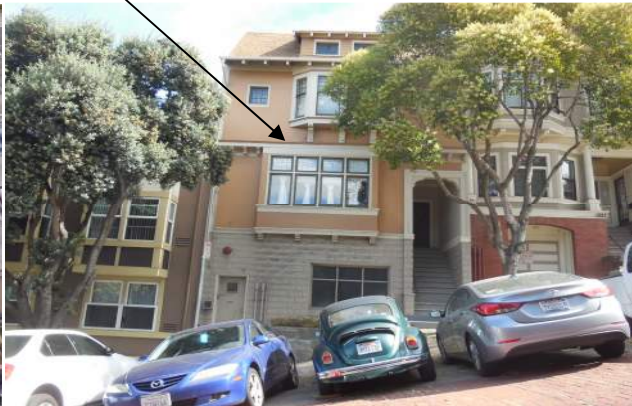
West elevation (looking east)

- Inadequate transverse-direction shear resistance in the lower level (especially at the narrow/short shear wall panels due to the large opening in the front (west) exterior wall).
- Sheetrock wall sheathing and 1x T&G straight floor sheathing in three-story wood framed structures on a steeply sloped site.

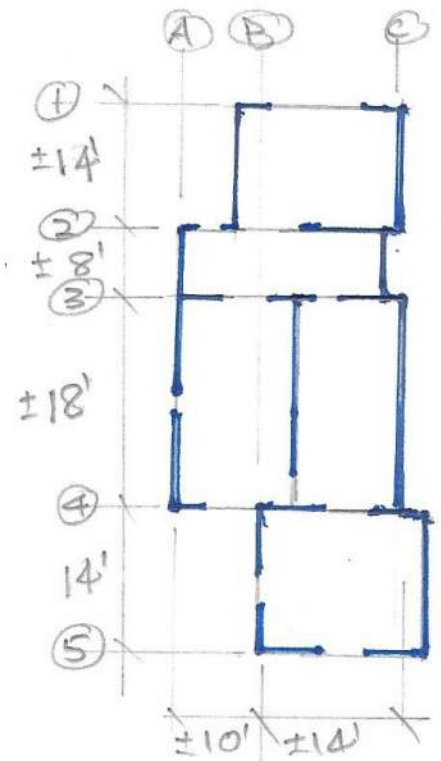
APPROX. 2<sup>ND</sup> & 3<sup>RD</sup> FL.

LONG. WALLS ≈ 160 LF } AT 2<sup>ND</sup> FL.  
TRANS. WALLS ≈ 125 LF } #3<sup>RD</sup> FL.  
LONG. WALLS ≈ 120 LF } GROUND FL.  
TRANS. WALLS ≈ 80 LF }

Story	V/M <sub>s</sub>	LONGITUDINAL		TRANSVERSE	
		L <sub>w</sub>	V <sub>avg</sub>	L <sub>w</sub>	V <sub>avg</sub>
3-R	22.2	160 <sup>LF</sup>	139 plf	125 <sup>LF</sup>	178 plf
2-3	38.9	160 <sup>LF</sup>	243 plf	125 <sup>LF</sup>	311 plf
1-2	46.4	120 <sup>LF</sup>	387 plf	80 <sup>LF</sup>	580 plf

All V<sub>avg</sub> shear stress levels > 100 plf (Assumed for gyp-board walls)

All shear walls (N/C)
