June 26, 2019

**UCSF Building Seismic Ratings**  
**50 Kirkham Residence**

CAAN #2411

50 Kirkham Street, San Francisco

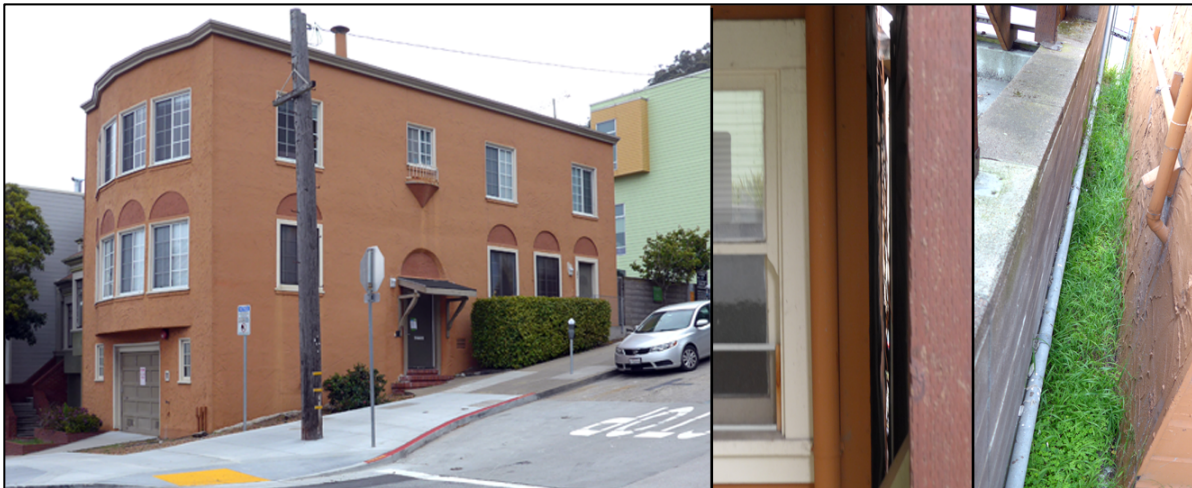
Center image is separation gap from building on the north and left image is the separation from retaining wall to the east.

- The building is light weight and has no significant vertical or horizontal configurational irregularities of the exterior walls.
- The building is fully fire sprinkled by a modern office-type system.
- Early wood framed construction without major configurational irregularities has tended to perform in a life-safe manner in California earthquakes since the 1880s. Damageability may be significant, but not life threatening if there are no serious irregularities in the lateral load-resisting system, which there are here.
- The building is separated by a few inches from the adjacent building to the north, see cover figure middle image. The adjacent building's floor diaphragms are modestly aligned, see Figure 3.

- The concrete stem wall on the northwest side was observed to be cracked, see cover figure.

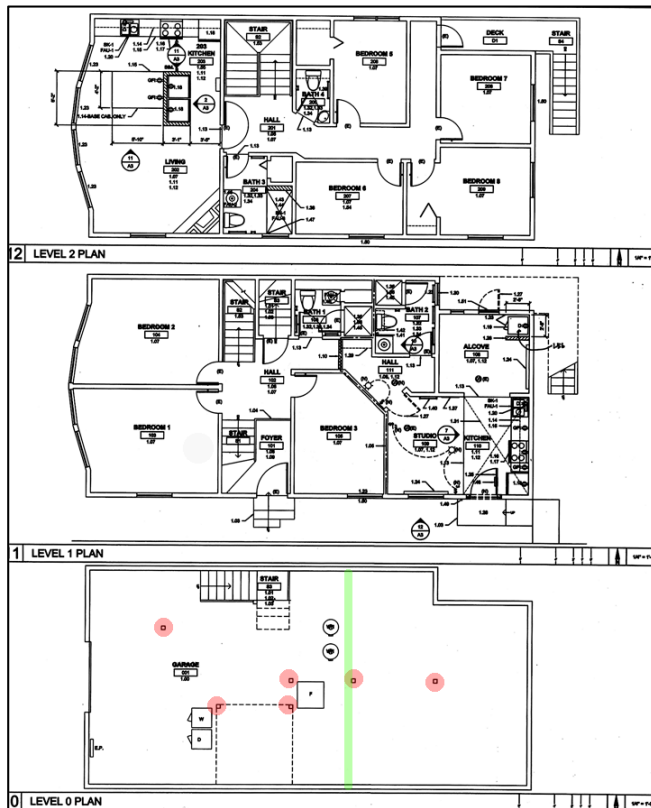
**Figure 1.** The floor plans (top image is the third floor) from the 2010 remodel of the building. There was no apparent structural work done. At the bottom floor the locations of timber posts supporting the second floor are indicated in red, and the concrete 3-foot high cut off wall is indicated in green. The parking area has a concrete slab-on-grade, and the area to the right of the green line is a sloping rat-slab.

**Foundation System:** Foundation support is provided by shallow concrete grade beams and spread footings. The first floor is a concrete slab-on-grade in the garage area facing 5<sup>th</sup> Avenue, with a low concrete cut-off wall see Figures 1 and 2, beyond which is sloping rat-proof slab.

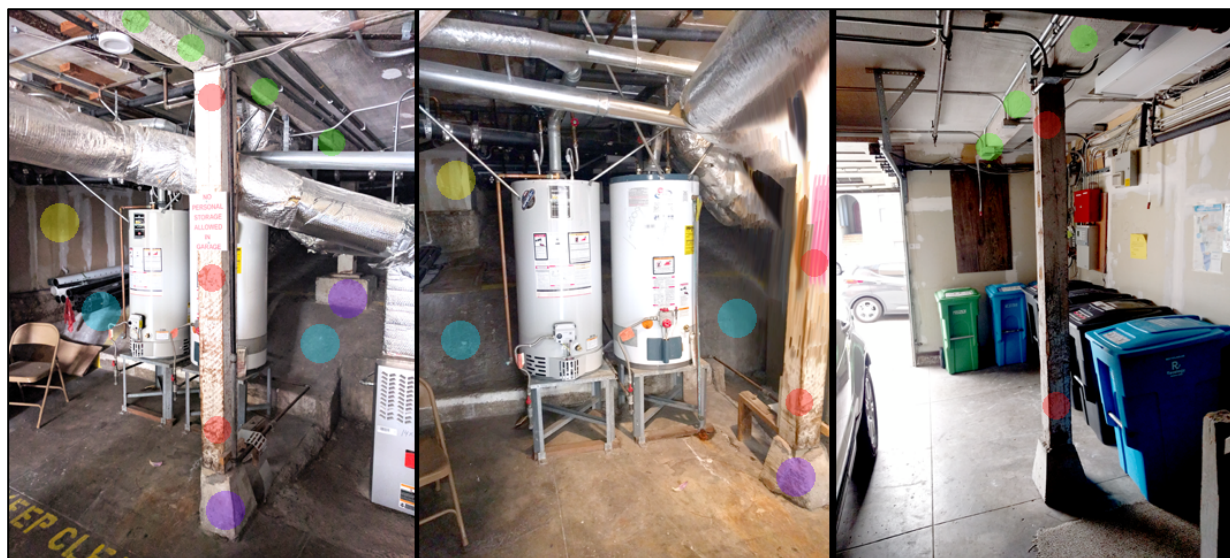
**Figure 2.** Interior images of the first story showing the framing of the interior, and the water heaters. The left and right images are in opposite longitudinal directions. The green dots indicate dimensional lumber beams, the red are dimensional lumber posts, the purple are the footings, the blue is a low transverse stem wall, and the yellow is gypsum board installed at some locations when the fire sprinklers were installed. In the middle image note the diagonal braces from the ceiling to the water heaters.

- It was observed in the basement that there are no interior walls to support the second floor diaphragm, but there are dimensional lumber elements on the interior, see Figure 2. The posts are supported on concrete elements, but there is no positive attachment to the foundation. The posts support segmented beams at the top which are toe-nailed into the posts, and have no reliable tension connection to each other or to the posts.

- Wood siding on the north side is straight board sheathing and deteriorated. There is no flashing at the separation between the buildings.
- There are two gas-fired water heaters in the garage, see Figure 2, that have bracing to the second floor framing and are supported on pedestals that have limited lateral force-resistance capacity, see Figure 2.
- The building is located a few inches at most from the adjacent building on the north, see cover figure. The condition of the north wall is unknown as too close to the adjacent building to be assessed, see the middle image of the front illustration and cover figure. Unless the wood sheathing boards are redwood, they are likely to be deteriorated. It would be prudent to install deformable flashing on the full perimeter of the separation between this building and the one to the immediate north

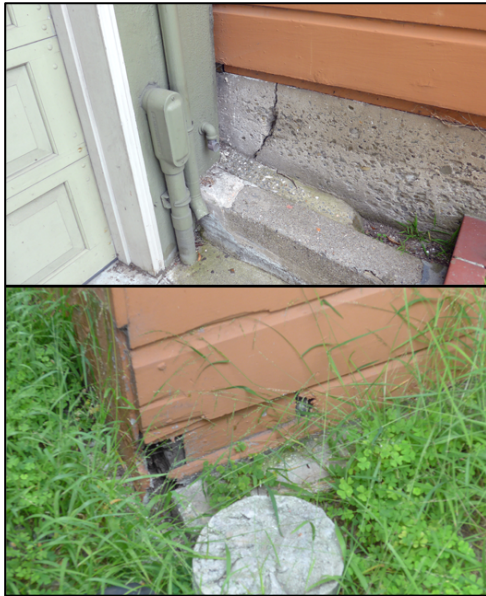
**Figure 3.** The upper image shows the bottom section of the north party line wall foundation and original straight-board sheathing. The lower image is of the corner of the building to the right of the above image.

- The first (garage) story has no reliable lateral load-resisting system on the north wall, with straight board sheathing on the exterior in a dilapidated condition, and gypsum board over some of interior walls.

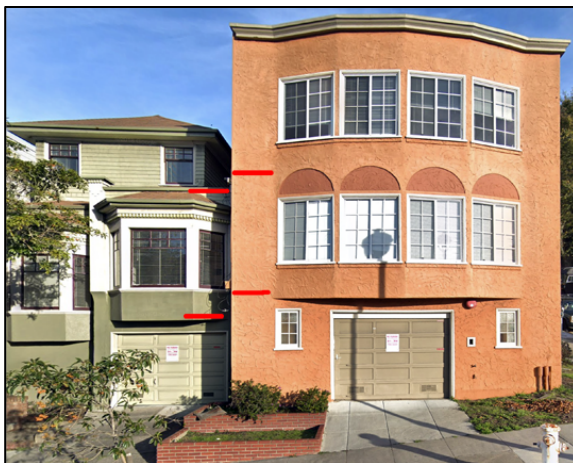
**Figure 4.** Street view from Fifth Avenue showing the adjacent building to the north and the approximate floor levels for the two buildings in red.
