UCSF building seismic ratings

Kalmanovitz Library, University of California San Francisco

CAAN #2012

DATE: 2020-06-26

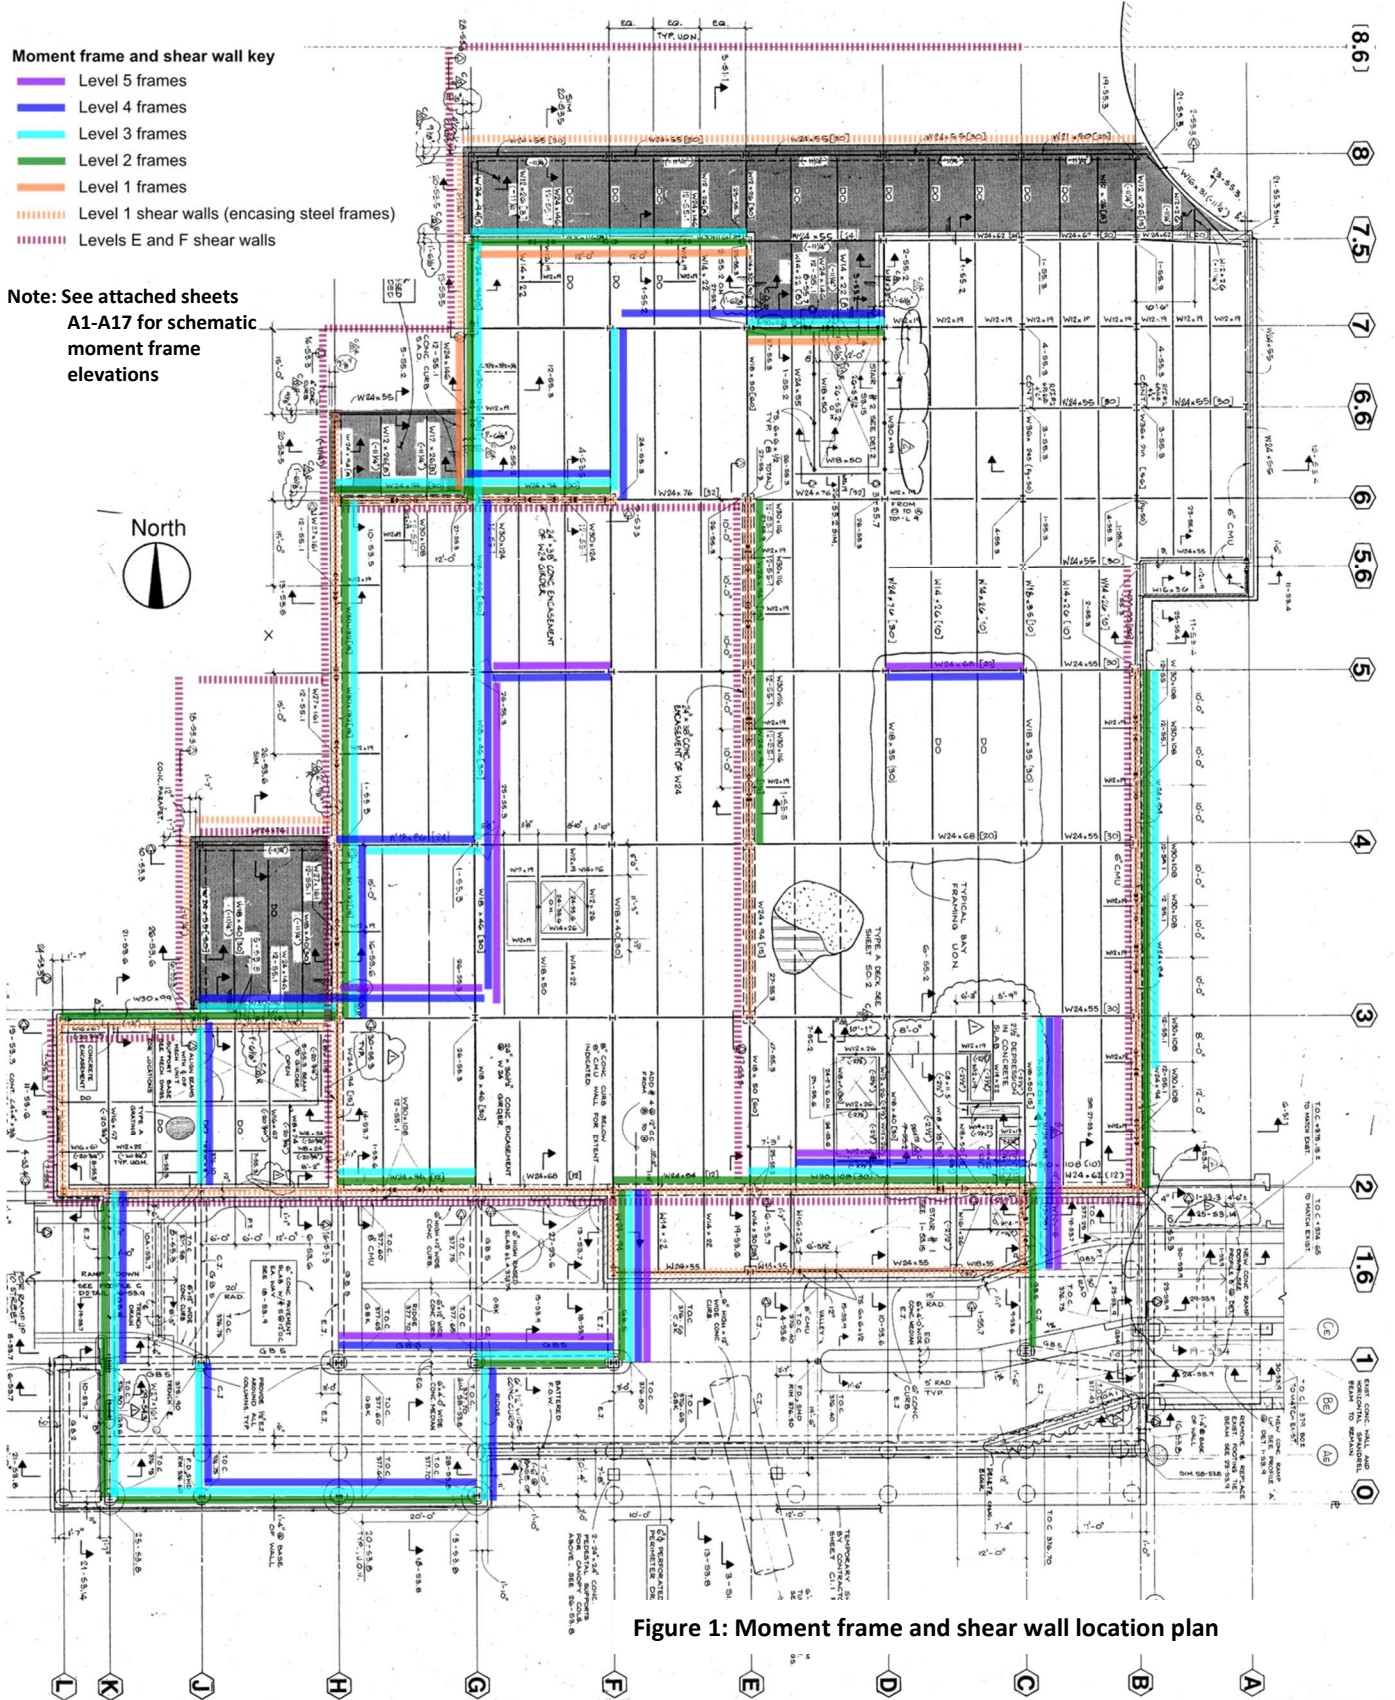
Figure 1: Moment frame and shear wall location plan

Structural feature or potential deficiency	Finding
Steel moment frame geometry	Moment frame geometry is irregular and is discontinuous in multiple places. This could lead to story concentrations of deformation and transfer forces in floor diaphragms and collectors that would have been underestimated in the original design, compared to post-1988 standards.
Welded moment connections	Full-penetration flange welds at steel frame moment connections likely to lack ductility because design and specification of the welds predates the October 1994 UBC Emergency Provisions for steel moment-resisting frames (i.e. pre-Northridge.) The welds have the potential to fracture when subjected to earthquake deformation demand. The issue has been studied for beams welded to columns. The severity of the issue for the infill columns welded to beams has to our knowledge not been studied.
Moment frame stability	There is limited lateral bracing at the connections of infill columns to beams. If the connections are not sufficiently braced, lateral buckling can limit the frame's ability to resist seismic forces and control story drift.

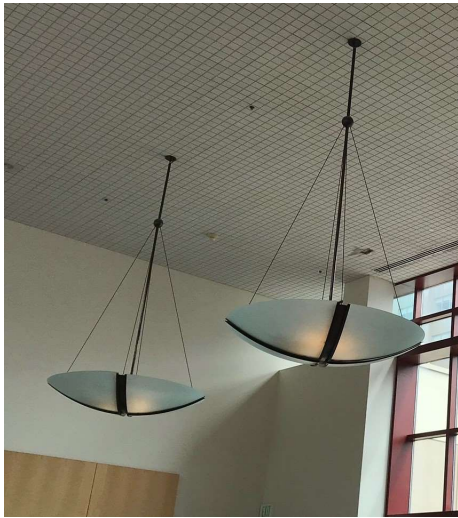
The building is clad with GFRC (glass fiber reinforced concrete) panels which are not considered a falling hazard. The attachment of the larger decorative pendant lights in the building should be reviewed and retrofitted if necessary.

Lighting, 5th floor lounge area
