## UCSF building seismic ratings

### 2330 Post Street, MOB 1

2330 Post Street, San Francisco, CA 94115

DATE: 2020-06-26

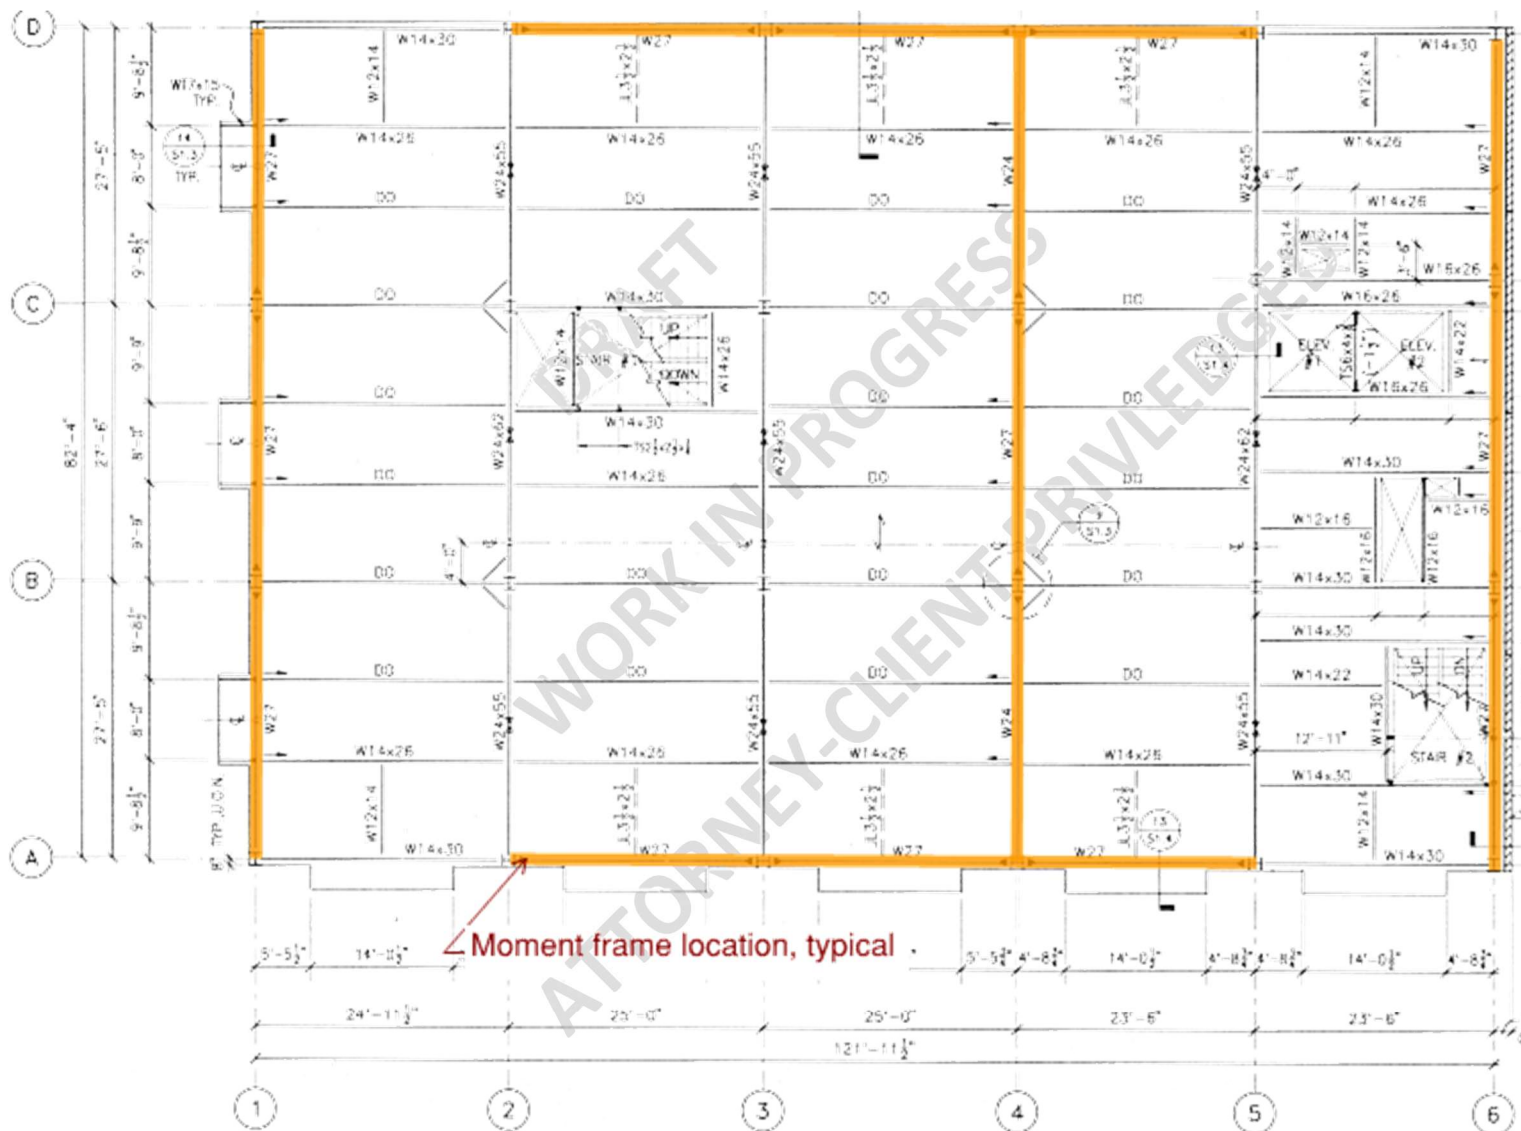
Figure 1: Moment frame location plan

Structural system for lateral forces: There is a full-height welded steel moment frame at the perimeter on all 4 sides of the building. There is a 5<sup>th</sup> full-height moment frame oriented east-west at grid line 4, which is the south façade at the 5<sup>th</sup> and 6<sup>th</sup> floors. See figures 1 and 2.

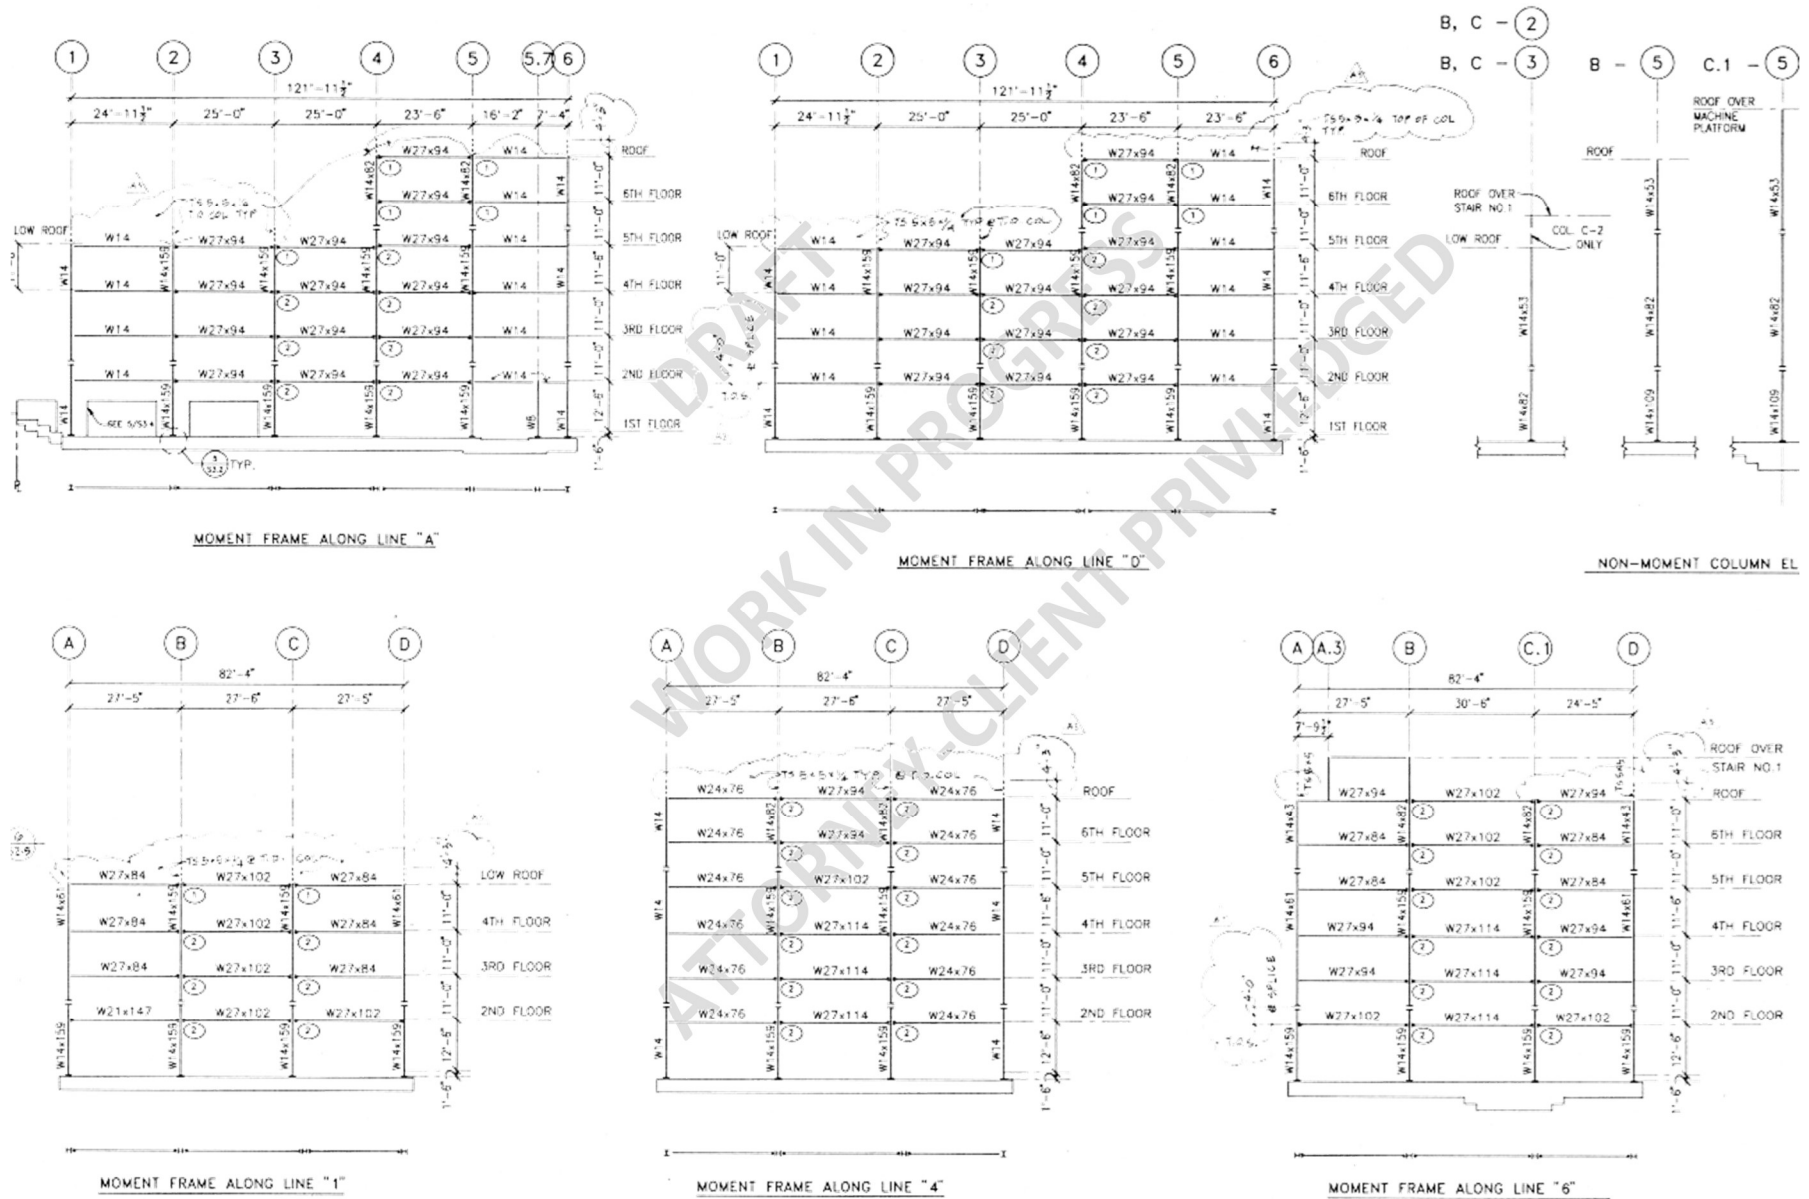
Figure 2: Moment frame elevations (ref. sheet S3.1)

| Structural feature or potential deficiency | Finding/notes |
|--|---|
| Welded moment connections | Full-penetration flange welds at steel frame moment connections are susceptible to early fracture because design and specification (and probably construction) of the welds predates the October 1994 UBC Emergency Provisions for steel moment-resisting frames (i.e. pre-Northridge.) The welds have the potential to fracture when subjected to earthquake deformation demand. |

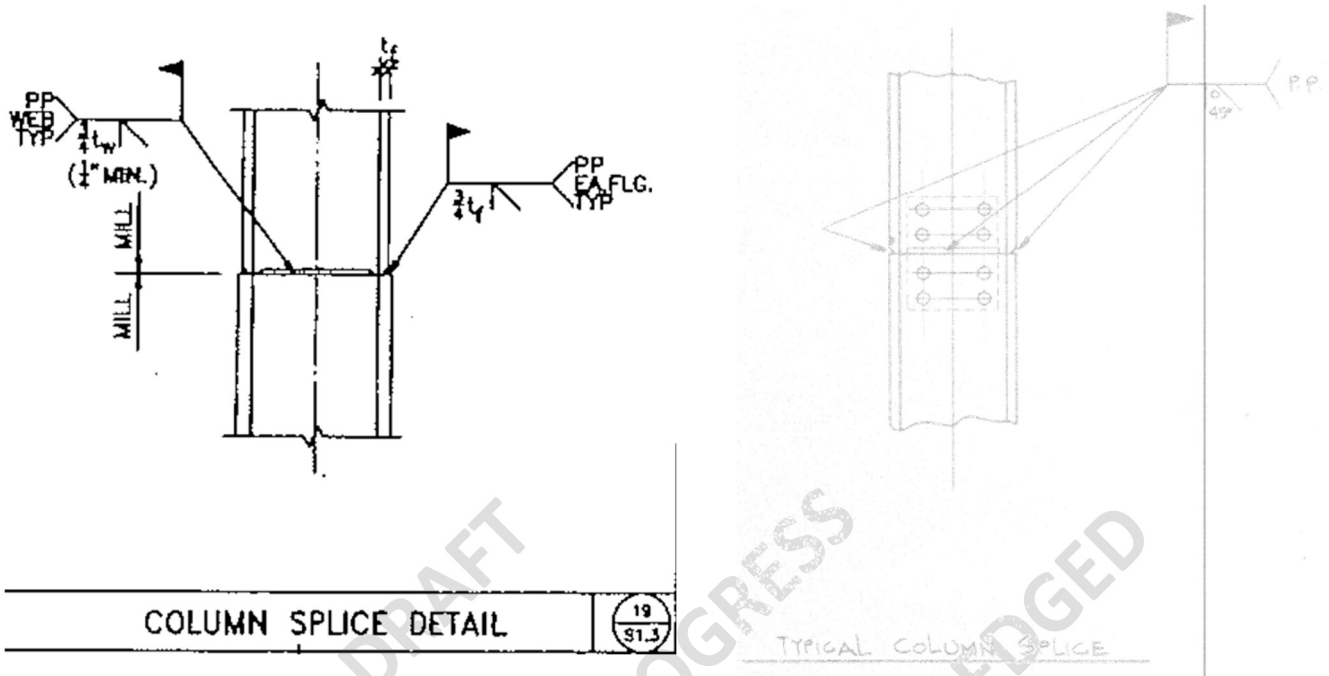
Figure 4: Column splice detail

| Structural feature or potential deficiency | Finding/notes |
|--|--|
| Welded column splices | <p>Tier 1 assumes no deficiency if both webs and flanges and column splices are connected in any manner. However, more detailed studies of moment-frame buildings have shown column splices to be a potential vulnerability, in particular those using partial penetration welds as is the case with this structure. For a typical case of welds sized to ½ of flange and web thickness, research has shown that the capacity of welds may be as low as 10% of the column section capacity. Each column in the building is spliced above the second floor, and each column that extends to the higher portion of the building is spliced above the 5<sup>th</sup> floor.</p> |

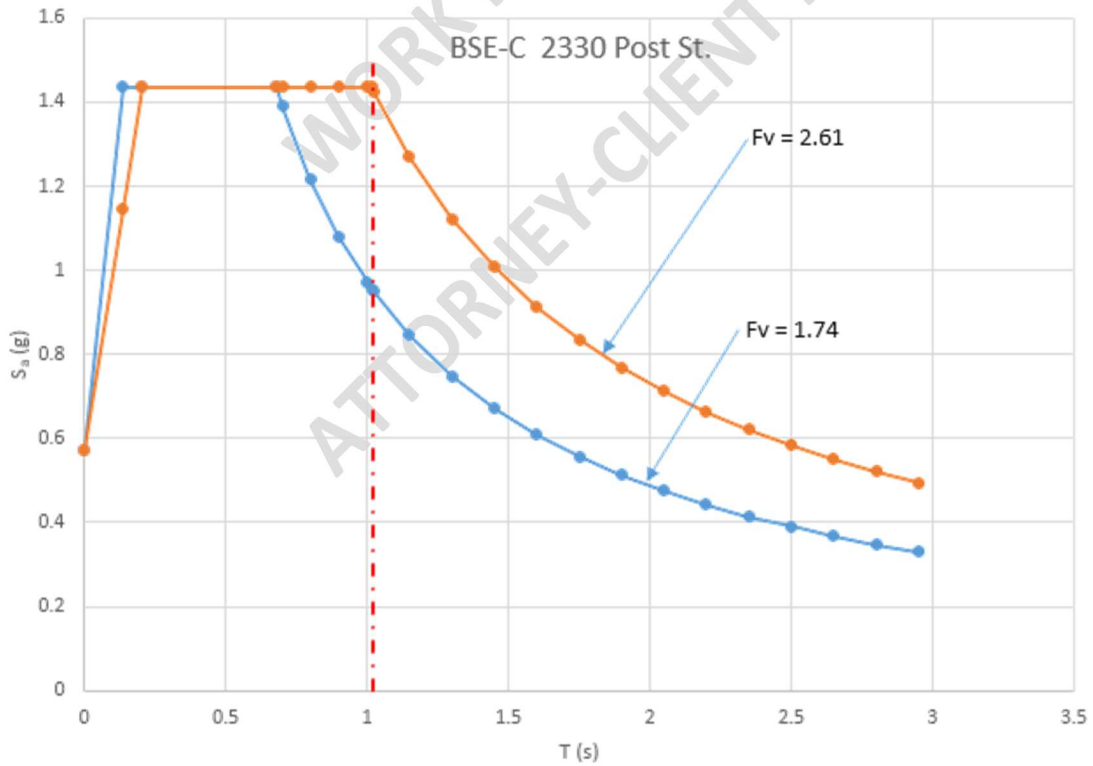
Figure 5: Response spectra

| Structural feature or potential deficiency | Finding/notes |
|--|--|
| Site class D spectral shape | Per footnote 4, the earthquake demands are based on an $F_v$ factor that does not include the requirements of Section 11.4.8-3 of ASCE 7-16. If such requirements were to be included, for this building with $T=1.02$ seconds (using ASCE 41-17 equation 4-4 based on building height), demands would increase by a factor of about 1.5. (See Figure 5.) The Quick Check of inter-story drift ratios would then be noncompliant for all stories and directions, with values up to 6% at the 5 <sup>th</sup> floor. Also, the Quick Check for column flexural stress would be noncompliant in both the transverse and longitudinal directions at the 6 <sup>th</sup> floor (38% over) and in the transverse direction at the 3 <sup>rd</sup> floor (15% over). |

<sup>4</sup>  $F_v$  factor used does not include the requirements of Section 11.4.8-3 of ASCE 7-16 that are applicable to Site Class D, and which per Exception 2 would result in an effective  $F_v$  factor 1.5 times larger. At the UCSF Mt. Zion campus this affects structures with  $T > 0.68$  seconds.

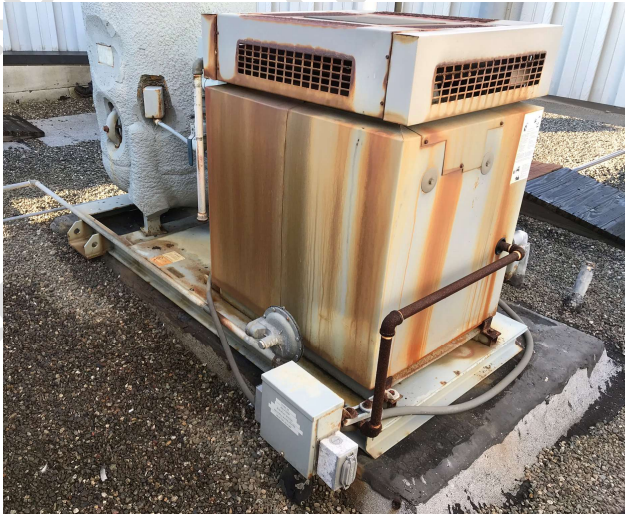
The anchorage of and fuel connections to 2 rooftop natural gas-fueled boilers should be reviewed and retrofitted if needed. There is an earthquake-activated automatic gas shutoff at the main gas service at ground level adjacent to Post Street. However, this rooftop equipment should be anchored. Note that rooftop seismic motions will be amplified.

| UCOP non-structural checklist item | Life safety hazard? | UCOP non-structural checklist item | Life safety hazard? |
|--|---|--|---|
| Unbraced masonry parapets, cornices or other ornamentation above exit ways and public access areas | None observed | Unrestrained natural gas-fueled equipment such as water heaters, boilers, emergency generators, etc. | Investigate rooftop boilers |

Rooftop boiler for domestic hot water

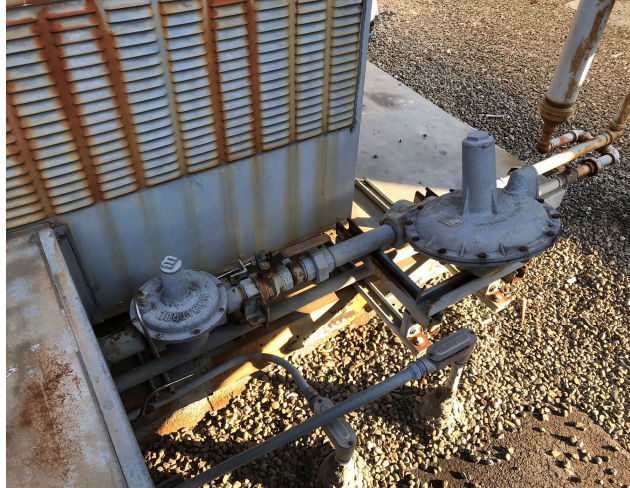
Natural gas line to HVAC boiler
