UCSF Building Seismic Ratings
1490 5TH AVENUE

CAAN #2021
1490 5th AVENUE, SAN FRANCISCO, CA 94122
UCSF Campus: Parnassus

Rating summary	Entry	Notes
UC Seismic Performance Level (rating)	V	Findings based on drawing review and ASCE 41-17 Tier 1 evaluation ¹
Rating basis	Tier 1	ASCE 41-17
Date of rating	2020	
Recommended UCSF priority category for retrofit	Priority B	Priority A = Retrofit ASAP Priority B=Retrofit at next permit application for modification
Ballpark total project cost to retrofit to IV rating	High	See recommendations on further evaluation and retrofit.
Is 2018-2019 rating required by UCOP?	Yes	
Further evaluation recommended?	No

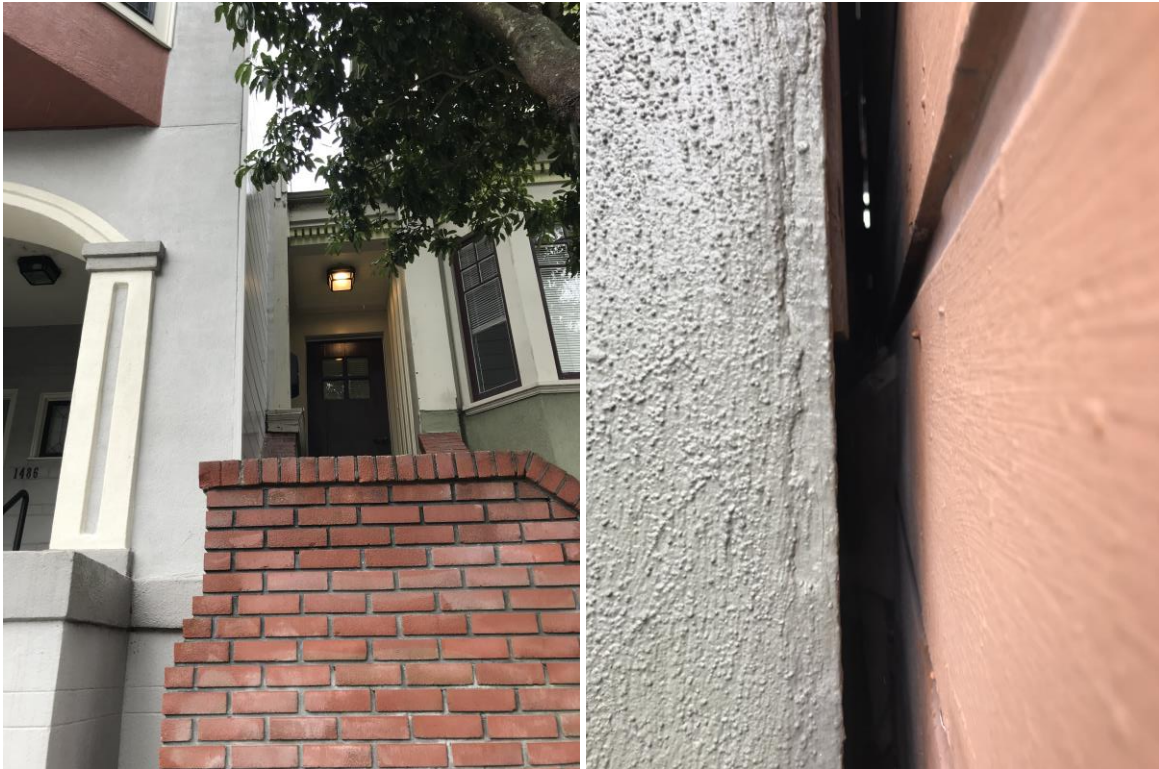
- There is nearly no separation to the north and the separation to the south is approximately 2 inches. The floor levels do not align with the adjacent buildings due to the sloped site.
- The basement cripple walls were primarily sheathed with plaster and gypsum board. Based on the age of construction it is assumed the anchor bolts for the sill plate are not adequate.

Figure 4 - Building Separation to the North (Left) and South (Right)

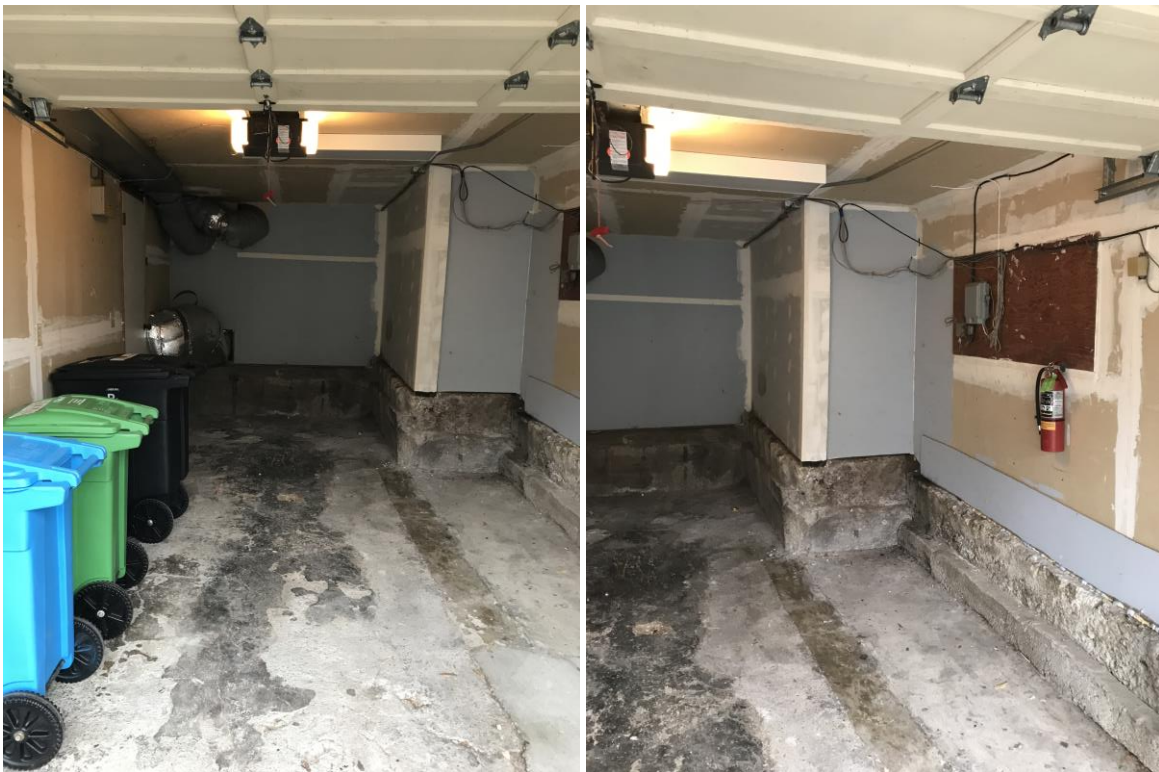
Building Condition: What could be observed of the structure of the building appeared to be in fair condition; however, most of the structure was concealed behind finishes. The concrete stem walls in the garage were in poor condition, with widespread spalling and/or poor consolidation. The stucco seemed to be in good condition.

Figure 5 – Concrete Spalling at Garage

No further evaluation of this building is recommended. There is relatively low risk to occupant life-safety posed by this type of building based on historical performance of similar building types. It is recommended that work to improve the seismic performance of the building be included with any future renovation requiring a building permit.

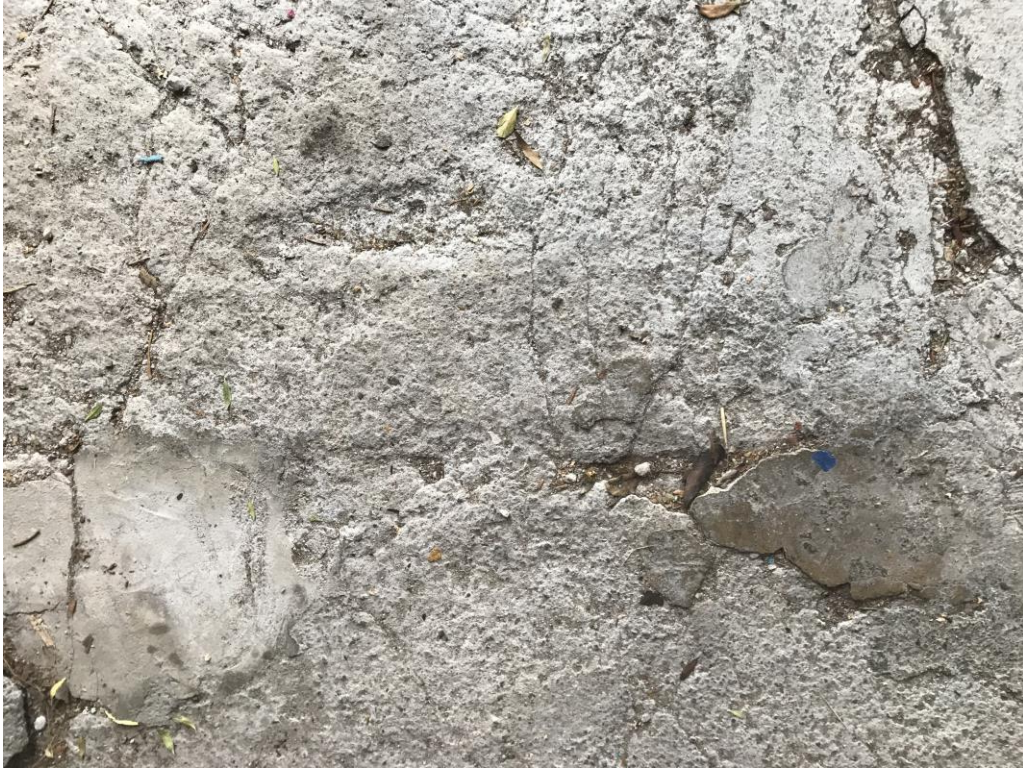
Figure 6 – Concrete Spalling of Garage Slab

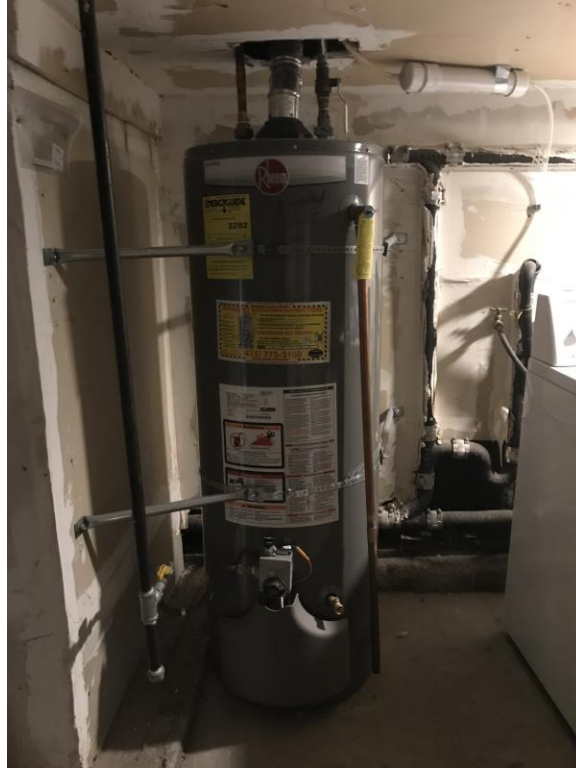
The water heater in the basement was anchored.

Figure 8 – Anchored Water Heater

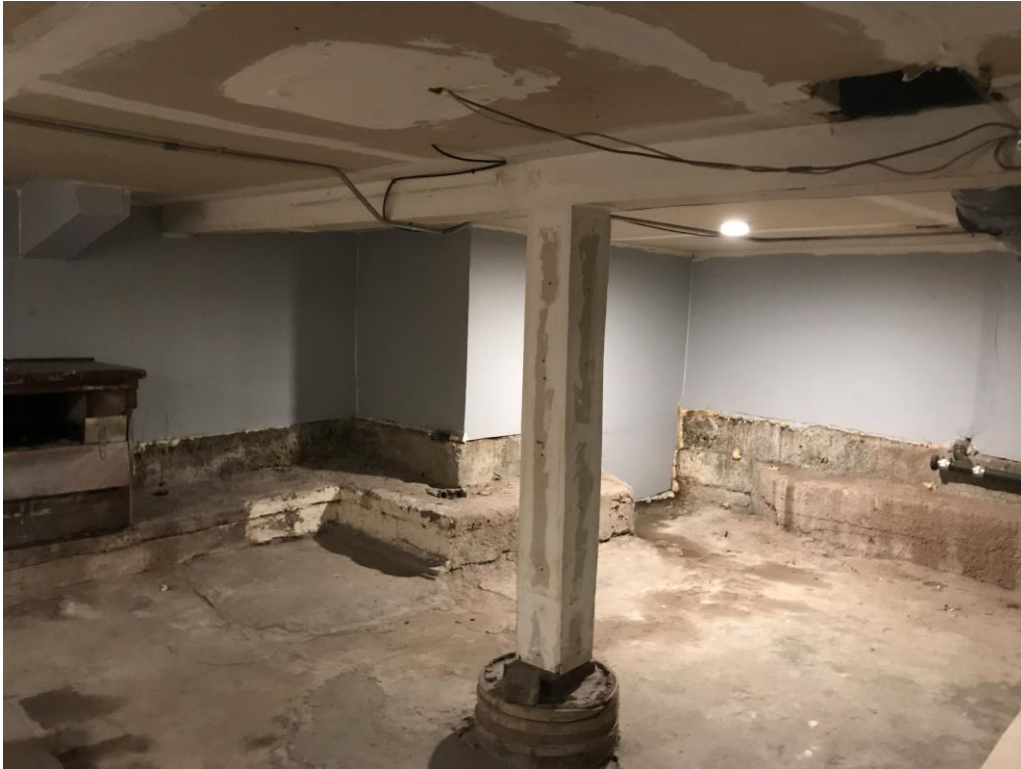
Figure 10 – Interior Basement Post

Description
C <input checked="" type="radio"/>	NC <input type="radio"/>	N/A <input type="radio"/>	U <input type="radio"/>	<p>WOOD POSTS: There is a positive connection of wood posts to the foundation. (Commentary: Sec. A.5.3.3. Tier 2: Sec. 5.7.3.3)</p> <p>Comments: Wood posts did not have positive connections to the foundation.</p>
C <input type="radio"/>	NC <input type="radio"/>	N/A <input type="radio"/>	U <input checked="" type="radio"/>	<p>WOOD SILLS: All wood sills are bolted to the foundation. (Commentary: Sec. A.5.3.4. Tier 2: Sec. 5.7.3.3)</p> <p>Comments: All wood sills in the basement space were concealed by finishes. However, based on the age of the building it is anticipated the wood sill bolting is not adequate.</p>
C <input checked="" type="radio"/>	NC <input type="radio"/>	N/A <input type="radio"/>	U <input type="radio"/>	<p>GIRDER-COLUMN CONNECTION: There is a positive connection using plates, connection hardware, or straps between the girder and the column support. (Commentary: Sec. A.5.4.1. Tier 2: Sec. 5.7.4.1)</p> <p>Comments: Girders did not have positive connections to the posts.</p>
