DATE: 2019-10-10

UCSF building seismic ratings

Mount Zion, Building E (Harold Brunn Research Institute)

CAAN #2024

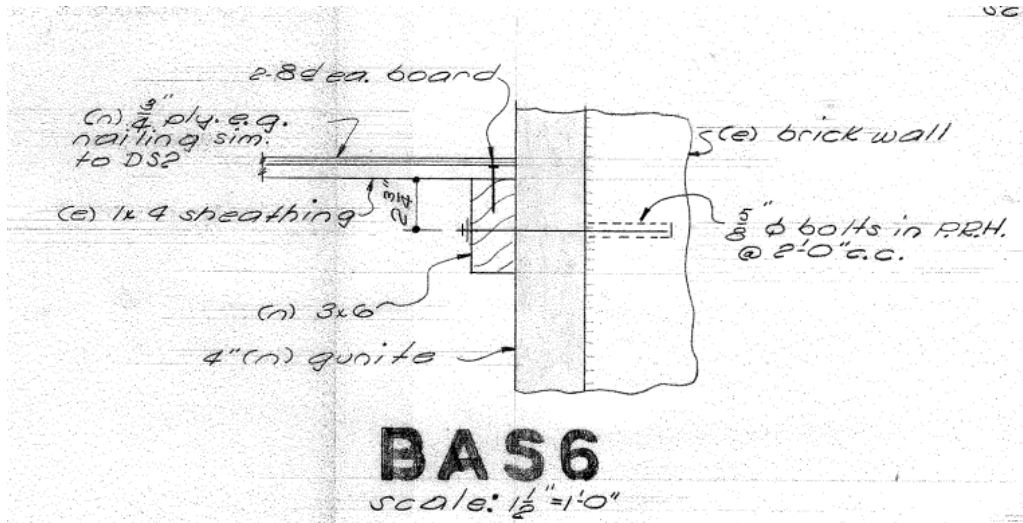
- In the north wing, the exterior wall-to-diaphragm connection relies upon cross-grain bending of the wood ledger.
- No diaphragm cross ties are present in the N-S direction of the north wing.

Connection A: Typical diaphragm-to-wall connection parallel to the wood trusses

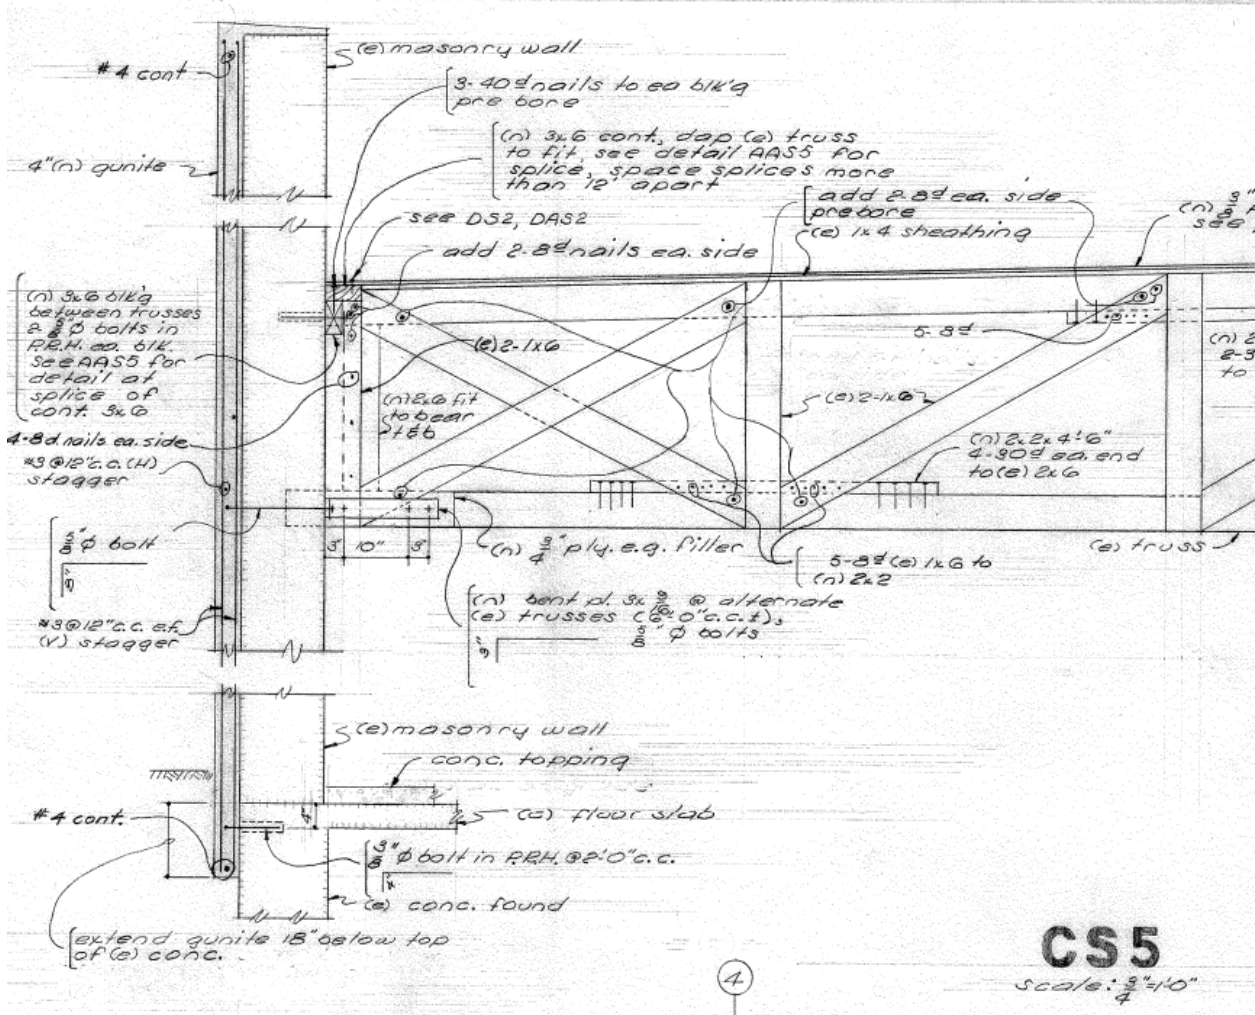
Connection B: Typical diaphragm-to-wall connection perpendicular to the wood trusses

Description
C NC N/A U <input type="radio"/> <input checked="" type="radio"/> <input type="radio"/> <input type="radio"/>	<p>WALL ANCHORAGE: Exterior concrete or masonry walls that are dependent on the diaphragm for lateral support are anchored for out-of-plane forces at each diaphragm level with steel anchors, reinforcing dowels, or straps that are developed into the diaphragm. Connections have strength to resist the connection force calculated in the Quick Check procedure of Section 4.4.3.7. (Commentary: Sec. A.5.1.1. Tier 2: Sec. 5.7.1.1)</p> <p>Comments: The connection details utilize wood members in cross-grain bending. In addition, there are no crossties developed into the diaphragm for the north wall.</p>
C NC N/A U <input type="radio"/> <input checked="" type="radio"/> <input type="radio"/> <input type="radio"/>	<p>WOOD LEDGERS: The connection between the wall panels and the diaphragm does not induce cross-grain bending or tension in the wood ledgers. (Commentary: Sec. A.5.1.2. Tier 2: Sec. 5.7.1.3)</p> <p>Comments: The roof connection located at the north wall of the structure is reliant upon cross-grain bending.</p>

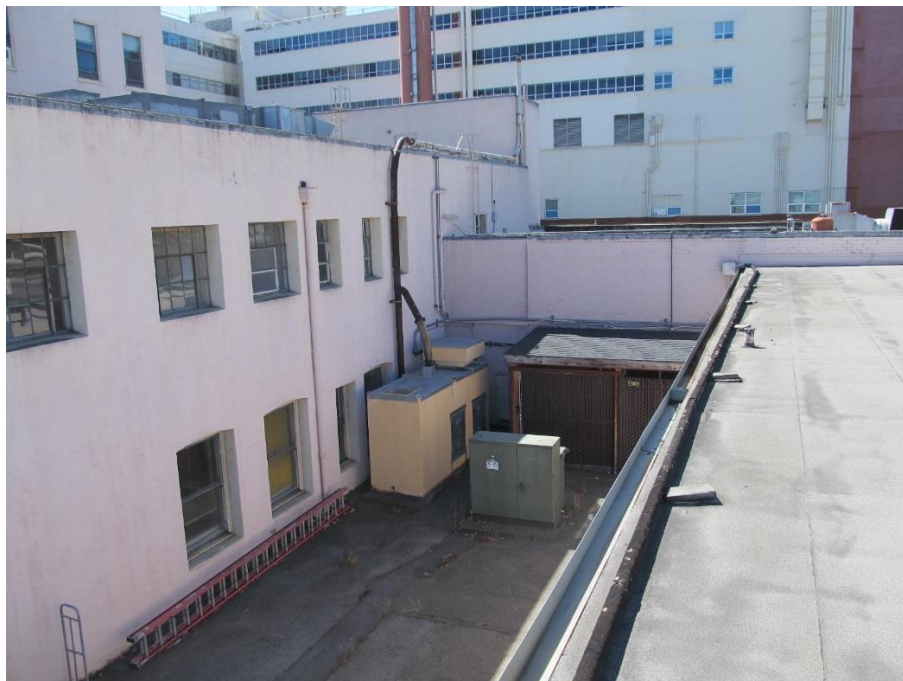
- The gunite walls do not extend to the top of the existing foundations and not have any bearing capacity.
- The building is L-shaped and contains some geometric irregularities including a re-entrant corner and split-level diaphragms.

Re-entrant corner at north elevation of the south wing and east elevation of the north wing (looking southwest from Building G)

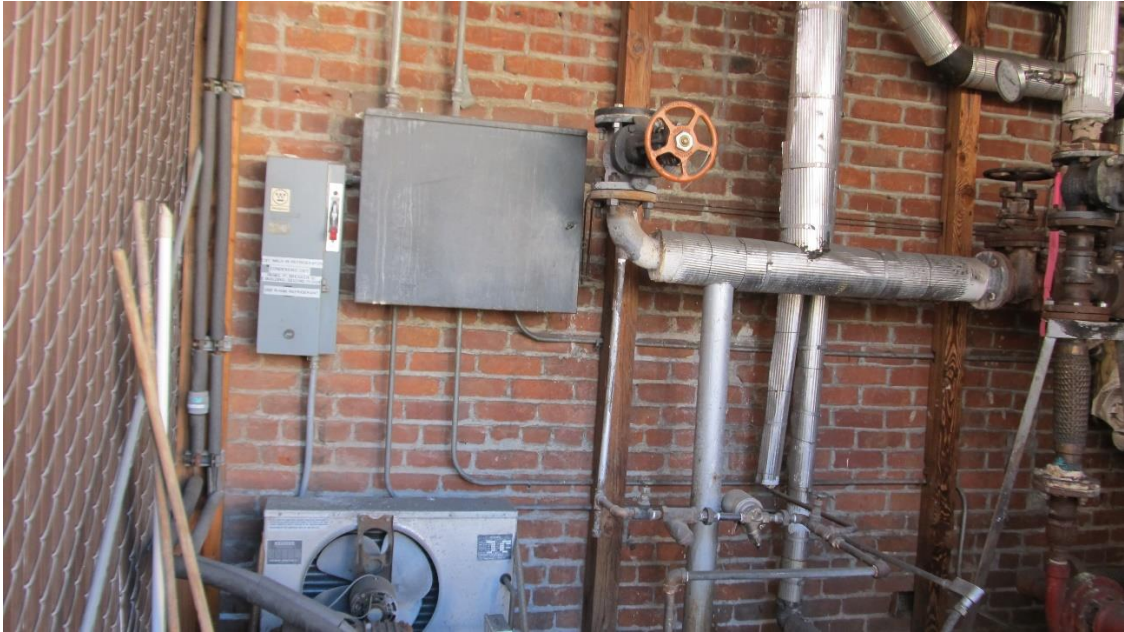
Exposed solid clay URM wall at east elevation of north wing
(looking west)

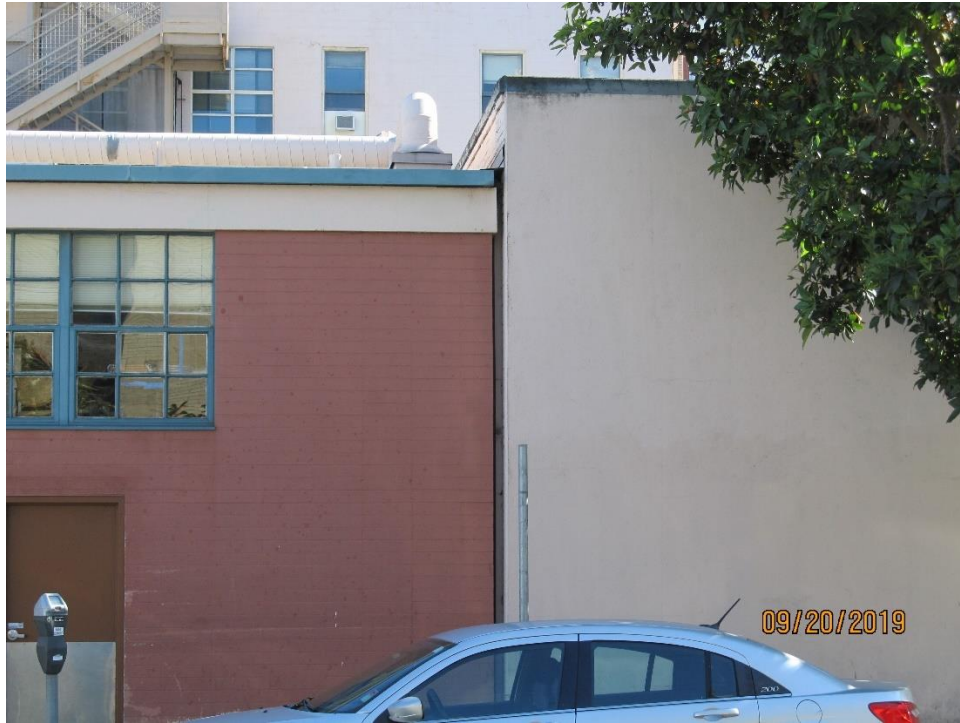
Seismic joint between Building G and Building E
(looking south, Building G on the left and Building E on the right)

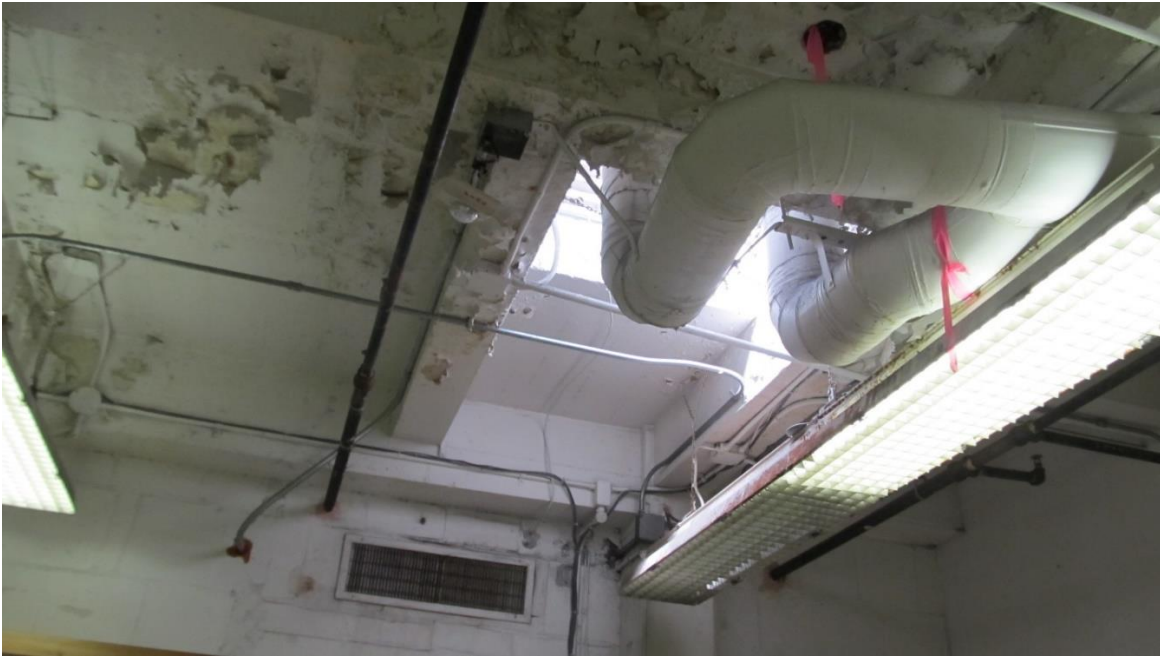
Building condition: The roof is in poor condition. On-going leaks at the roof were noted by the building engineer and observed in the field. Buckets are located to catch rainwater and the paint is peeling from the underside of the roof framing. Floor tiles are missing in a number of locations. Otherwise, the structure is in relatively good condition.

Water damage due to deficient waterproofing on south wing

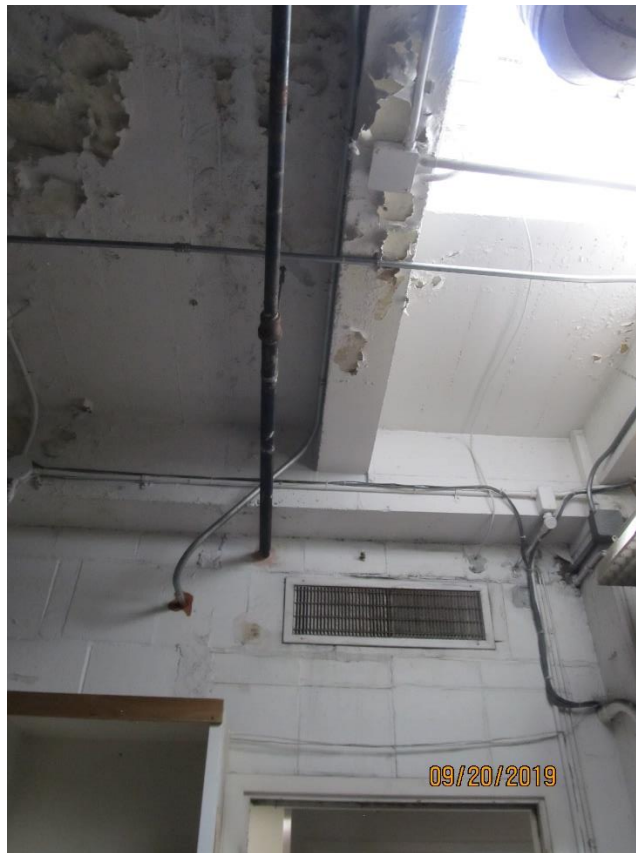
In the south wing, Building E contains hollow clay tile partitions located along one side of the main corridor. In addition to risk imposed by the presence of this partition, in some locations, the lateral bracing from the adjacent

Hollow clay tile partitions at second story (looking north)

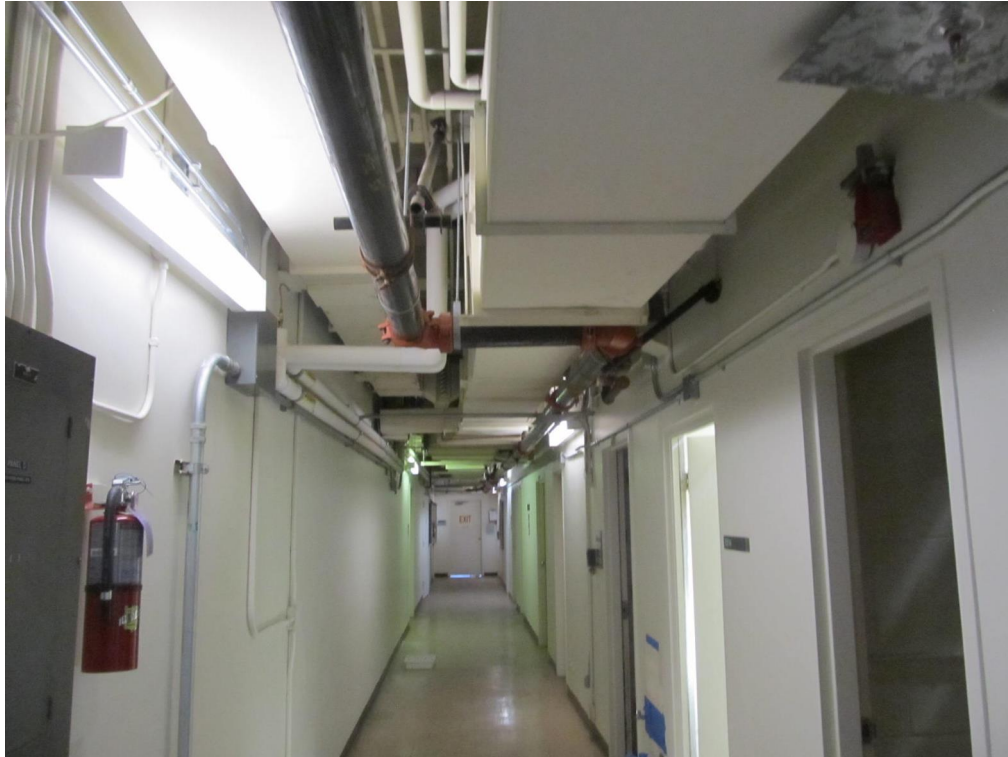
Corridor at second story with hollow clay tile partitions on the right side (looking east)

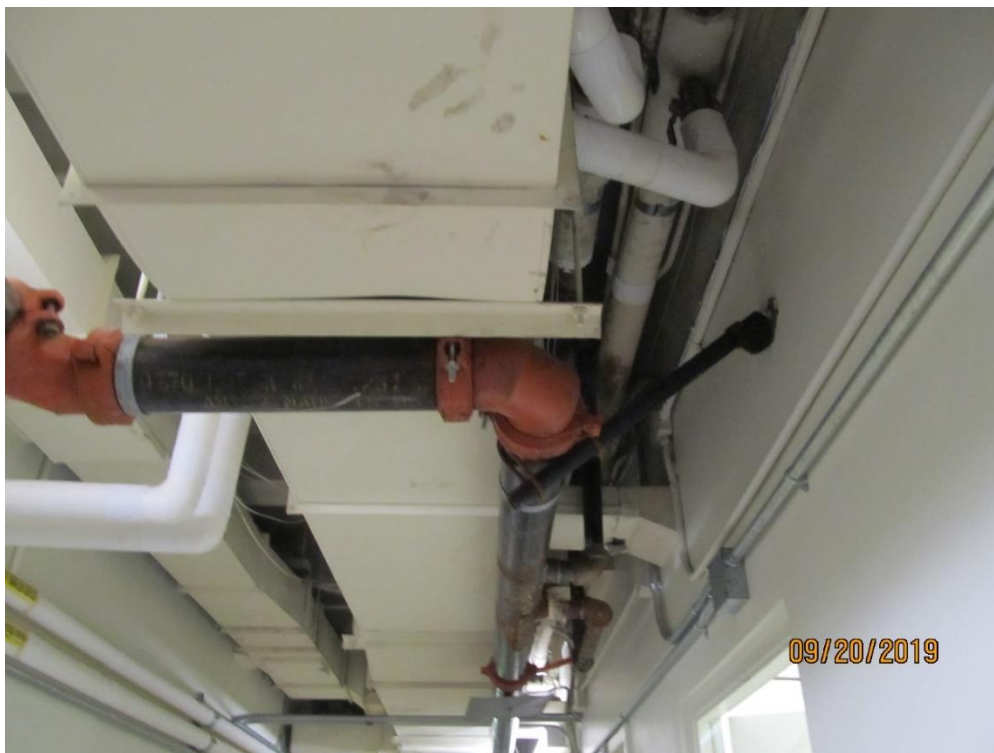
MEP distribution system is kicked to these partitions and will impose loads out-of-plane during a seismic event. Storage of items labeled as “biohazards” were observed in unbraced refrigerators. In addition, the building facility manager indicates the chemical waste from the adjacent hospital is stored inside the structure temporarily until it is transported for disposal. The lateral bracing of these items is unknown.

Pipe system braced to the hollow clay tile partitions at second story

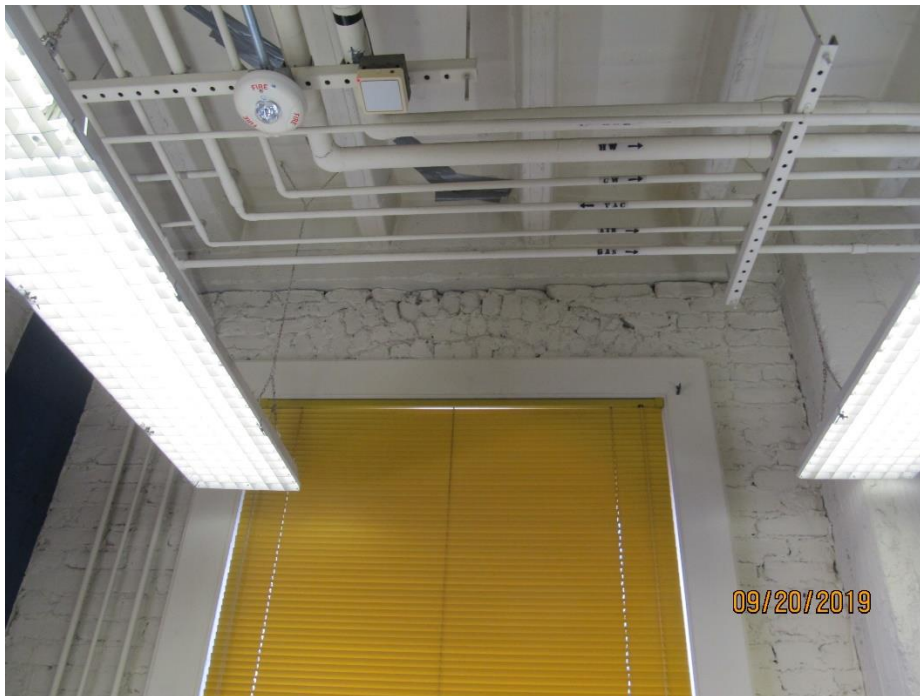
- Gaps were observed at the top of the masonry infill and the underside of the concrete frame.
- Given the building vintage, it is likely that the concrete frame contains non-ductile detailing and is shear controlled.

frame with URM infill, and in some locations a gap between the URM and the concrete members are visible. During a seismic event, as the URM degrades it may fall from the frame. It will be restrained from falling outwards by the gunite walls unless the anchors at the located at floor level fail. Although less common, the URM has the potential to fall inwards as it does not have restraint in this direction. If the infill falls, the lateral loads would be then be resisted by the remaining concrete frame. This frame is likely non-ductile, and the members shear controlled. As such, it would have limited displacement ductility before failure.

Gap between bottom of concrete framing and top of URM infill (looking east)

C NC N/A U <input type="radio"/> <input checked="" type="radio"/> <input type="radio"/> <input type="radio"/>	<p>INFILL WALL CONNECTIONS: Masonry is in full contact with frame. (Commentary: A.3.2.6.1. Tier 2: Secs. 5.5.3.5.1 and 5.5.3.5.3)</p> <p>Comments: Gaps between the infill walls and the masonry frame were observed in the field.</p>

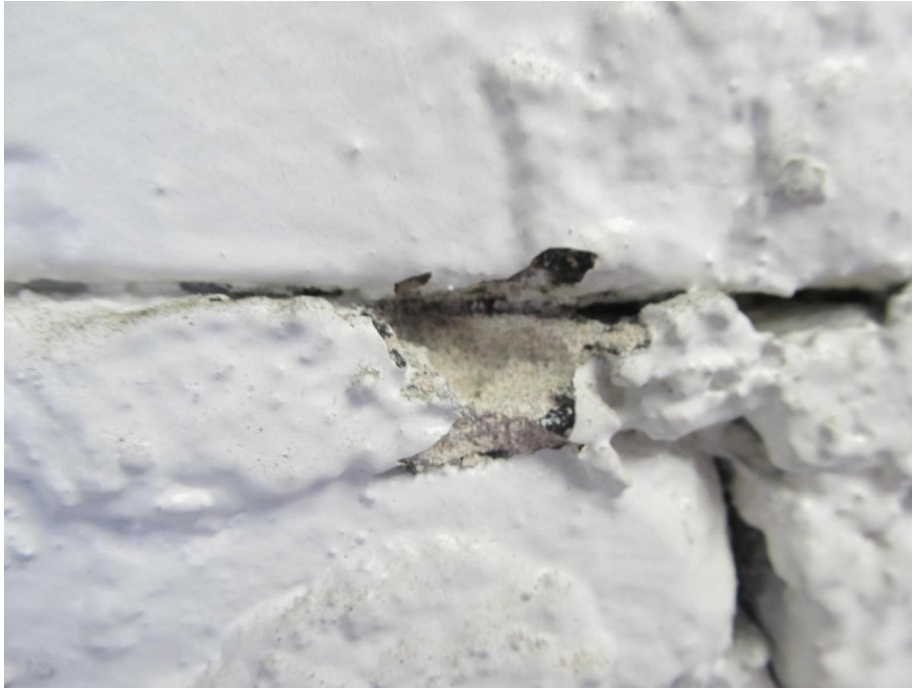
Scraped mortar of URM wall using flat-head screwdriver on southeast corner of building at the first story

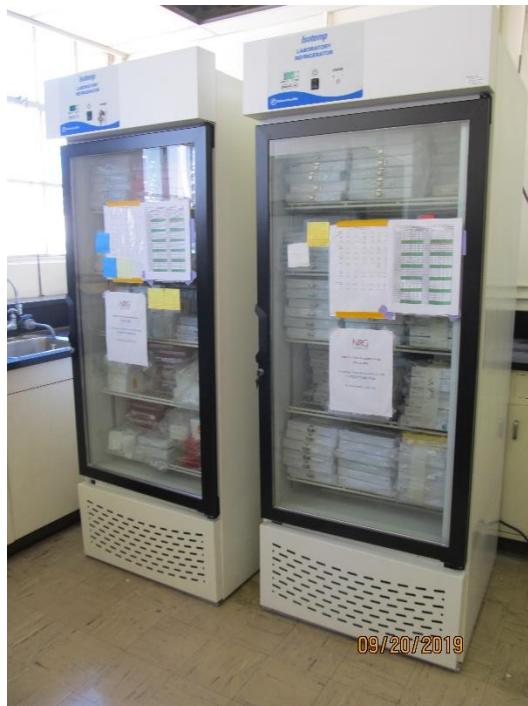
Unbraced refrigerators in laboratory with biohazard tag at second story (looking northeast)

P <input checked="" type="checkbox"/> N/A <input type="checkbox"/>	Unrestrained hazardous material storage Comments: Items marked as biohazards are being stored in unbraced refrigerators. In addition, the facility manager indicates that chemical waste from the adjacent hospital is stored inside the structure.
P <input type="checkbox"/> N/A <input checked="" type="checkbox"/>	Masonry chimneys Comments: No masonry chimneys are in the building.
P <input checked="" type="checkbox"/> N/A <input type="checkbox"/>	Unrestrained natural gas-fueled equipment such as water heaters, boilers, emergency generators, etc. Comments: The UCSF Mt. Zion campus assistant engineer indicates that gas is supplied to the lab benches in Building E. Since Building E is vacant, it is unknown if the gas supply was capped when the occupants relocated. It is unknown if the gas lines are braced.
P <input checked="" type="checkbox"/> N/A <input type="checkbox"/>	Other: Comments: The structure contains hollow clay tile partitions along the interior corridors. In addition, in some locations the lateral bracing for the MEP piping that runs above the corridor is kicked to these partitions and will load them out-of-plane.
