**UCSF Building Seismic Ratings**  
**1478-80 5<sup>TH</sup> AVENUE**

CAAN #2028

1478-80 5<sup>th</sup> AVENUE, SAN FRANCISCO, CA 94122

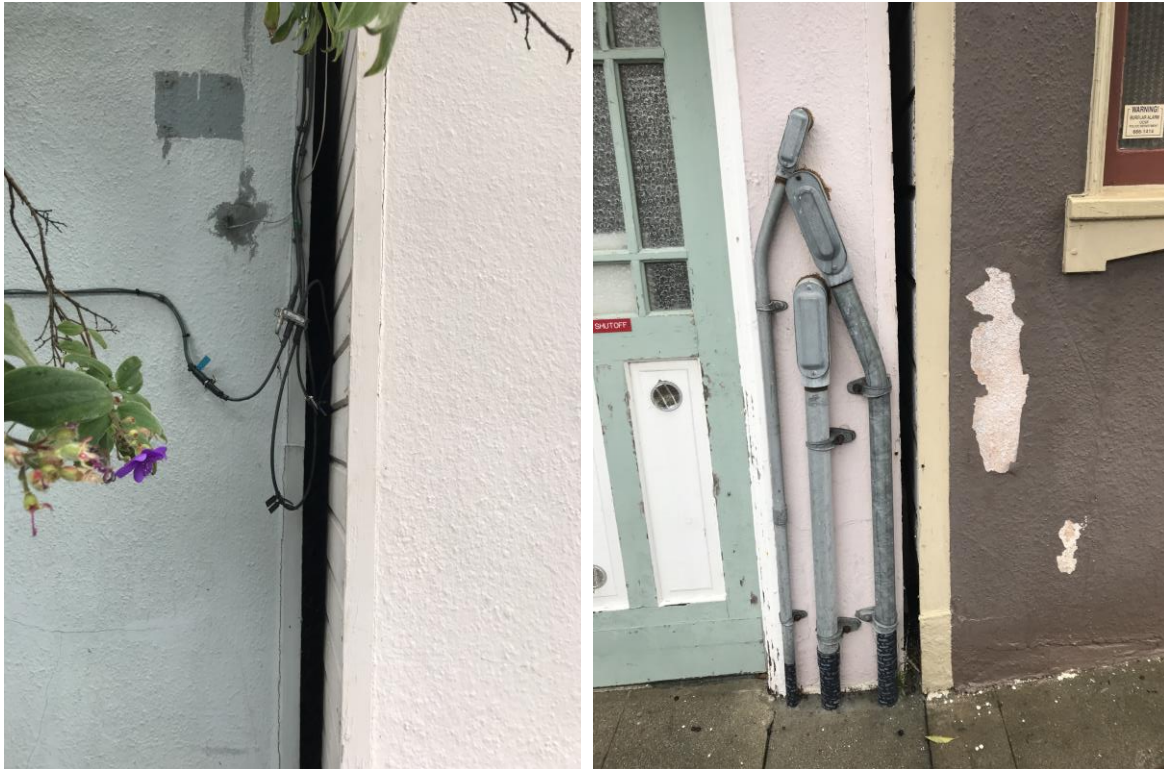
**Figure 6 - Building Separation to the North (Left) and South (Right)**

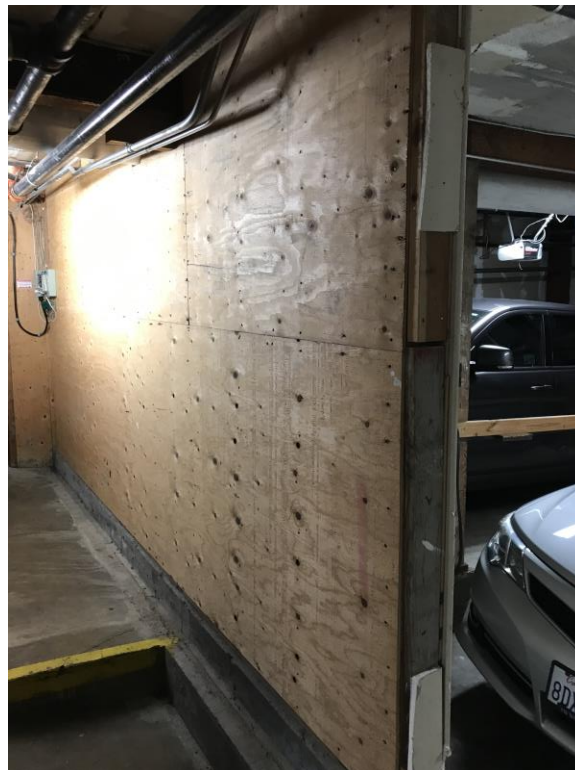
**Figure 7 – New Transverse Plywood Shearwall**

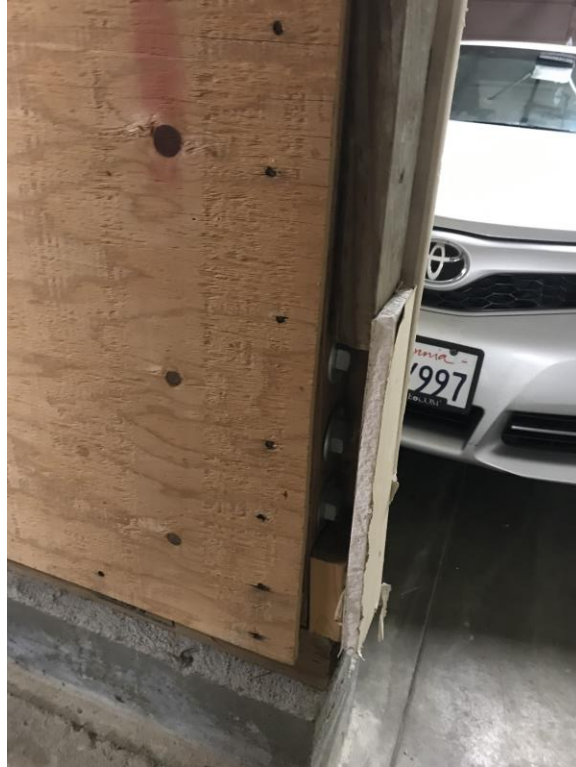
**Figure 8 – New Transverse Plywood Shearwall Holddown Hardware**

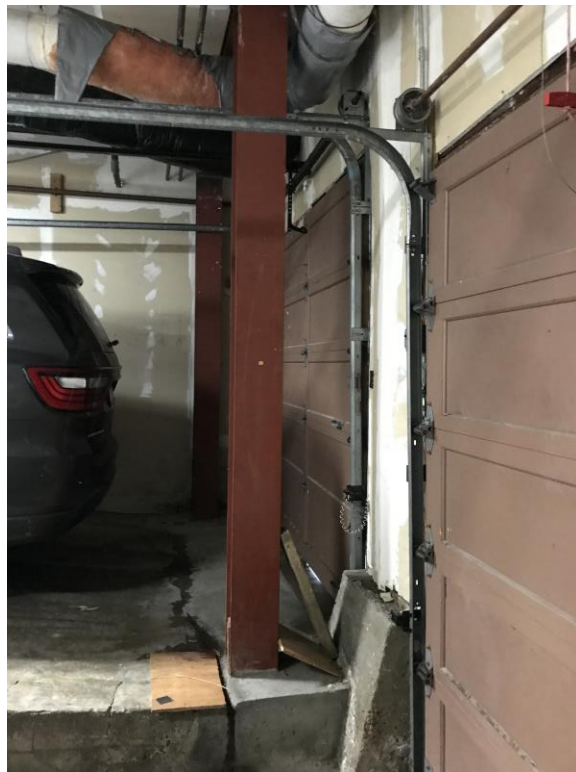
**Figure 9 - New Transverse Moment Frame at South Parking Space**

<input checked="" type="radio"/>	<input type="radio"/>	<input type="radio"/>	<input type="radio"/>	
C	NC	N/A	U	<p>CRIPPLE WALLS: Cripple walls below first-floor-level shear walls are braced to the foundation with wood structural panels. (Commentary: Sec. A.3.2.7.7. Tier 2: Sec. 5.5.3.6.4)</p> <p><b>Comments:</b> Although not visible, it is our understanding that the basement cripple walls were sheathed with wood structural panels based on the 1994 drawings and confirmed by the engineer of record, Tom Butzback.</p>
<input checked="" type="radio"/>	<input type="radio"/>	<input type="radio"/>	<input type="radio"/>	
C	NC	N/A	U	<p>OPENINGS: Walls with openings greater than 80% of the length are braced with wood structural panel shear walls with aspect ratios of not more than 1.5-to-1 or are supported by adjacent construction through positive ties capable of transferring the seismic forces. (Commentary: Sec. A.3.2.7.8. Tier 2: Sec. 5.5.3.6.5)</p> <p><b>Comments:</b> The garage openings exceed 80% of the length of the front wall. However, a moment frame is providing lateral resistance to this line.</p>

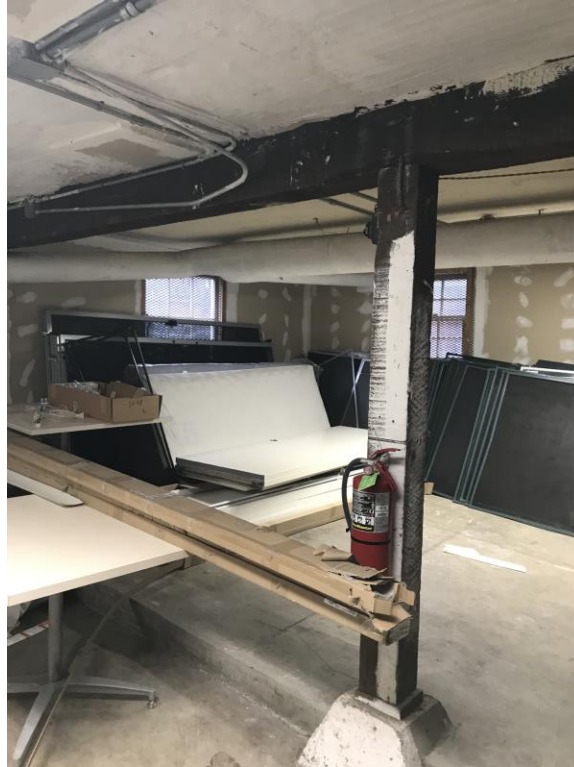
**Figure 10 – Typical Interior Basement Post Without Connectors**

Description
C	NC	N/A	U	<p>WOOD POSTS: There is a positive connection of wood posts to the foundation. (Commentary: Sec. A.5.3.3. Tier 2: Sec. 5.7.3.3)</p> <p><b>Comments:</b> All posts were concealed by finishes.</p>
<input type="radio"/>	<input type="radio"/>	<input type="radio"/>	<input checked="" type="radio"/>	
C	NC	N/A	U	<p>WOOD SILLS: All wood sills are bolted to the foundation. (Commentary: Sec. A.5.3.4. Tier 2: Sec. 5.7.3.3)</p> <p><b>Comments:</b> All wood sills in the basement space were concealed. However, anchor bolts were to be added per the 1994 retrofit.</p>
<input checked="" type="radio"/>	<input type="radio"/>	<input type="radio"/>	<input type="radio"/>	
C	NC	N/A	U	<p>GIRDER-COLUMN CONNECTION: There is a positive connection using plates, connection hardware, or straps between the girder and the column support. (Commentary: Sec. A.5.4.1. Tier 2: Sec. 5.7.4.1)</p> <p><b>Comments:</b> All posts were concealed by finishes.</p>

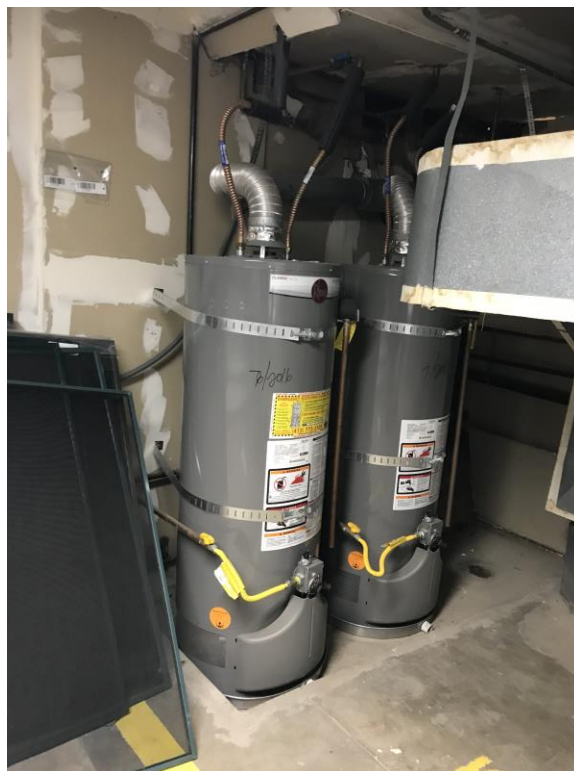
The water heaters were restrained.

**Figure 11 – Braced Water Heaters**
