**UCSF Building Seismic Ratings**  
**1472-74 5<sup>TH</sup> AVENUE**

CAAN #2029

1472-74 5<sup>th</sup> AVENUE, SAN FRANCISCO, CA 94122

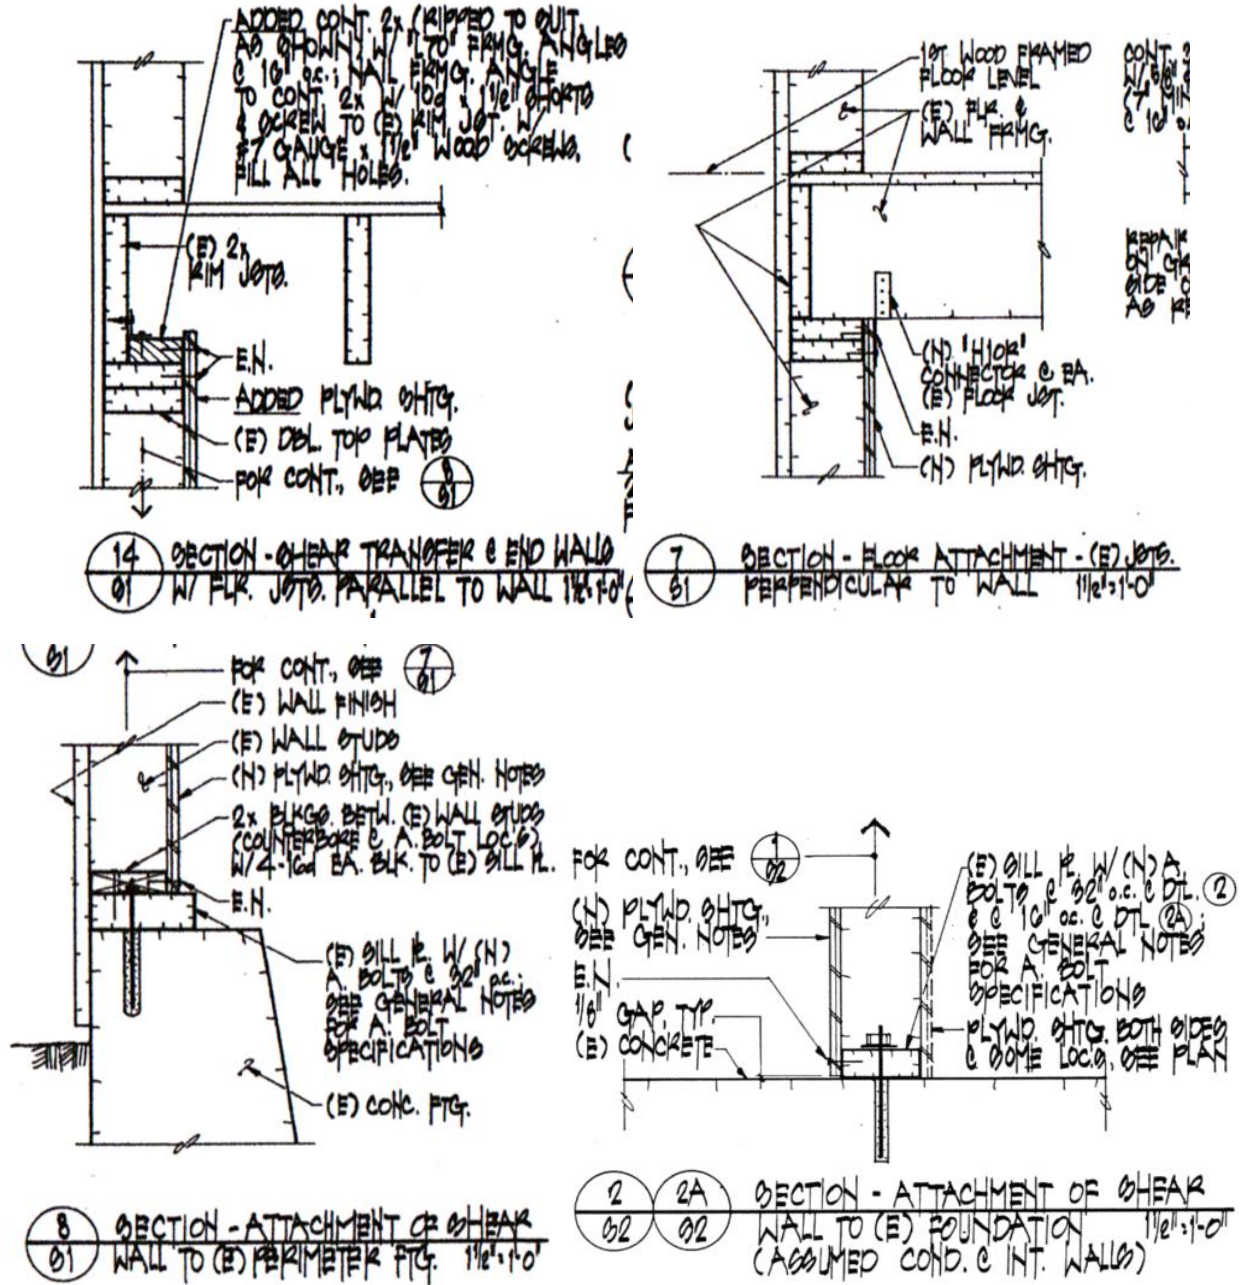
Figure 5 – Selected Structural Retrofit Details (1994 drawings)

Description
<b>C</b> <b>NC</b> <b>N/A</b> <b>U</b> <input checked="" type="radio"/> <input type="radio"/> <input type="radio"/> <input type="radio"/>	<p>WOOD SILL BOLTS: Sill bolts are spaced at 6 ft or less with acceptable edge and end distance provided for wood and concrete. (Commentary: Sec. A.5.3.7. Tier 2: Sec. 5.7.3.3)</p> <p><b>Comments:</b> All wood sills in the basement space were concealed. However, anchor bolts were to be added per the 1994 retrofit.</p>

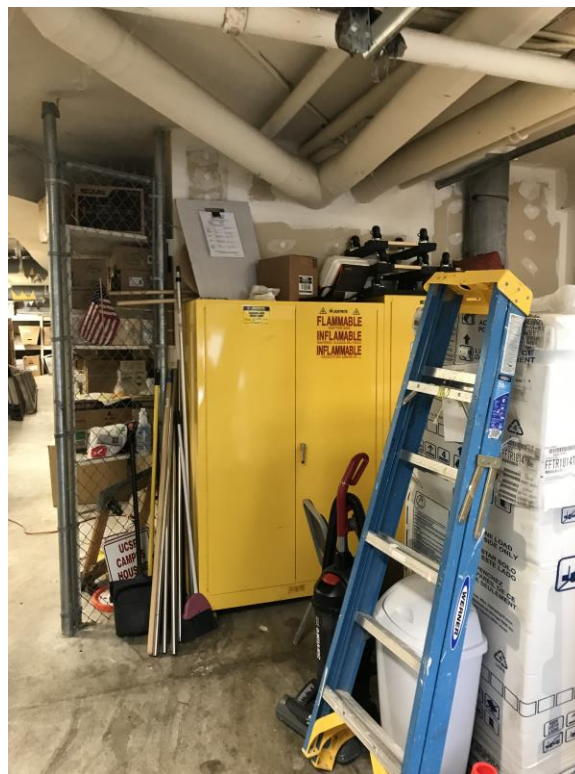
**Figure 7 - Flammable Material Storage in Garage**

The basement storage includes multiple flammable storage cabinets that may not be restrained. A container of Noxon Metal Polish, which is a flammable liquid, was observed on an open shelf, outside of the storage cabinet. Several cleaning products were also stored on open shelves.

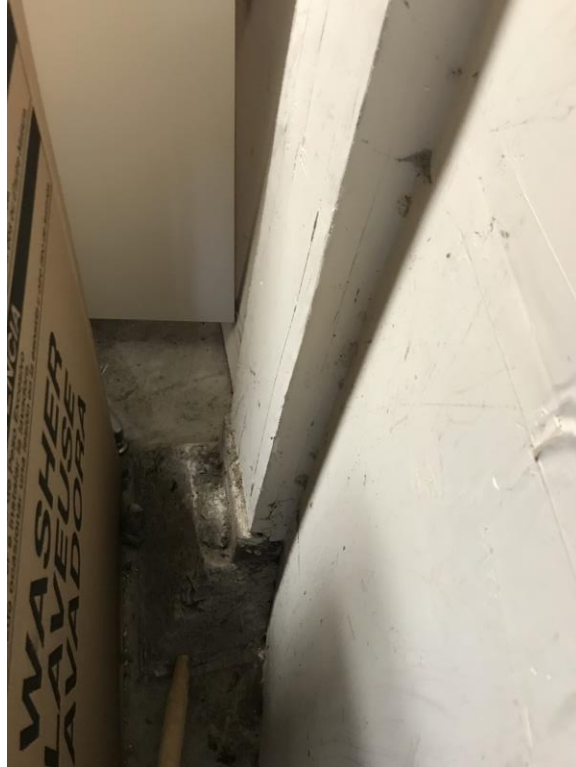
**Figure 10 – Base of Concealed Post**

Description
C	NC	N/A	U	<p>WOOD POSTS: There is a positive connection of wood posts to the foundation. (Commentary: Sec. A.5.3.3. Tier 2: Sec. 5.7.3.3)</p> <p><b>Comments:</b> All posts were concealed by finishes.</p>
<input type="radio"/>	<input type="radio"/>	<input type="radio"/>	<input checked="" type="radio"/>	
C	NC	N/A	U	<p>WOOD SILLS: All wood sills are bolted to the foundation. (Commentary: Sec. A.5.3.4. Tier 2: Sec. 5.7.3.3)</p> <p><b>Comments:</b> All wood sills in the basement space were concealed. However, anchor bolts were to be added per the 1994 retrofit.</p>
<input checked="" type="radio"/>	<input type="radio"/>	<input type="radio"/>	<input type="radio"/>	
C	NC	N/A	U	<p>GIRDER-COLUMN CONNECTION: There is a positive connection using plates, connection hardware, or straps between the girder and the column support. (Commentary: Sec. A.5.4.1. Tier 2: Sec. 5.7.4.1)</p> <p><b>Comments:</b> All posts were concealed by finishes.</p>
