UCSF Building Seismic Ratings

1482 5TH AVENUE

CAAN #2030

1482 5TH AVENUE, SAN FRANCISCO, CA 94122

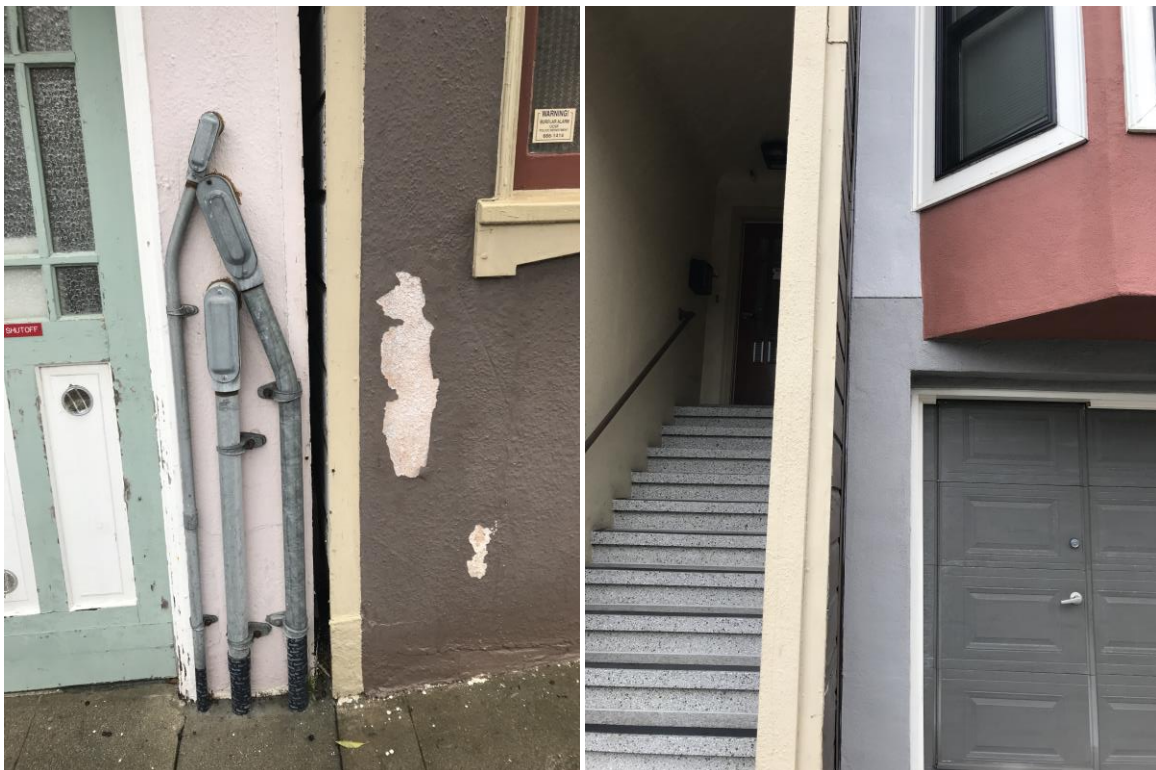
- The building is built to the property line with virtually no separation between the neighboring buildings to the north and south.
- The basement cripple walls were sheathed with a mixture of stucco, gyp board, and straight sheathing. Where wall sill plates were visible, no anchor bolts were observed.

Figure 6 - Building Separation to the North (Left) and South (Right)

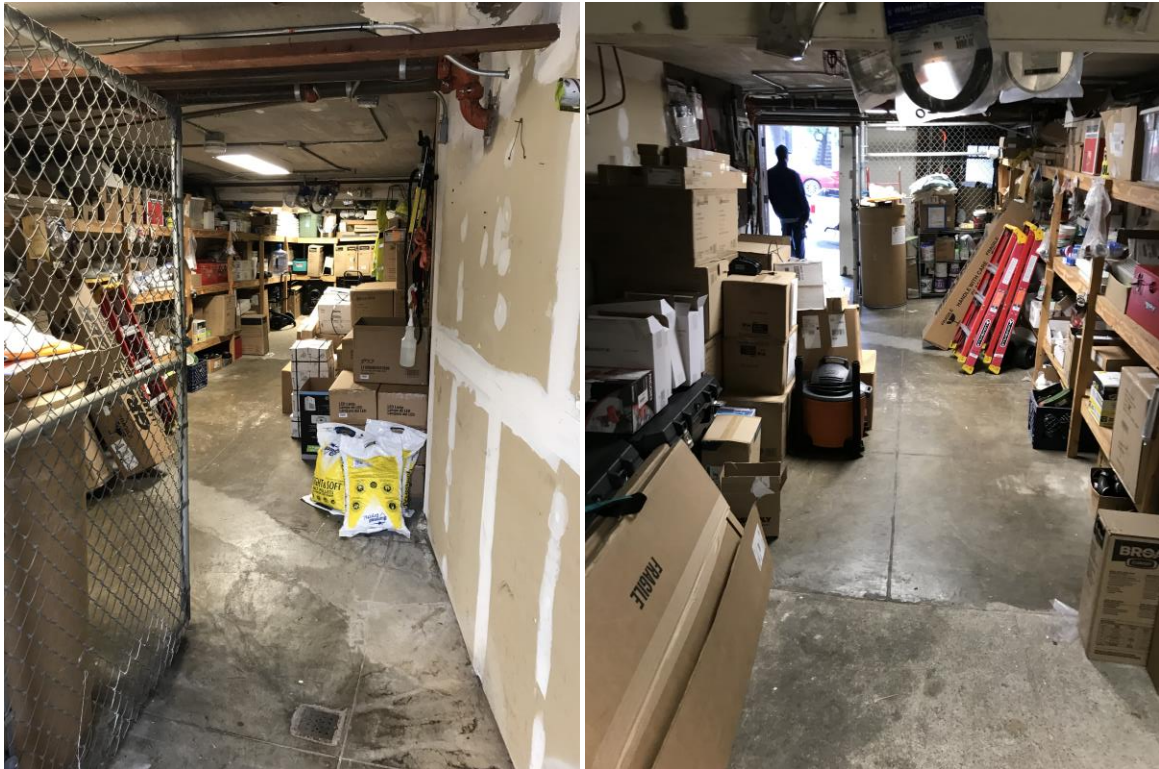
Figure 7 – Building Maintenance Storage in Basement. Left: Looking West. Right: Looking East.

Description
C NC N/A U <input checked="" type="radio"/> <input type="radio"/> <input type="radio"/> <input type="radio"/>	<p>DIAPHRAGM CONTINUITY: The diaphragms are not composed of split-level floors and do not have expansion joints. (Commentary: Sec. A.4.1.1. Tier 2: Sec. 5.6.1.1)</p> <p>Comments No split levels or expansion joints.</p>
C NC N/A U <input type="radio"/> <input type="radio"/> <input type="radio"/> <input checked="" type="radio"/>	<p>ROOF CHORD CONTINUITY: All chord elements are continuous, regardless of changes in roof elevation. (Commentary: Sec. A.4.1.3. Tier 2: Sec. 5.6.1.1)</p> <p>Comments: Chords are at one elevation. However, existing drawings showing splice details are not available.</p>
C NC N/A U <input type="radio"/> <input checked="" type="radio"/> <input type="radio"/> <input type="radio"/>	<p>STRAIGHT SHEATHING: All straight-sheathed diaphragms have aspect ratios less than 2-to-1 in the direction being considered. (Commentary: Sec. A.4.2.1. Tier 2: Sec. 5.6.2)</p> <p>Comments: The first floor diaphragm has an aspect ratio greater than 2-to-1 over the building maintenance storage space.</p>

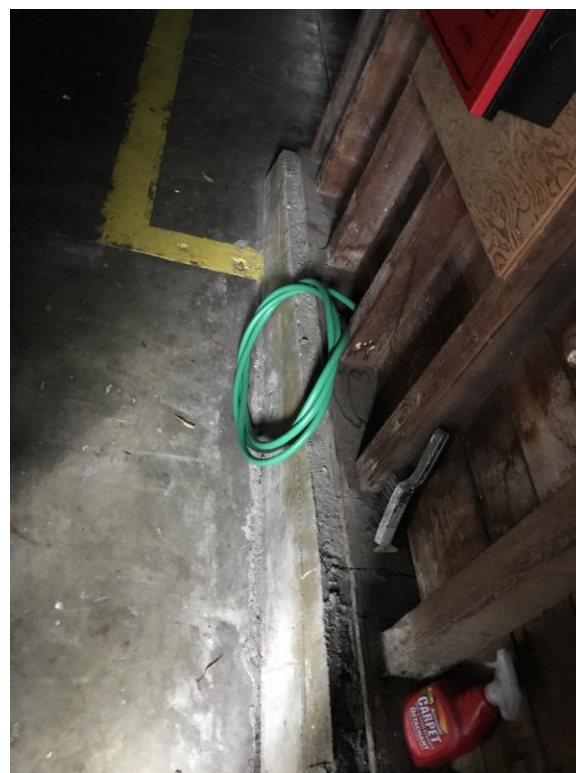
Figure 8 – Sill Plate South Garage Entrance

Description
C NC N/A U <input type="radio"/> <input checked="" type="radio"/> <input type="radio"/> <input type="radio"/>	<p>WOOD SILL BOLTS: Sill bolts are spaced at 6 ft or less with acceptable edge and end distance provided for wood and concrete. (Commentary: Sec. A.5.3.7. Tier 2: Sec. 5.7.3.3)</p> <p>Comments: Most of the walls were sheathed on both sides. On the walls that were not, there were no anchor bolts or the spacing was greater than 6 feet on center.</p>

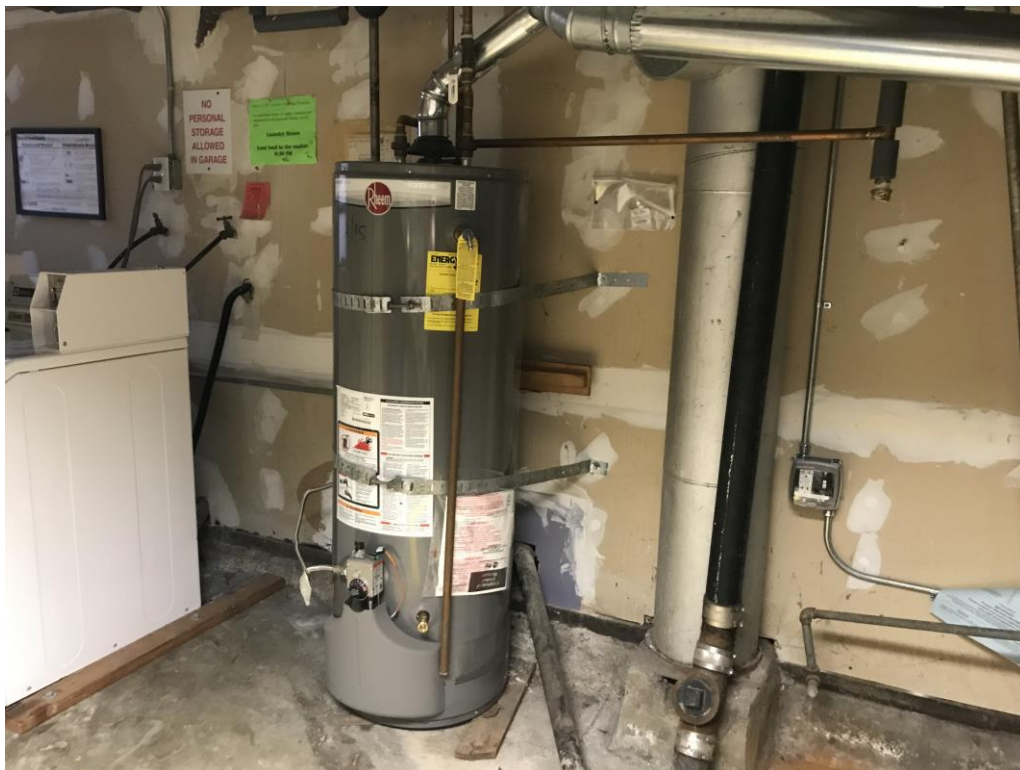
The water heaters in the basement were anchored to the wall.

Figure 10 – Anchored Water Heater

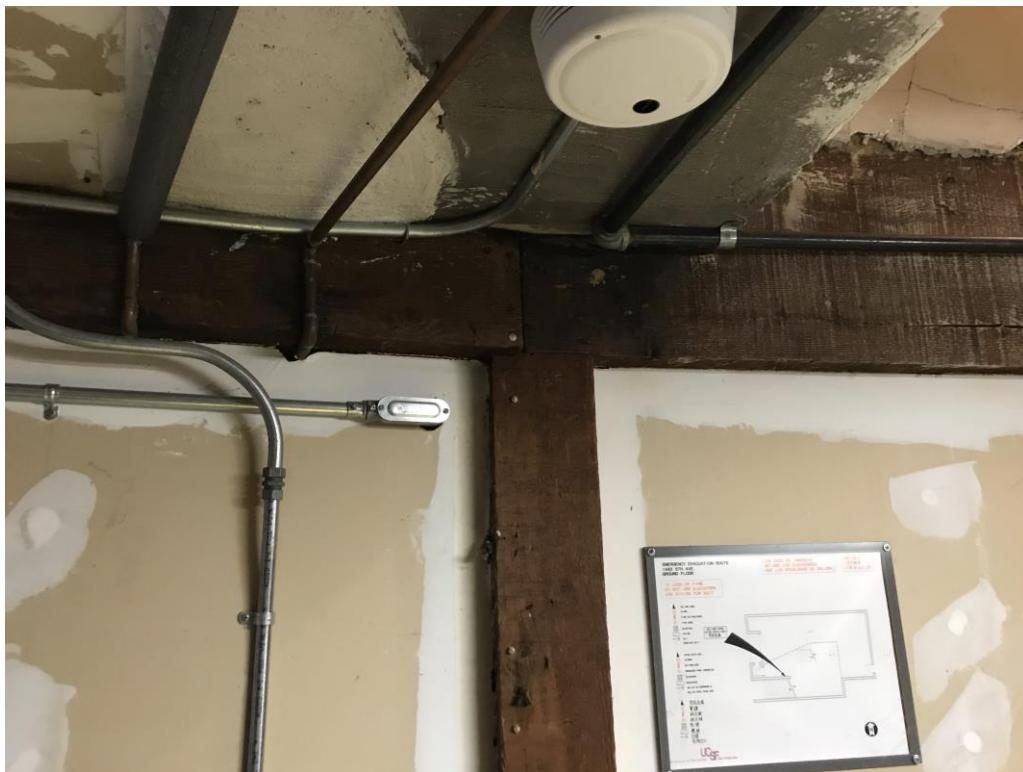
Figure 12 – Top of Basement Post

Description
C <input type="radio"/>	NC <input checked="" type="radio"/>	N/A <input type="radio"/>	U <input type="radio"/>	<p>WOOD POSTS: There is a positive connection of wood posts to the foundation. (Commentary: Sec. A.5.3.3. Tier 2: Sec. 5.7.3.3)</p> <p>Comments: Positive connections of wood posts to foundations was not observed.</p>
C <input type="radio"/>	NC <input checked="" type="radio"/>	N/A <input type="radio"/>	U <input type="radio"/>	<p>WOOD SILLS: All wood sills are bolted to the foundation. (Commentary: Sec. A.5.3.4. Tier 2: Sec. 5.7.3.3)</p> <p>Comments: Most of the walls were sheathed on both sides. On the walls that were not, there were no anchor bolts or the spacing was greater than 6 feet on center.</p>
C <input type="radio"/>	NC <input checked="" type="radio"/>	N/A <input type="radio"/>	U <input type="radio"/>	<p>GIRDER-COLUMN CONNECTION: There is a positive connection using plates, connection hardware, or straps between the girder and the column support. (Commentary: Sec. A.5.4.1. Tier 2: Sec. 5.7.4.1)</p> <p>Comments: Positive connections of wood posts to girder was not observed.</p>
