DATE: 2019-10-10

UCSF building seismic ratings
Mount Zion, Building J

CAAN #2031

2356 Sutter Street, San Francisco, CA 94115

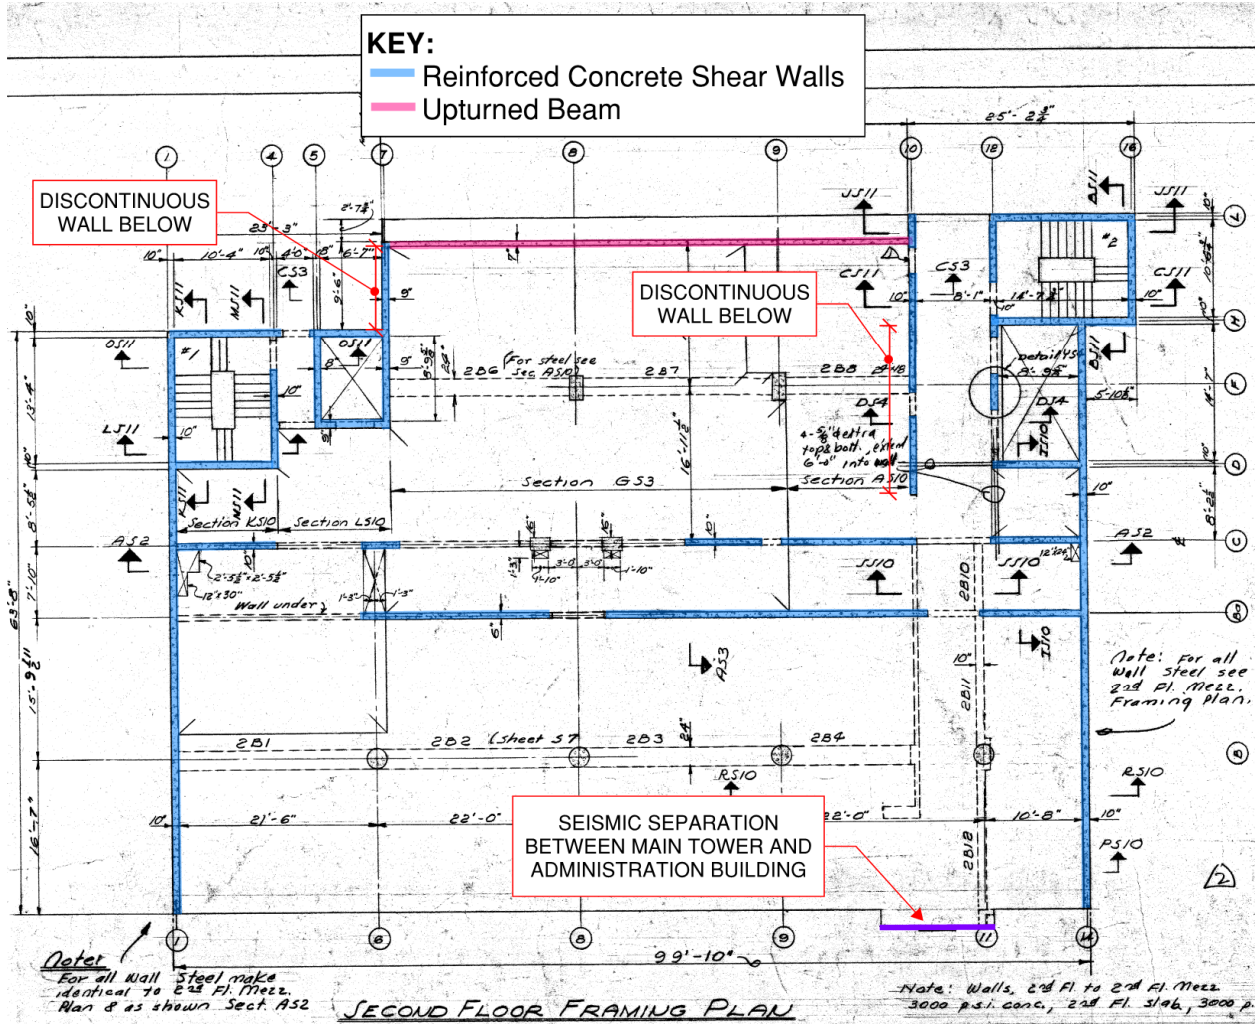
Lateral force-resisting system at the second floor (Main Tower)

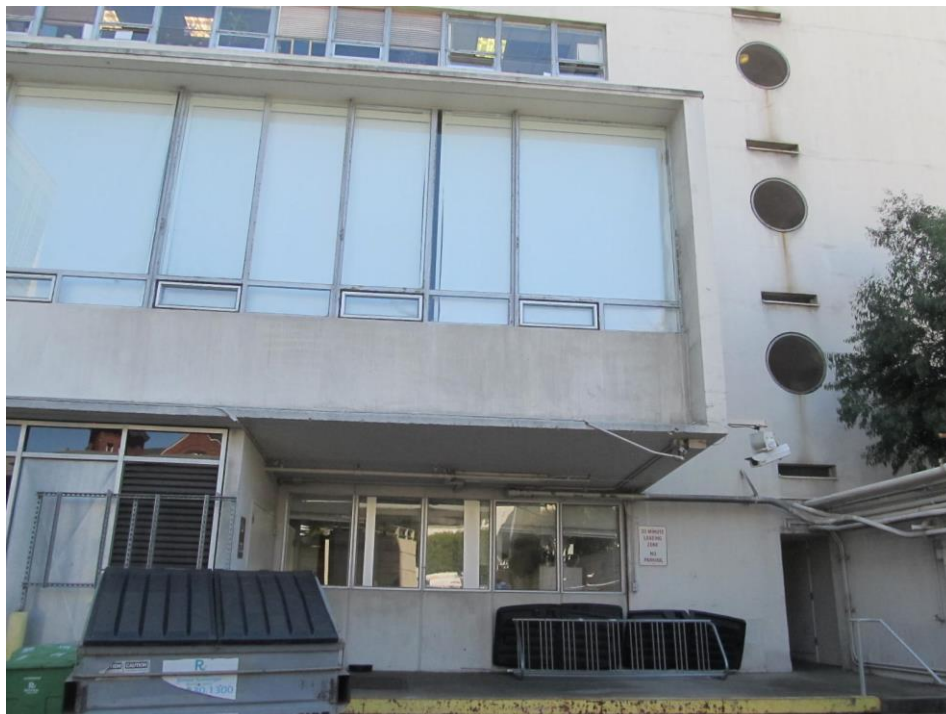
- Discontinuous shear walls are located on Line 10 and Line 7.
- The shear walls are primarily located around stair and elevator cores. The floor diaphragms contain openings that match the wall lengths at these locations. The load transfer into these walls relies on the typical slab-to-wall connection as no collectors were provided.
- The building does not contain a secondary vertical load-carrying system. The slabs are supported by the walls and the walls typically do not contain embedded column reinforcing.
- The building columns are shear-controlled.

Discontinuous wall at north elevation (looking south)

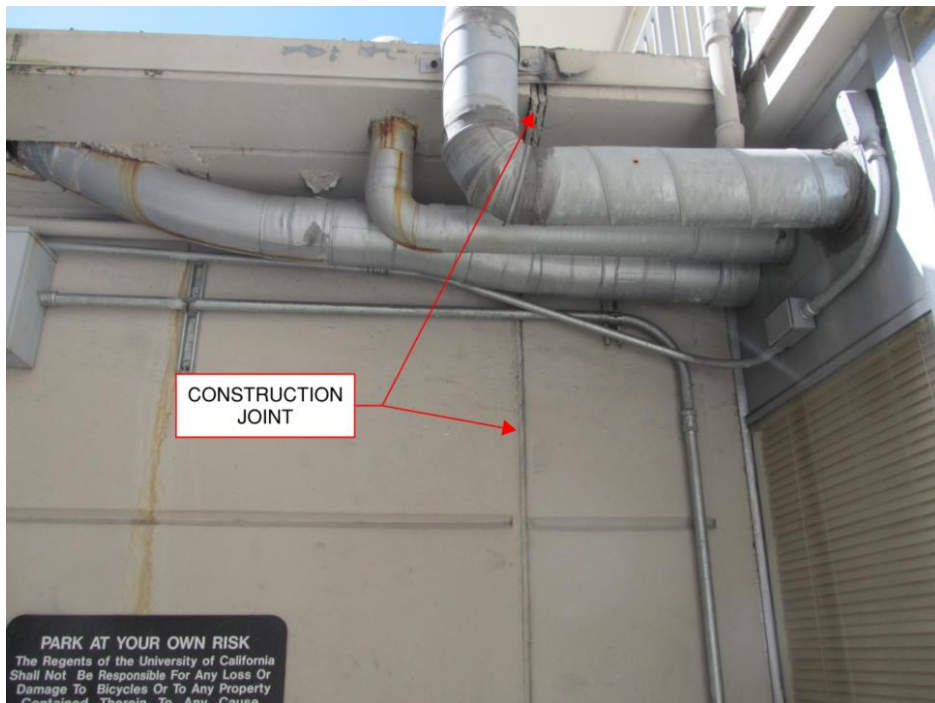
- There is no lateral resistance located on the north end of this structure and only one shear wall oriented in the east-west direction.
- The strip footings are located below the building walls. No lateral restraint is present in the direction perpendicular to the walls.
- The roof slab is located at different elevations.
- There is inadequate seismic separation between the Administration Building and the Main Tower.

Construction joint between the Administration Building and the Main Tower (looking west)

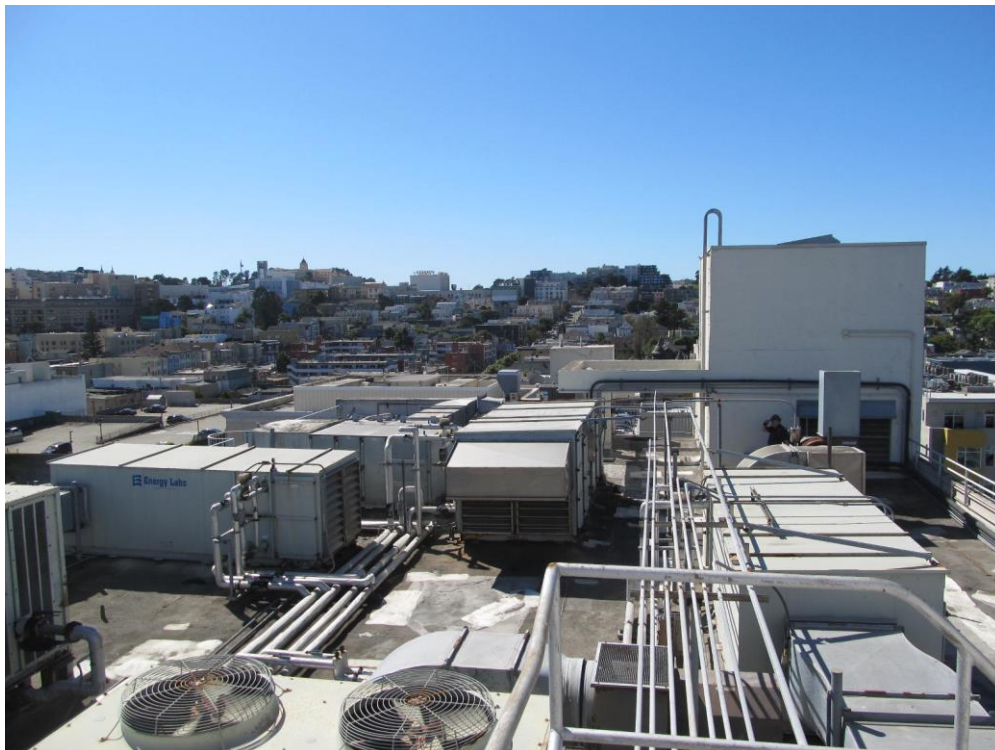
Building condition: The building engineer noted on-going maintenance issues with leaks in the roof. Significant bubbling and patching of the roof membrane was observed. Corrosion was observed at the base of multiple pieces of roof equipment. Water staining along with minor cracking and spalling was observed in the exterior concrete walls. Otherwise, the structure is in generally good condition.

Mechanical equipment at the Main Tower roof (looking west)

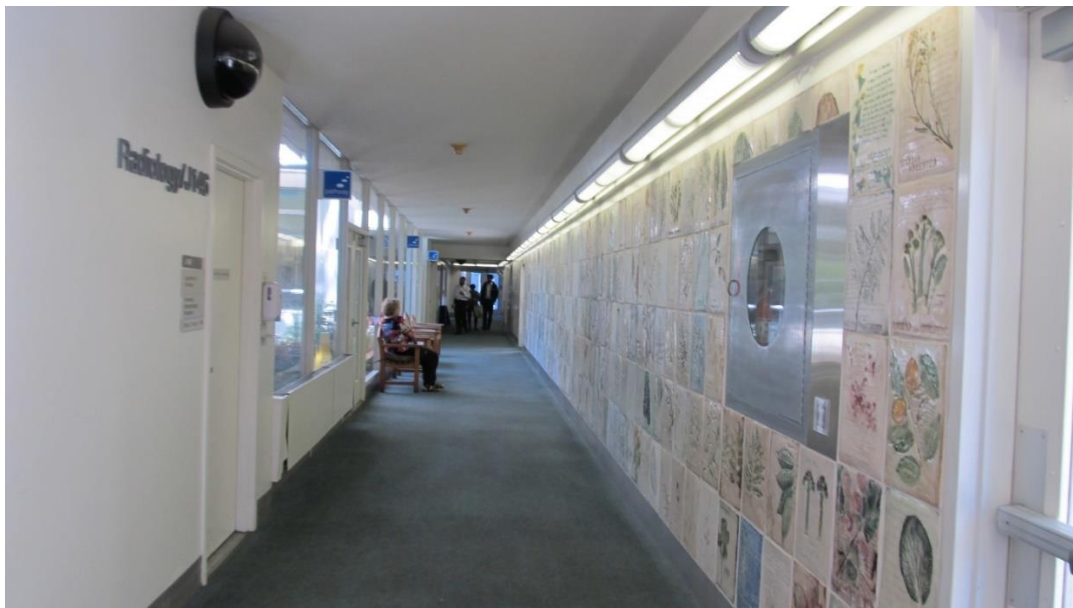
The Administration Building is a one-story L-shaped reinforced concrete structure. Although the walls are not overstressed, they are poorly configured. The corridor that connects the Administration Building to the Main Tower contains one wall oriented in the north-south direction. It does not contain lateral support in the east-west direction at the north end of the structure. In addition, a construction joint was noted in the field at the interface of the Main Tower and the Administration Building. It does not appear to contain a separation gap between the two structures. Although no gap is present, it is expected that pounding damage would be minimal as the slabs of the two structures align.

Corridor in the Administration Building leading to the Main Tower.
The primary shear wall is on the right (looking north)

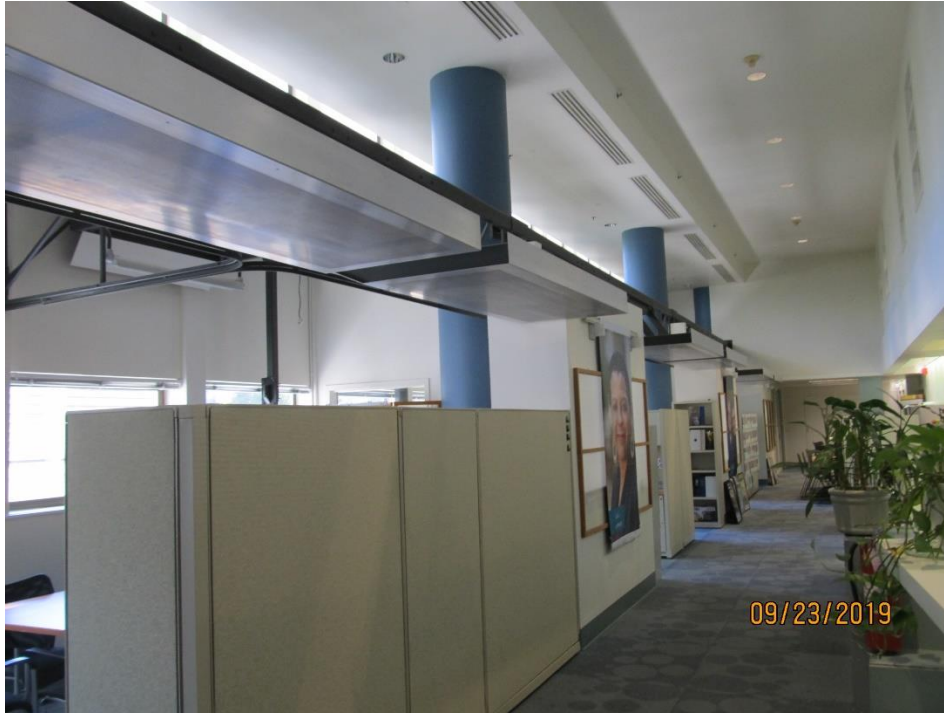
The walls also do not typically contain embedded column reinforcing and the structure does not have a secondary vertical load-carrying system. The provided columns are shear-controlled (with an induced shear demand / capacity = 3.16 when flexural hinges form at each end of the column) and contain minimal ¼" and 1/2" diameter ties spaced at 12" o.c. with heavy 1"x 1" longitudinal reinforcing. Assuming a fixed-fixed end condition, the columns can drift approximately 1/8" before failing in shear.

Two-story tall concrete columns at the second floor of the Main Tower (looking southwest)
