11-05-2019

## UCSF Building Seismic Ratings Alumni House

CAAN #2032

745 Parnassus Avenue, San Francisco, CA 94122

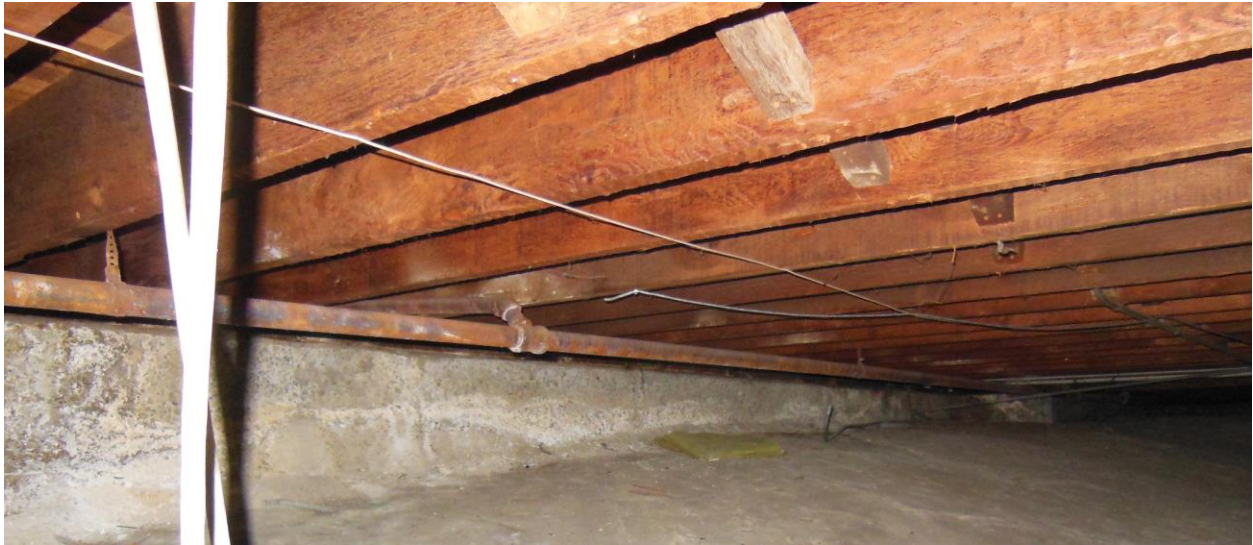
**Figure 2 - Crawl Space Prior to Interim Seismic Retrofit**

On the West side of the basement level there are cripple walls. The remainder of the building is framed directly to the foundation. The cripple walls are not sheathed in plywood and are non-compliant under the Tier-1 evaluation. This deficiency will require retrofit.

- Cripple walls were sheathed with plywood, walls were interconnected to the first-floor diaphragm, and mudsills were anchored to the concrete foundations.
- Boiler and hot water heater were restrained.
- Hollow clay tile was removed in the basement mechanical room, and walls were framed with wood studs.
- Tall cabinets at the second floor were restrained.
- Spanish clay tile roofing within 3 feet of the edge of the roof around the patio and building entrance was removed and reinstalled with fasteners to the roof framing.

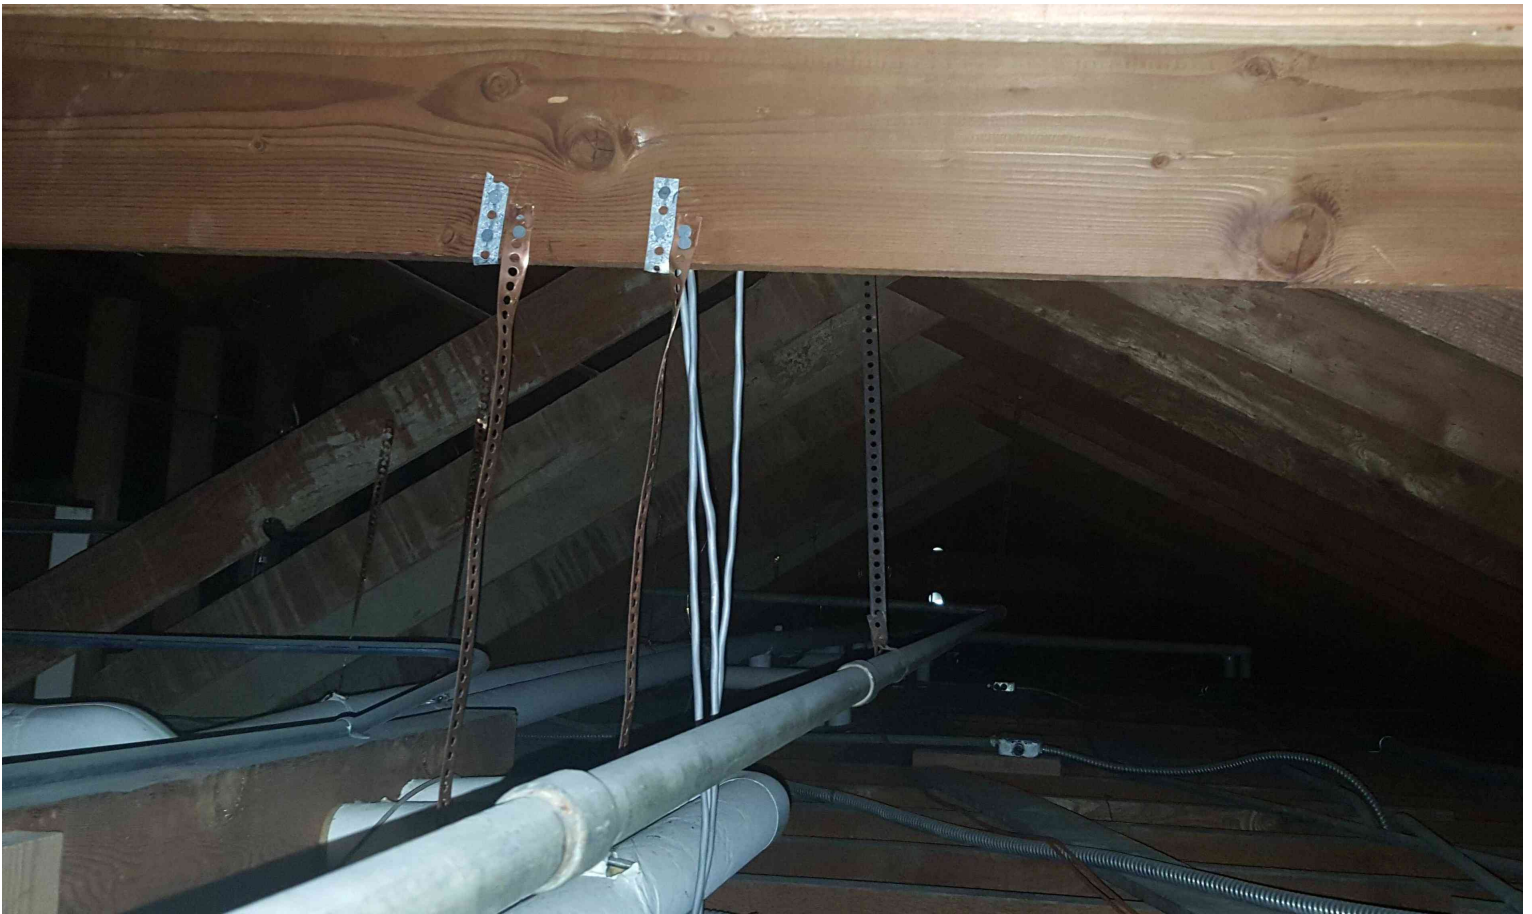
The roof does not have adequate connection to the wall plates which would act as the diaphragm cords. There is also no continuity of the diaphragm cords through the reentrant corner of the diaphragm. As such the roof chords are non-compliant under the Tier-1 evaluation. This deficiency will require retrofit.

PHOTO - Observed Roof Structure

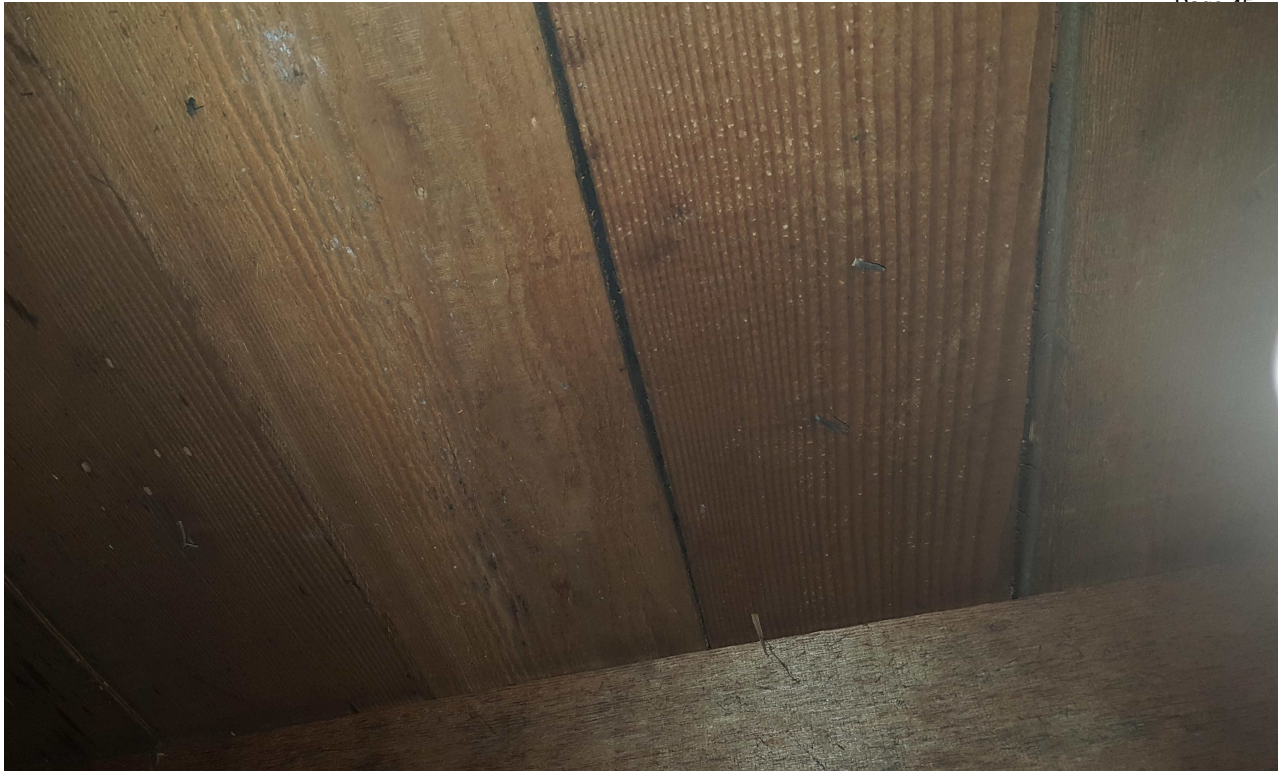
The roof and floor diaphragms are sheathed with straight sheathing and exceed the maximum allowed spans. As such they are non-compliant under the Tier-1 evaluation. This was further evaluated under the Tier-2 methodology and still found to be deficient and will require retrofit.

PHOTO - Roof 1" Horizontal Sheathing

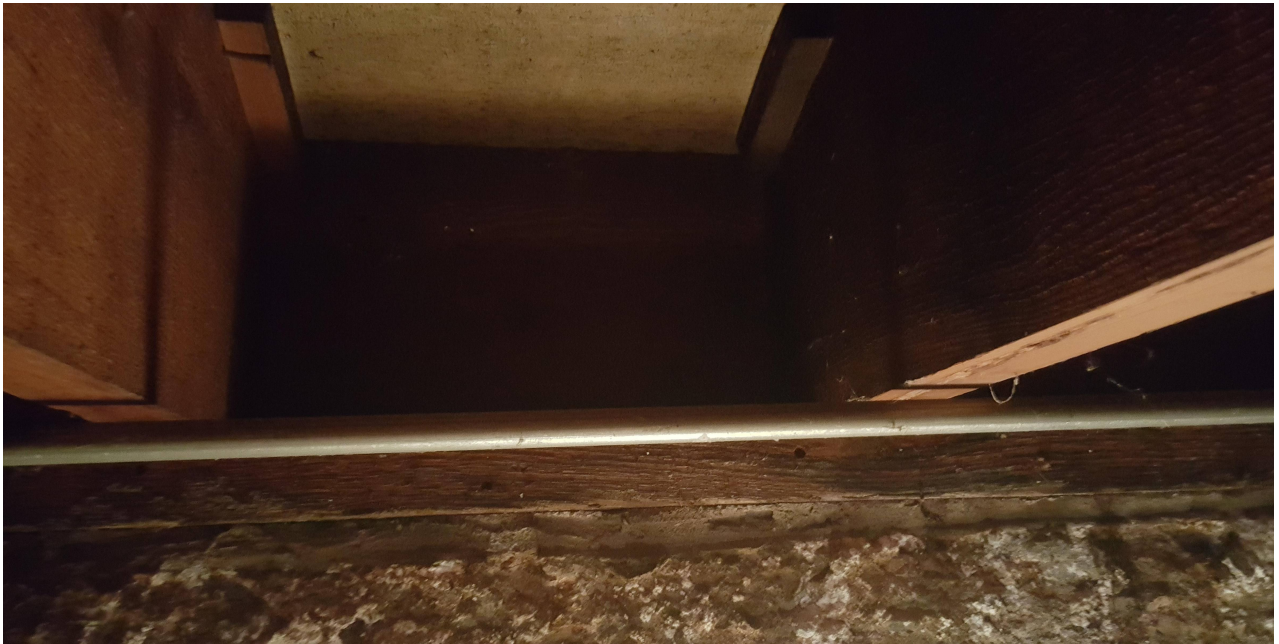
PHOTO - 1st Floor Framing (2x12@16" O.C.) on Sill Plate with not Shear Connection to Foundation
