UCSF Building Seismic Ratings
2255 Post Street, San Francisco

CAAN #2033
2255 Post Street, San Francisco, CA 94143
North UCSF Campus: Mount Zion

Rating summary	Entry	Notes
UC Seismic Performance Level (rating)	V	Findings based on drawing review and ASCE 41-17 Tier 1 evaluation ¹
Rating basis	Tier 1	ASCE 41-17
Date of rating	2019	
Recommended UCSF priority category for retrofit	Priority B	Priority A = Retrofit ASAP Priority B = Retrofit at next permit application for modification
Ballpark total project cost to retrofit to IV rating	High	See recommendations for retrofit
Is 2018-2019 rating required by UCOP?	Yes	
Further evaluation recommended?	No

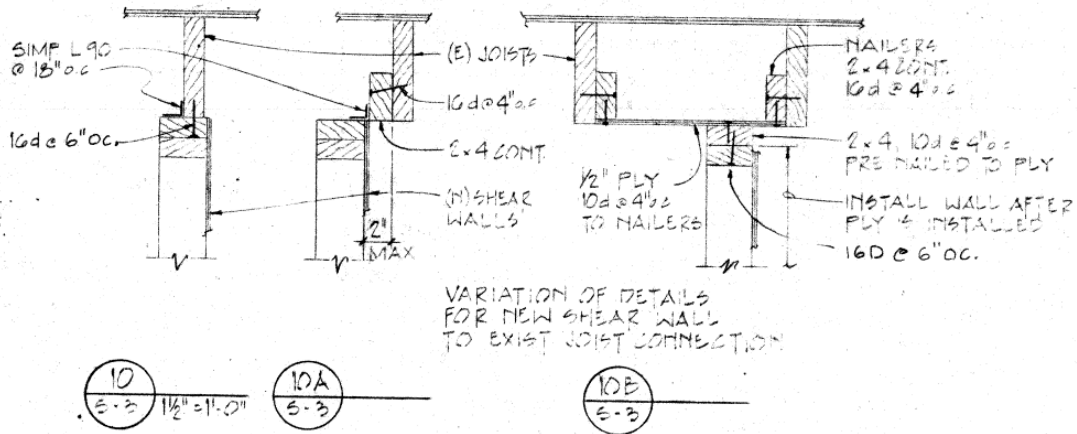
Figure 4 - Top of Shear Wall Details (1993 Renovation)

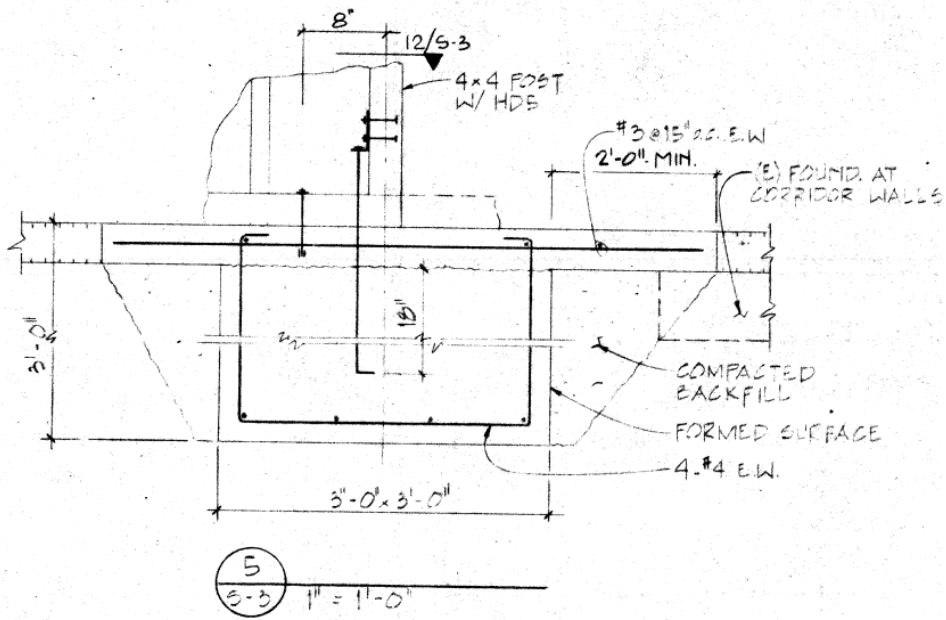
Figure 5 - Hold-down Detail at (E) Shear Walls (1993 Renovation)

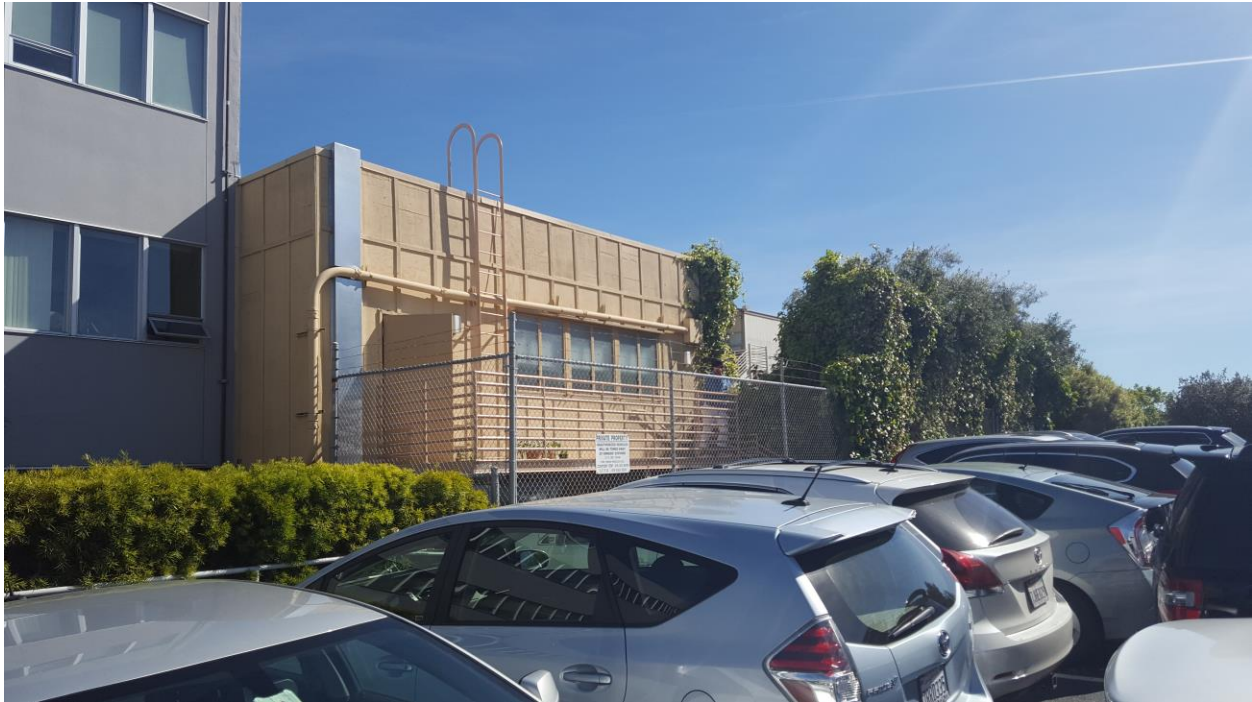
Figure 6 - Building Exterior (South Elevation)

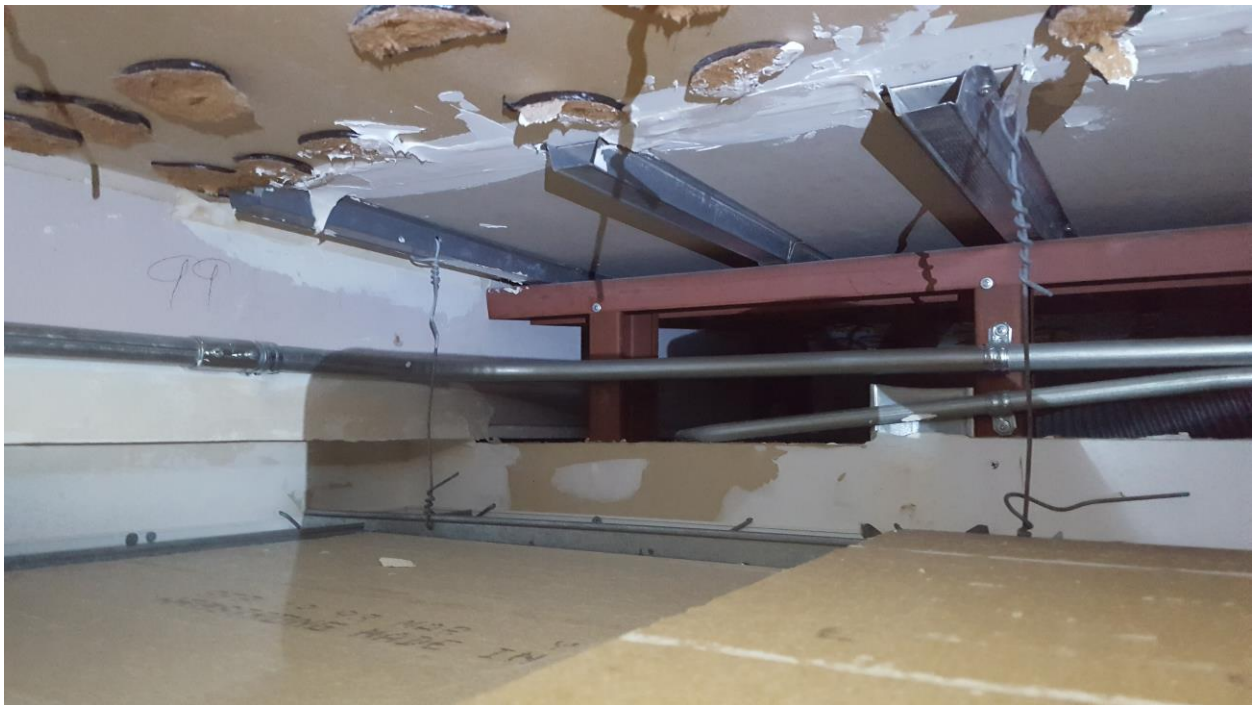
The building benefits from long continuous walls in the longitudinal direction, exterior diagonal sheathing and existing plywood shear walls on the first floor. Despite the plywood shear walls, the building lacks shear strength for seismic loading in the transverse (east-west) direction. In particular, the transverse direction shear strength at the second floor comes primarily from rated gypsum board walls around the elevator, stairs and mechanical shafts,

which are not adequate to satisfy the Tier 1 check. The building is classified as Priority B because historically wood frame buildings have performed well in earthquakes.

Figure 7 - Interior Partition Wall with Gypsum Board Sheathing Stopping Below Structure

Seismic retrofit is recommended. The retrofit measures shown in the 2017 Estructure drawings include installation of new plywood shear walls at the first and second floors in the transverse direction. Walls would be interconnected between floors and new interior shear walls would be constructed on new footings.

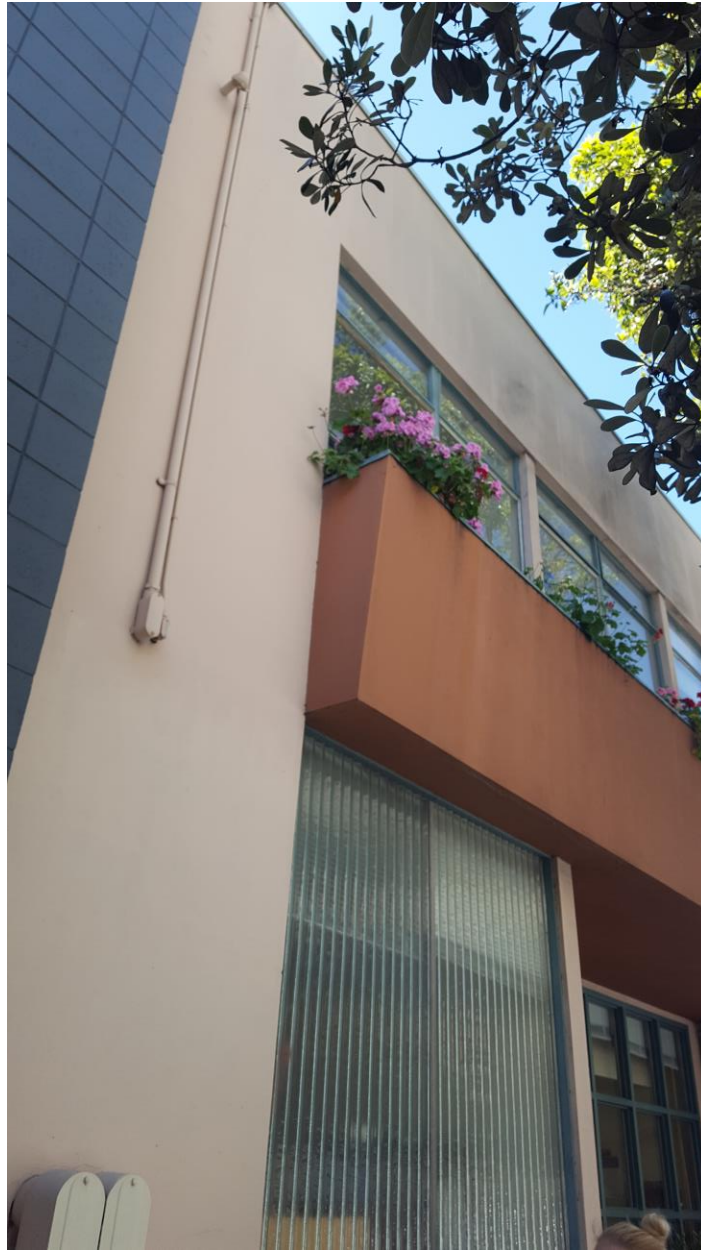
Figure 8 – Building Exterior (North Elevation)
