DATE: 2019-10-10

UCSF building seismic ratings
Mount Zion Building P

CAAN #2034

2375 Post Street, San Francisco, CA 94115

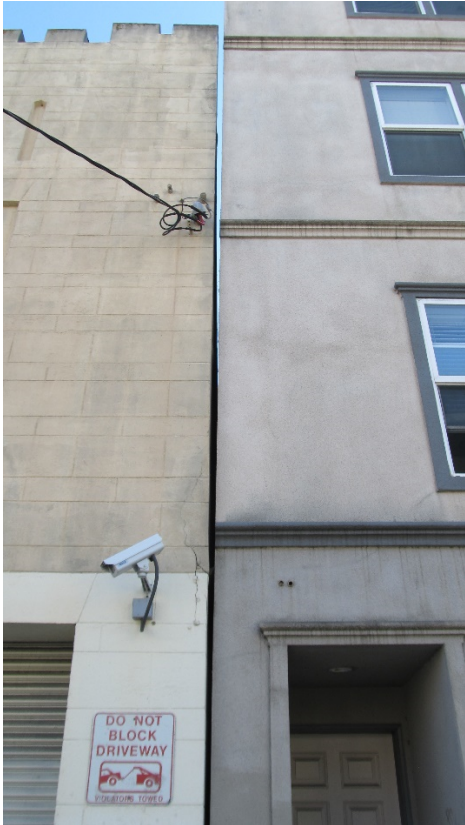
Finally, Building P is located in close proximity to adjacent wood frame structures on its west elevation. The seismic gap measured in the field at the south and north elevation are 3" wide.

- The building is located in close proximity to an adjacent structure on its west elevation. The provided gap is 3" wide and the required gap to meet the Tier 1 acceptance criteria is 5.8" wide.

Separation gap on north elevation (looking south)

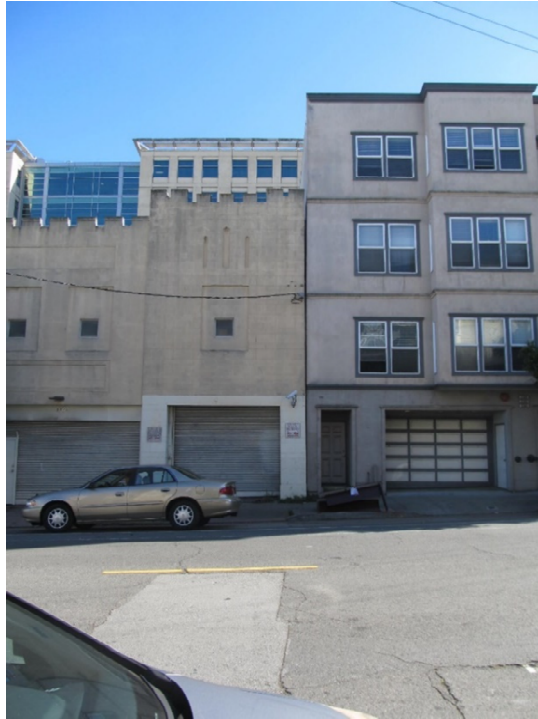
Finally, Building P contains inadequate seismic separation on its west elevation. The measure seismic joint is 3" wide and the gap required by ASCE 41-17 for an interstory drift ratio of 1.5% is 5.8". It is likely that Building P will drift less than predicted due to its stiff shear wall lateral system. However, the flexibility of the adjacent structure is unknown.

It is also not known if the floor levels of the two structures align. There is the potential for increased damage due to pounding.

Adjacent wood frame building to the west (looking south)

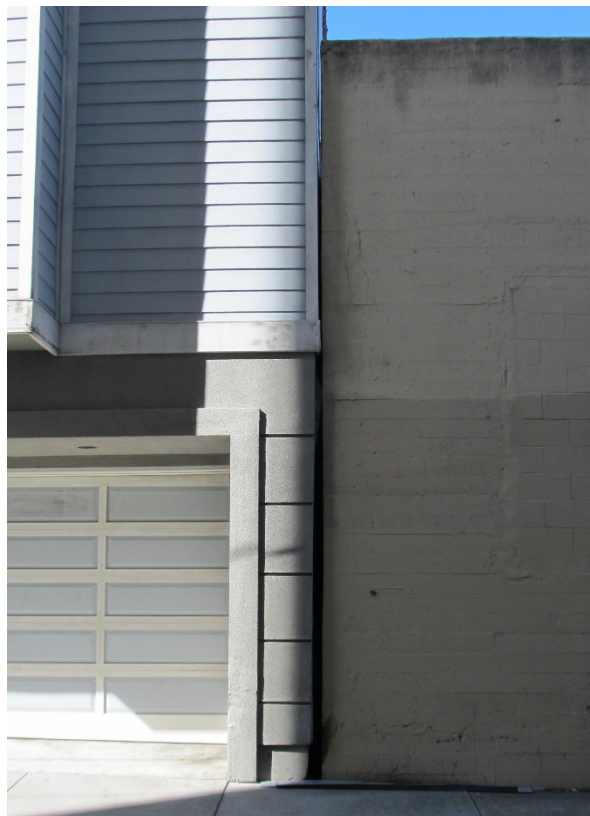
Separation gap on south elevation (looking north)

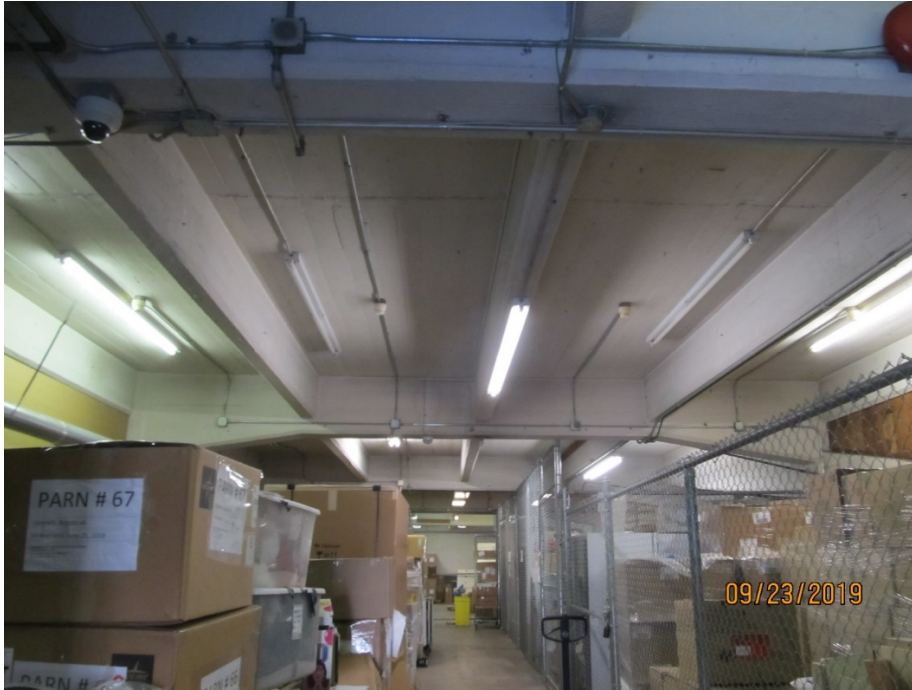
Concrete framing at underside of the second floor (looking south)

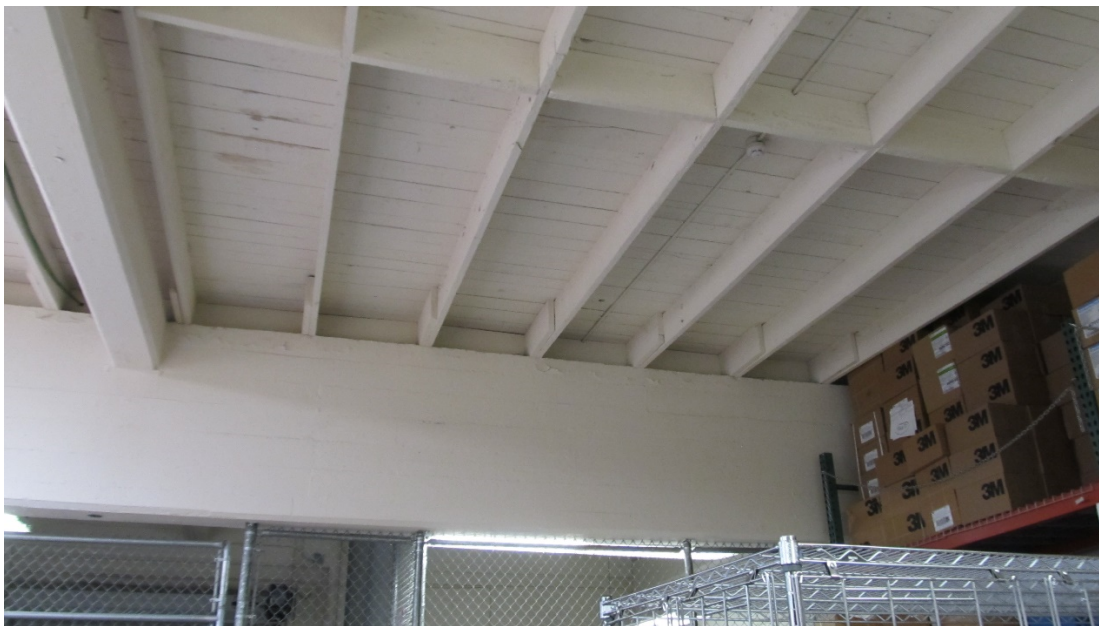
The wood framing located at the roof is currently bearing on the concrete beams and girders with no attachment between the two materials to transfer in-plane forces. As such, the building relies on friction as a lateral load transfer mechanism. Similarly, the roof diaphragm does not offer out-of-plane anchorage for the walls. The 6" thick walls do not have sufficient capacity to cantilever above the 2nd floor slab. When checked under this load condition, they are severely overstressed.

Wood roof framing bearing on concrete girders

It is recommended that this structure be retrofit. The diaphragm should be anchored to the exterior walls around the perimeter of the structure to provide both in-plane and out-of-plane connection to the exterior walls. The diaphragm should also be strengthened with plywood, crossties, and sub-diaphragm detailing. Interior shear walls may be added in the transverse direction and located towards the northern end of the structure. These would help reduce the stresses on the north wall, help to mitigate torsion, and reduce the span of the straight-sheathed diaphragm.

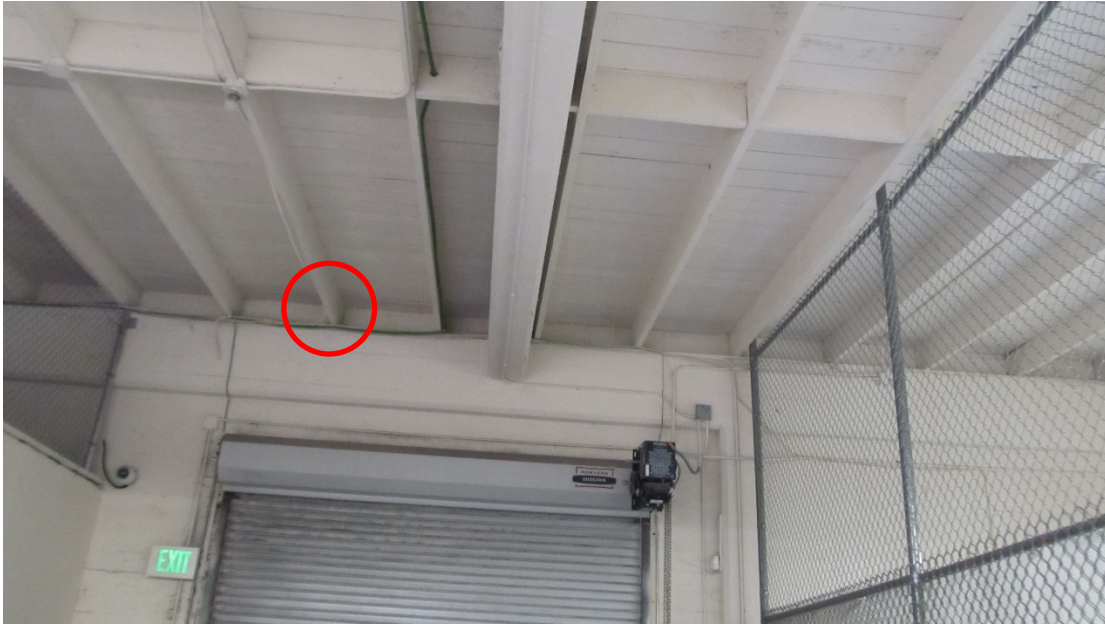
- The wood roof framing is not positively connected to the concrete frame, therefore; the exterior concrete walls do not have either in-plane or out-of-plane anchorage at the roof.

Photo A: Wood joist bearing on south concrete wall ledge with no positive connection (see close-up of circled connection in Photo A1 below)

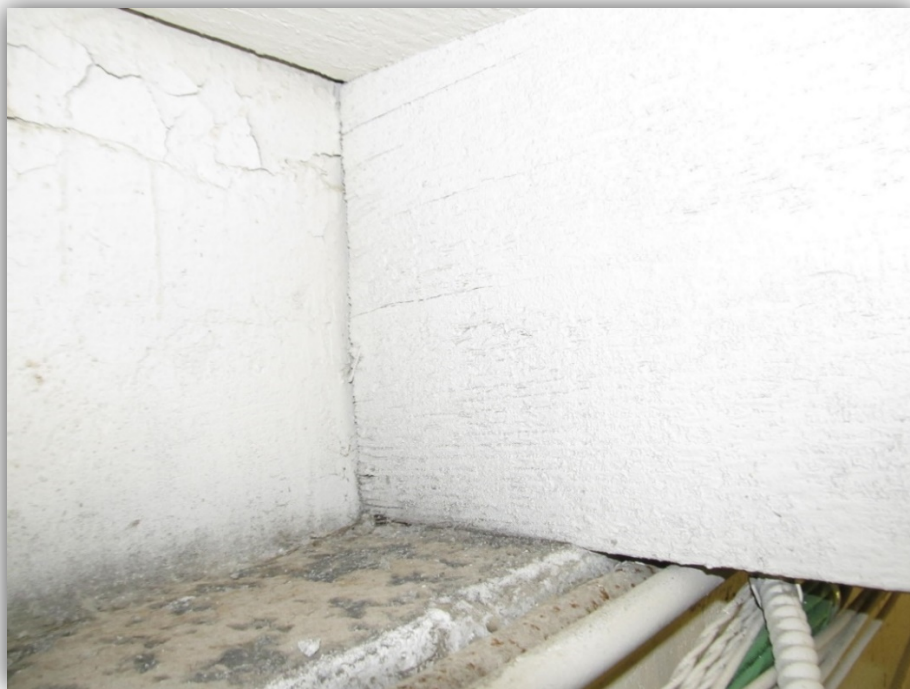
Photo A1: Wood joist bearing on south concrete wall ledge with no positive connection (inside face of concrete parapet to the left and wood joist to the right)

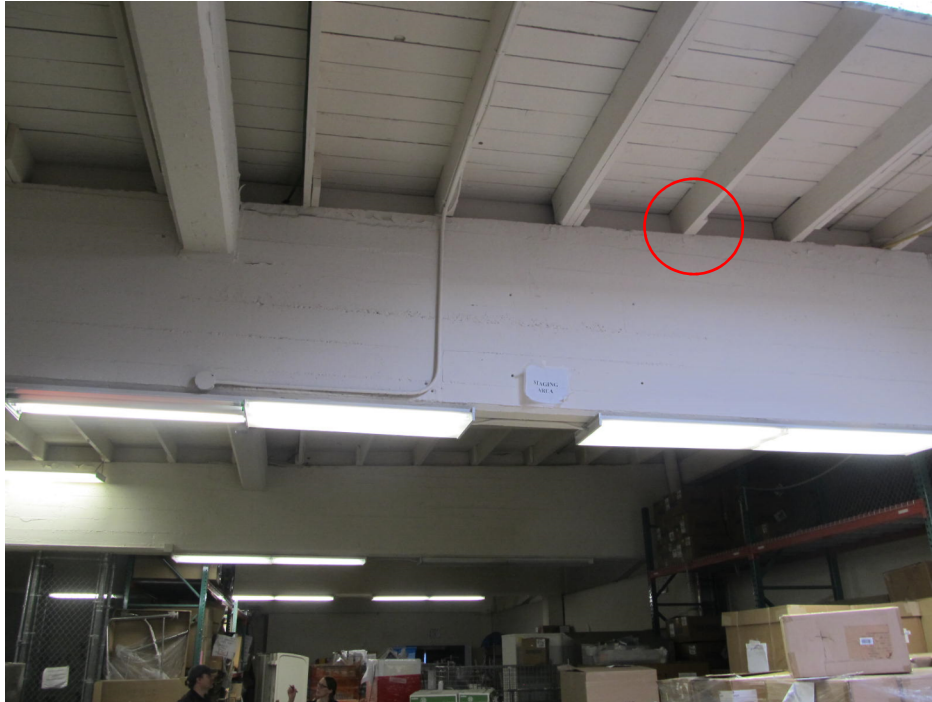
The wood-to-concrete connections were observed in the field at an interior girder and at a perimeter wall condition. At the interior concrete girder, the wood joists are oriented perpendicular to the girders and bear directly on the top of the concrete framing. Wood blocking is provided at the between the joists on top of the girders. At the exterior wall condition, a concrete beam is cast on the inside face of the wall. The exterior wall extends above this beam to form the parapet. The wood joists bear on the top of the concrete beam with a slight gap between the end of the joist and the inside face of the wall. No wood blocking is provided along the face of the wall. In both the interior and exterior conditions, the wood diaphragm does not appear to have a positive connection to the concrete structure. No tension or shear wall-to-roof connections were found. As such, the exterior concrete walls are not braced out-of-plane at the roof level, and the inertial load from the roof mass is reliant on friction resistance at the interface of the wood joist to concrete framing for shear transfer and the ability of the walls to cantilever out-of-plane above the second floor.

Photo B: Interior wood joist bearing on concrete girder with no positive connection (see close-up of circled similar connection in Photo B1 below)

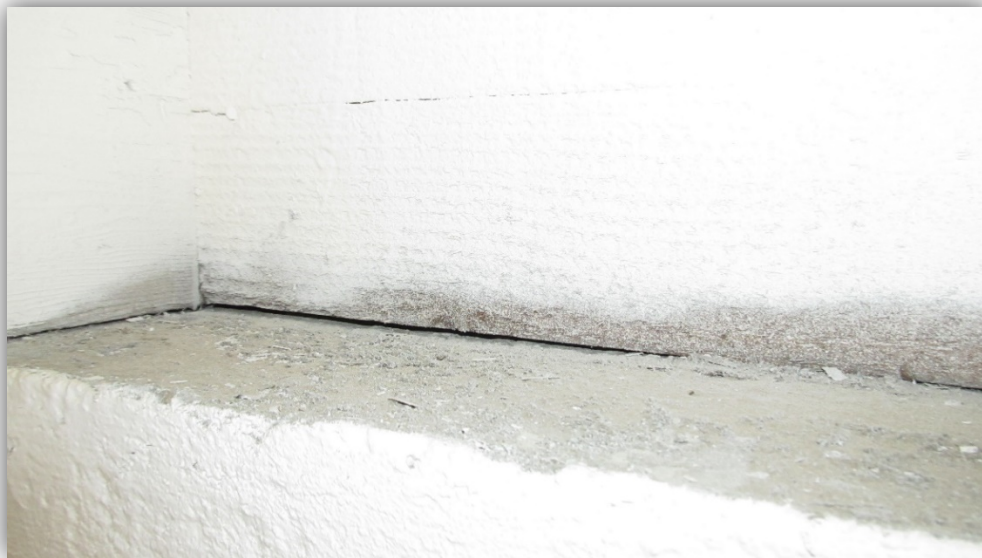
Photo B1: Interior wood joist bearing on concrete girder with no positive connection (wood blocking to the left and wood joist to the right)

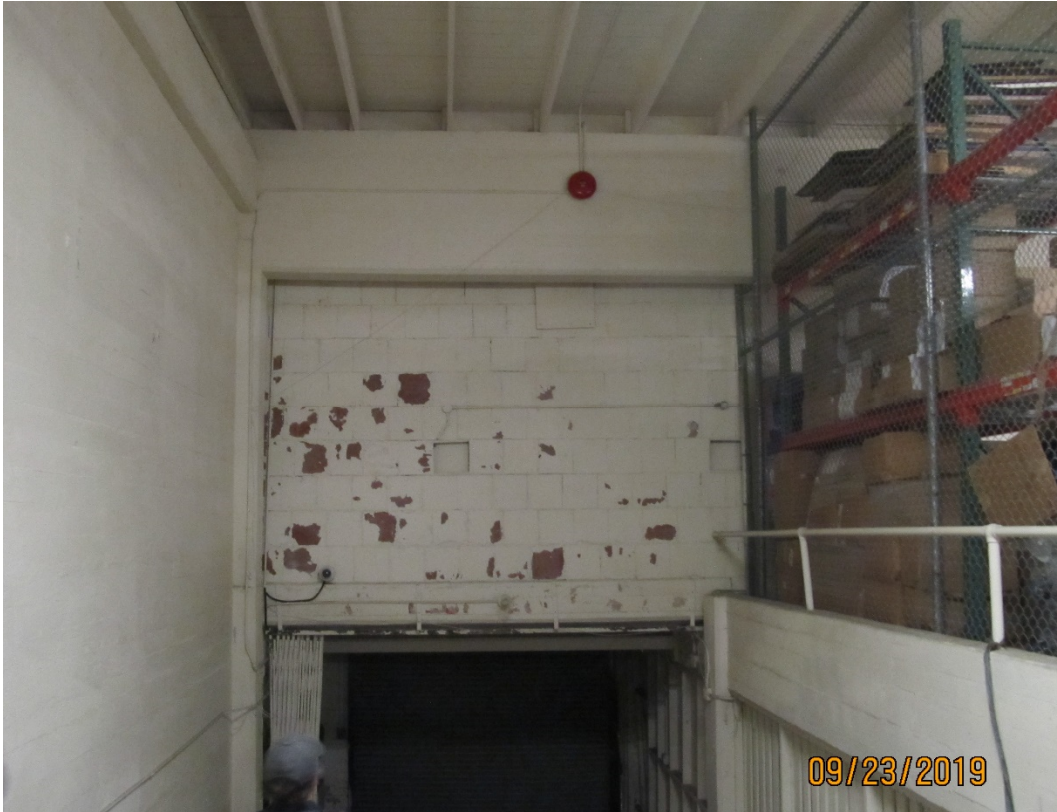
A hollow clay tile partition was observed above the entry ramp between the 2nd floor and roof. Although there are exits to the exterior at both the 1st and 2nd floor; the ramp is the only interior connection between the floors.

Hollow clay tile partition above ramp (looking north)

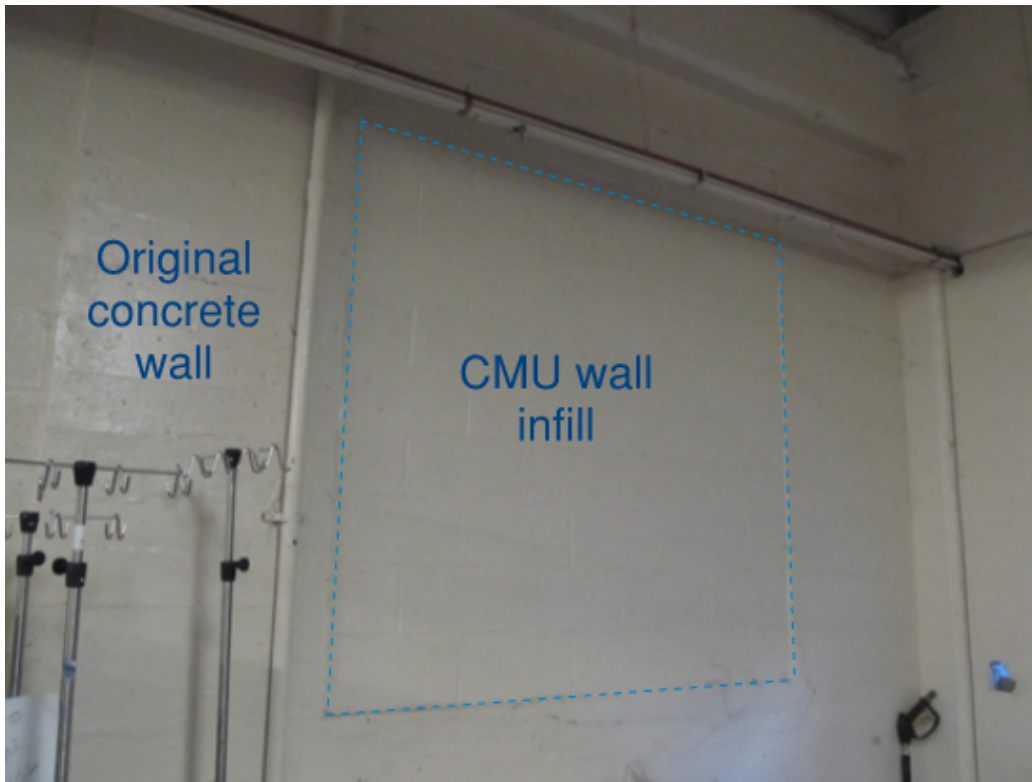
Field observation indicates that some wall penetrations were infilled with CMU block. The extent of the infill is unknown as it is not shown on the available drawings. It was, however, observed for multiple openings on the east, south and north elevations. For the purpose of this assessment, CMU infill is considered to be solid concrete.

CMU wall infill on east elevation (looking southeast)
