UCSF building seismic ratings

1701 Divisadero, MOB 2

CAAN #2036

DATE: 2020-06-26

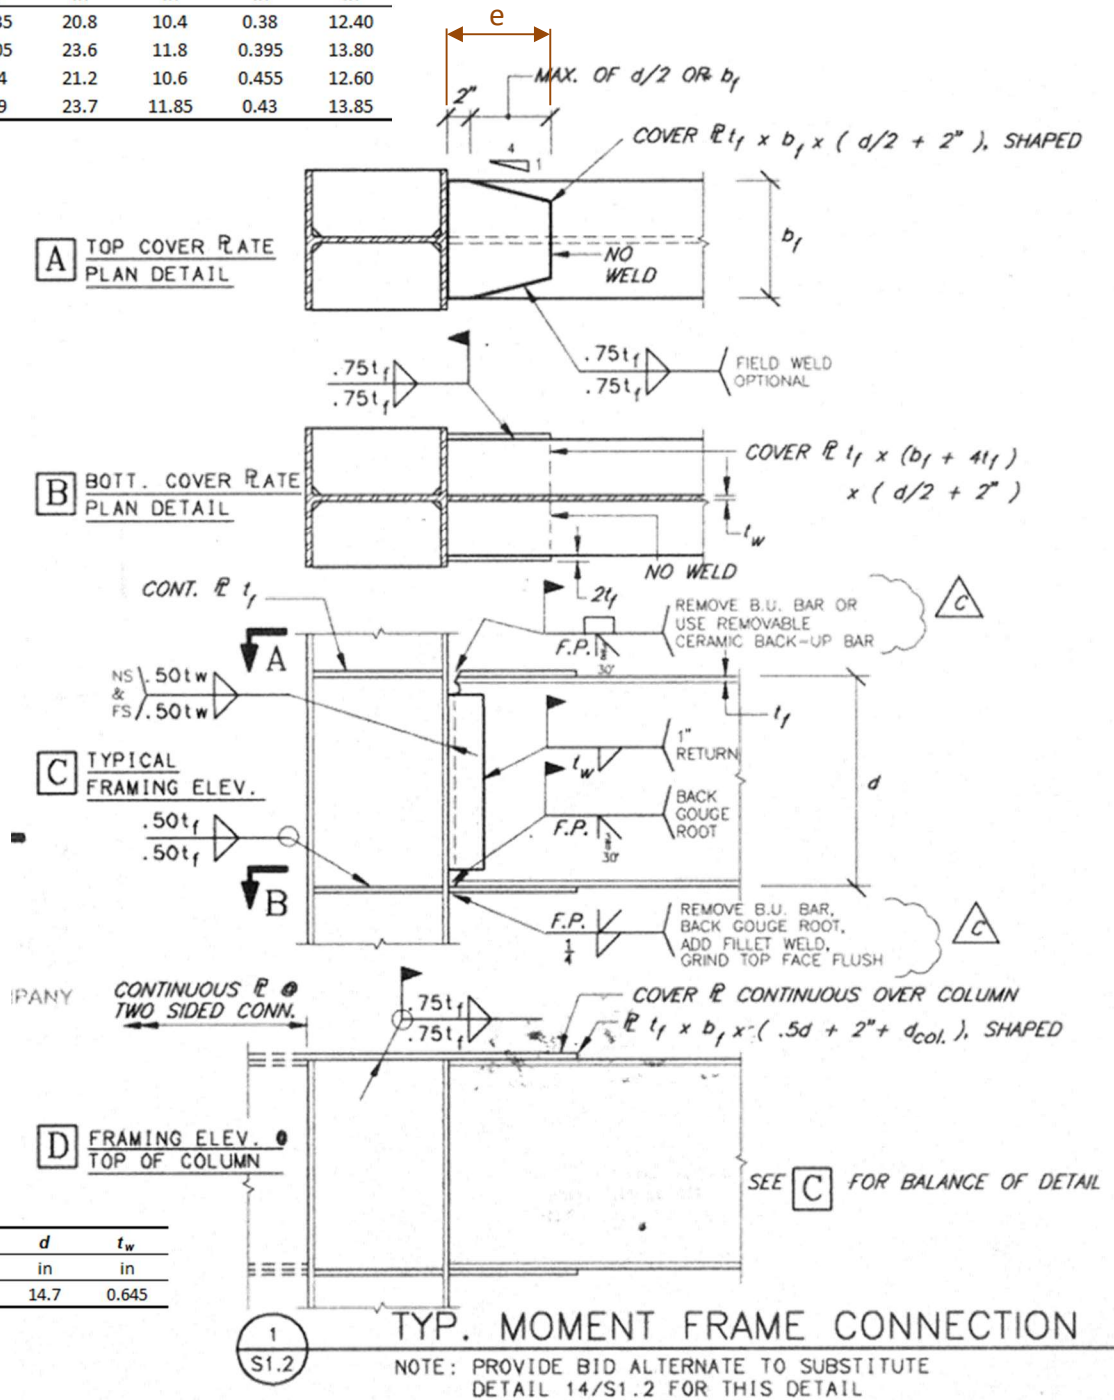
Figure 3: Moment frame beam-column connection

Structural feature or potential deficiency	Finding/notes
Welded moment connections	The steel moment-resisting frame connections use welded beam flange cover plates as shown in Figure 3 below. Because of the cover plates, this connection configuration is significantly stiffer and stronger than a typical pre-Northridge welded steel moment frame where the ends of the beam flanges are unreinforced. It is likely that the beam flange reinforcement will protect the connection by forcing flexural yielding in the beams to occur away from the welded connections. This connection configuration is different, however, from the prequalified welded flange plate connection in FEMA 350 (2000) and there is no prequalified welded flange plate connection in AISC 358-16. This may be because there are concerns about the reliability of this connection compared to the connection types that are prequalified. We expect that the ductility capacity of the connections is substantially greater than that of typical pre-Northridge connections, however there is still a potential for connection fracture under earthquake action.

(4) AT W21 & W24 MOMENT FRAME GIRDERS, EXTEND TAB PLATE TO BOTTOM FLANGE AND WELD.

As-built drawings indicate alternate detail was not used.

Note on shear tab detail 2/S1.2

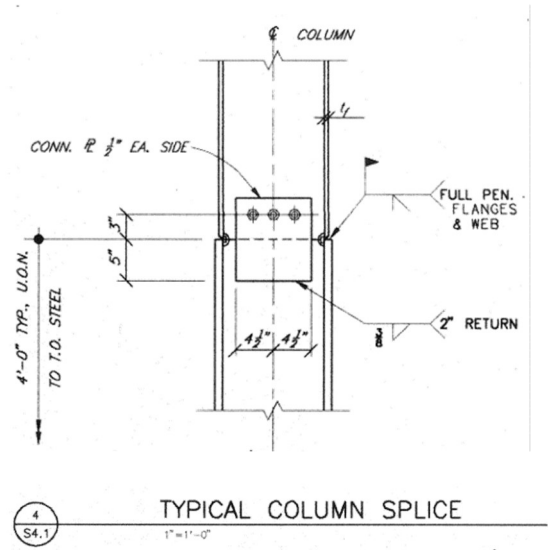
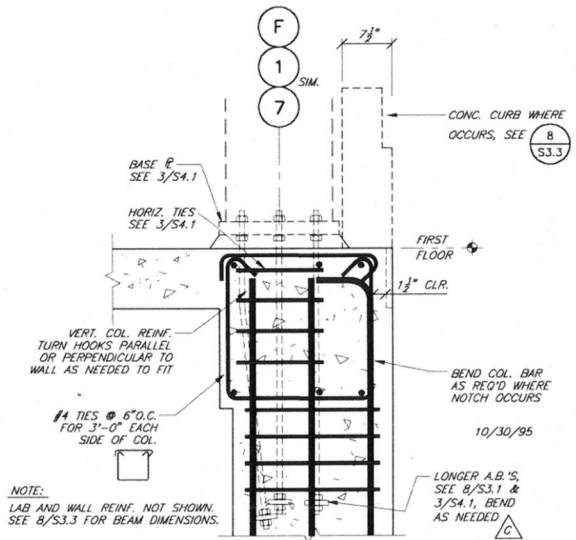
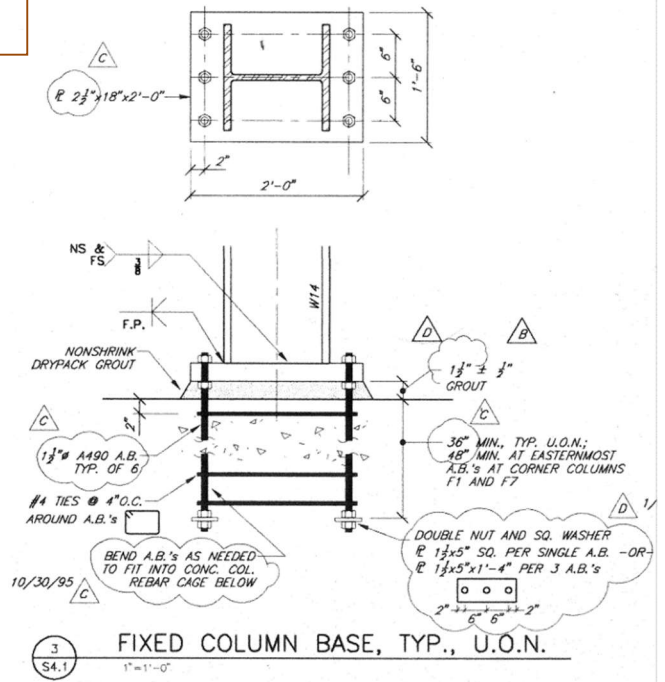
Figure 4: Moment column connection details

SRC members had concerns about the column base plates (Figure 4) that do not provide full fixity for the columns. SRC members also felt that that the frame was light and were concerned about the weak panel zones and uncertainty about how effective the cover-plated connections would be.

Base plate detail at perimeter moment frames only. (Not used at Line 3.)

We also account for the weak base plates by using the moment strength of the six-anchor base plate instead of the flexural capacity of the columns at the column base at Level 1.

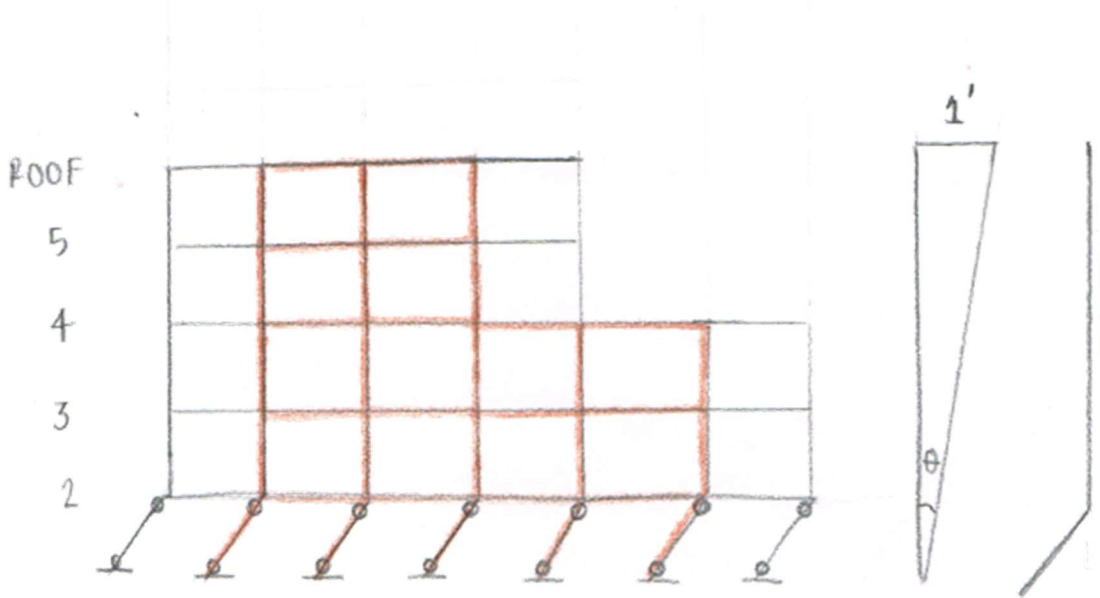
Figure A2-1: Story mechanism below level 2

Case	Below Level 2	Below Level 5
Including gravity columns	1.03	1.36
Neglecting gravity columns	0.72	0.86

We believe that the results that include gravity columns are a better representation of the actual behavior

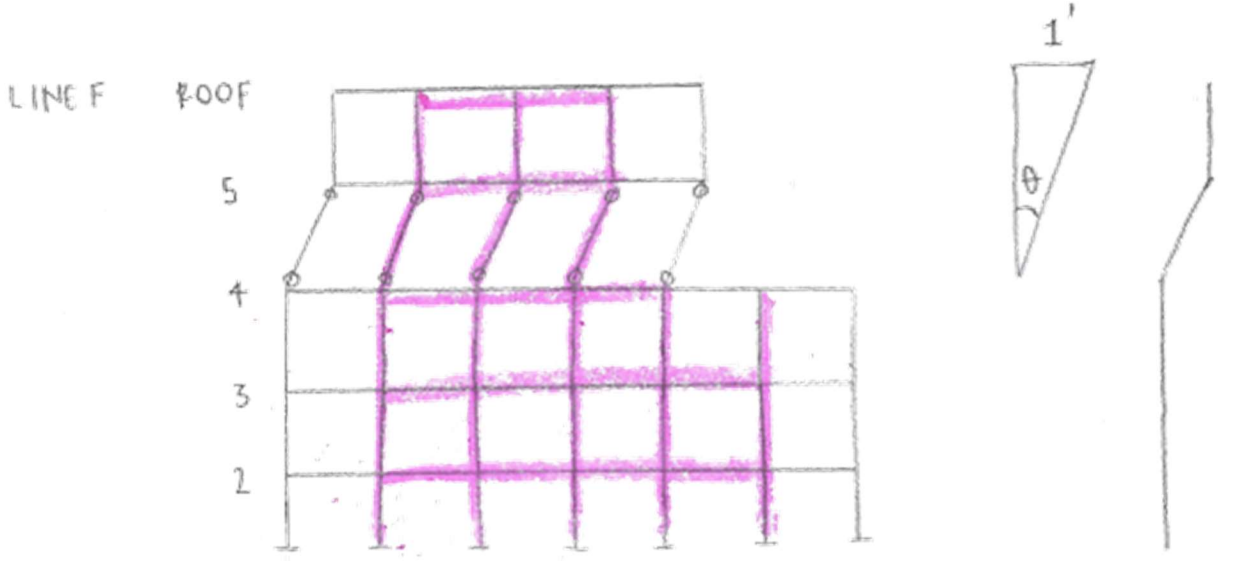
Figure A2-2: Story mechanism below level 5

These evaluations indicate that a story mechanism is unlikely as none of the cases that include gravity columns indicate a likely story mechanism. Also, our results show that the building setback that occurs above Level 4 does not result in a story mechanism vulnerability above the setback.

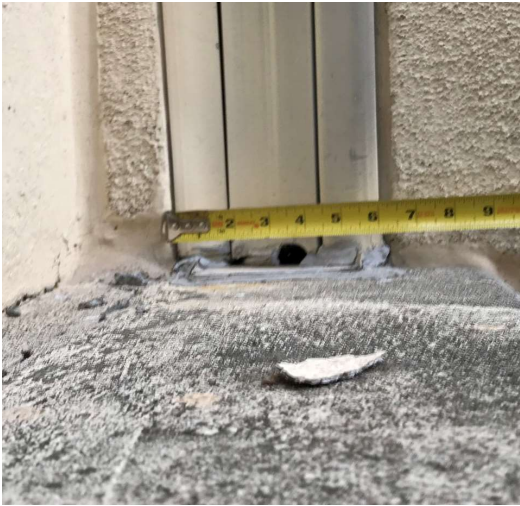
Covered seismic gap at NW corner of building

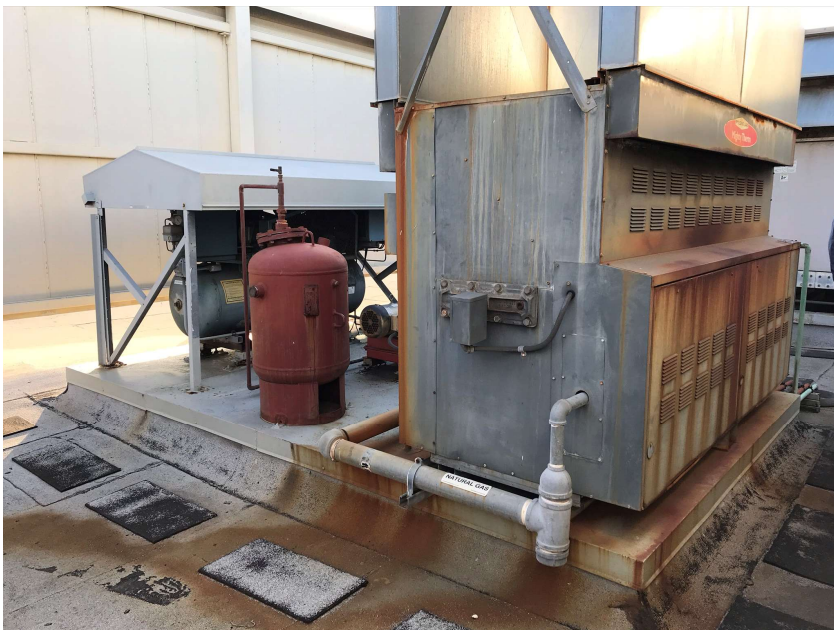
We did not identify any non-structural life-safety concerns during our walkthrough. There is a natural gas-fueled water heater at the upper roof level with seismic restraints, and there is an earthquake-activated automatic gas shutoff device at the main shutoff.

Gas-fired domestic water heater – high roof

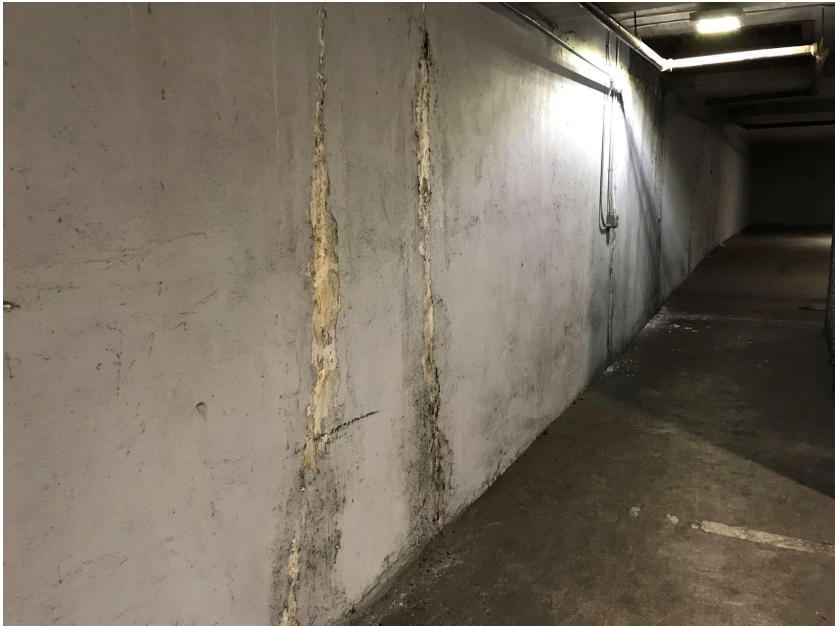
The building appears in generally good condition, and UCSF personnel noted that there are no current maintenance issues. There is rust on some rooftop mechanical equipment. There is evidence of moisture intrusion through the perimeter concrete walls at level B4.

**Level B4 perimeter wall with
evidence of moisture intrusion**
