DATE: 07-22-2019 (Group 1 Building Assessment was performed in December, 2018)

UCSF building seismic ratings
Mt. Zion Cancer Research

CAAN #2037
2340 Sutter Street, San Francisco, CA 94115
UCSF Campus: Mt. Zion Hospital

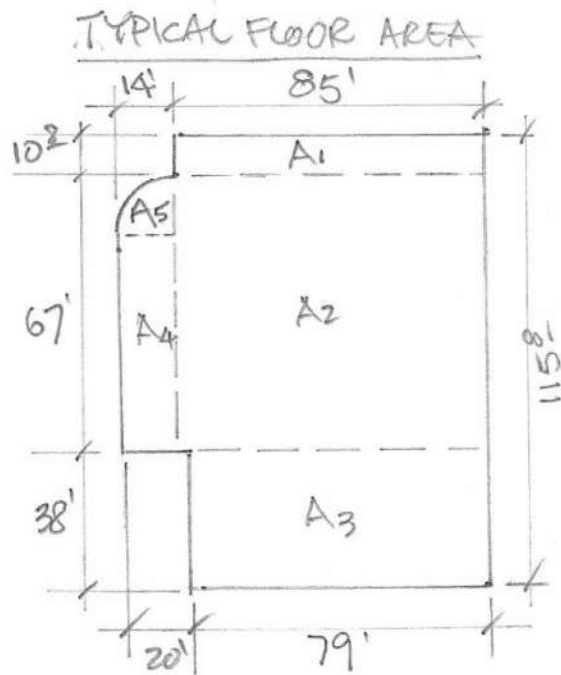
NORTH SECTION (N & S sections are essentially the same)

$A_1: 85 \times 10.67 = 907 \text{ } \phi$
 $A_2: 85 \times 67 = 5695$
 $A_3: 79 \times 38 = 3002$
 $A_4: 14 \times 53 = 742$
 $A_5: \pi(14^2)/4 = 154$

$\Sigma A = 10,500 \phi$
