## UCSF Building Seismic Ratings

### 1442 5<sup>TH</sup> AVENUE

CAAN #2046

UCSF Campus: Parnassus

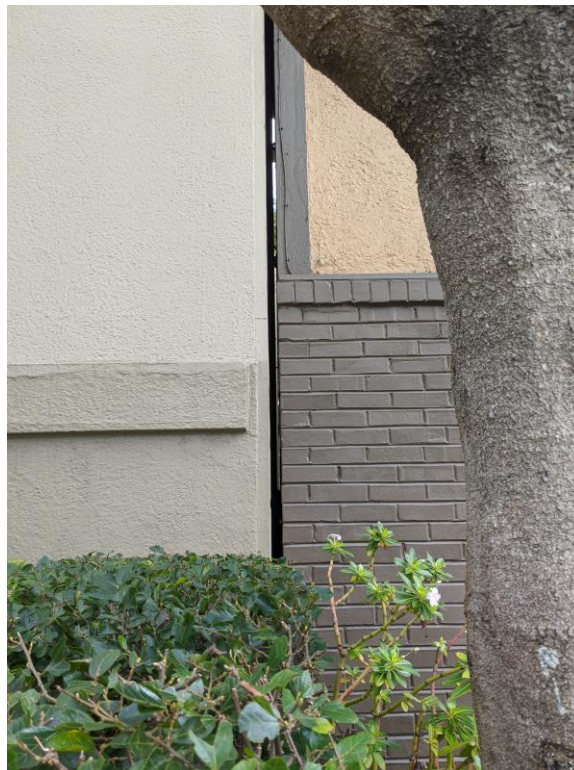
**Figure 5 – Building Separation to the North**

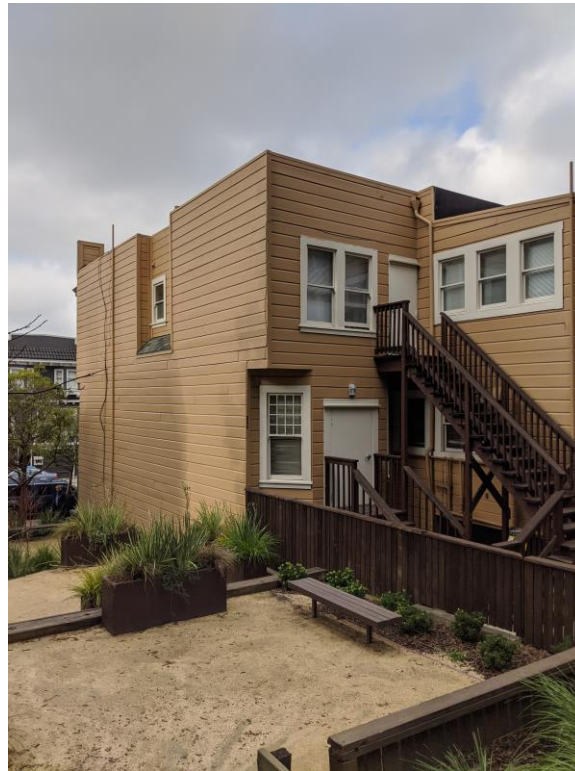
**Figure 6 – South Exterior Wall and Rear**

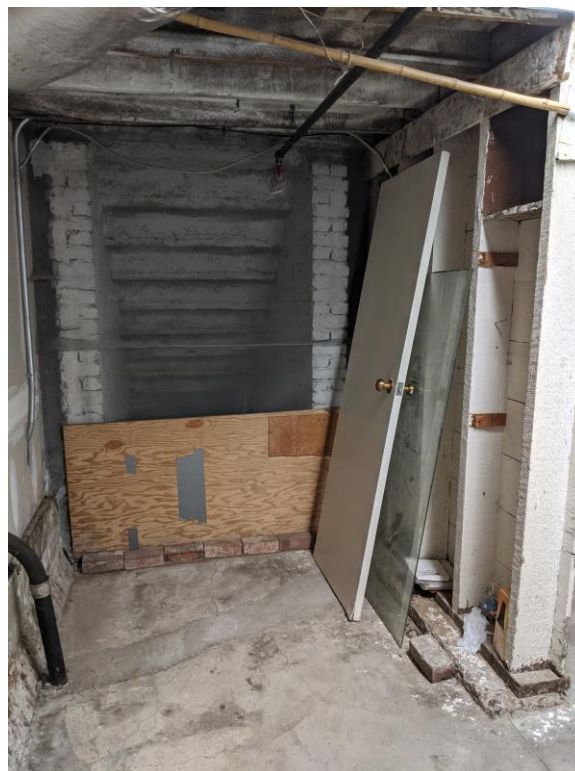
**Figure 7 – Underside of First Floor Entrance Stairs and Backside of Interior Partition**

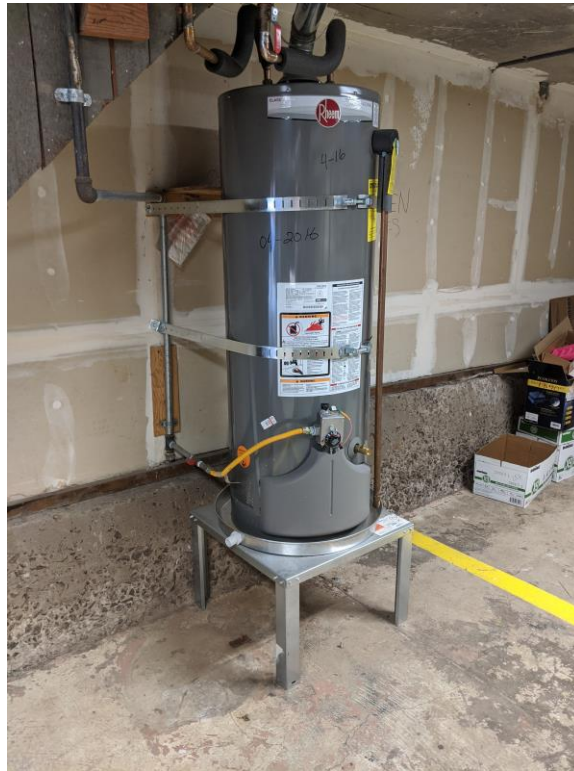
Building Condition: What could be observed of the structure of the building appeared to be in fair condition; however, most of the structure was concealed behind finishes. The concrete stem walls in the utility space were poorly consolidated in many areas and some spalling was observed. The wood siding, trim, and rear wood exterior patio and stairs looked to be in good condition. The building underwent a renovation in 1988, which was mostly cosmetic in nature.

The water heater in the basement is strapped to the wall and had flex connections to the gas line. Bracing of the furnace was not observed.

**Figure 8 – Anchored Water Heater, Concrete Stem Wall, & Gyp Wall Sheathing**

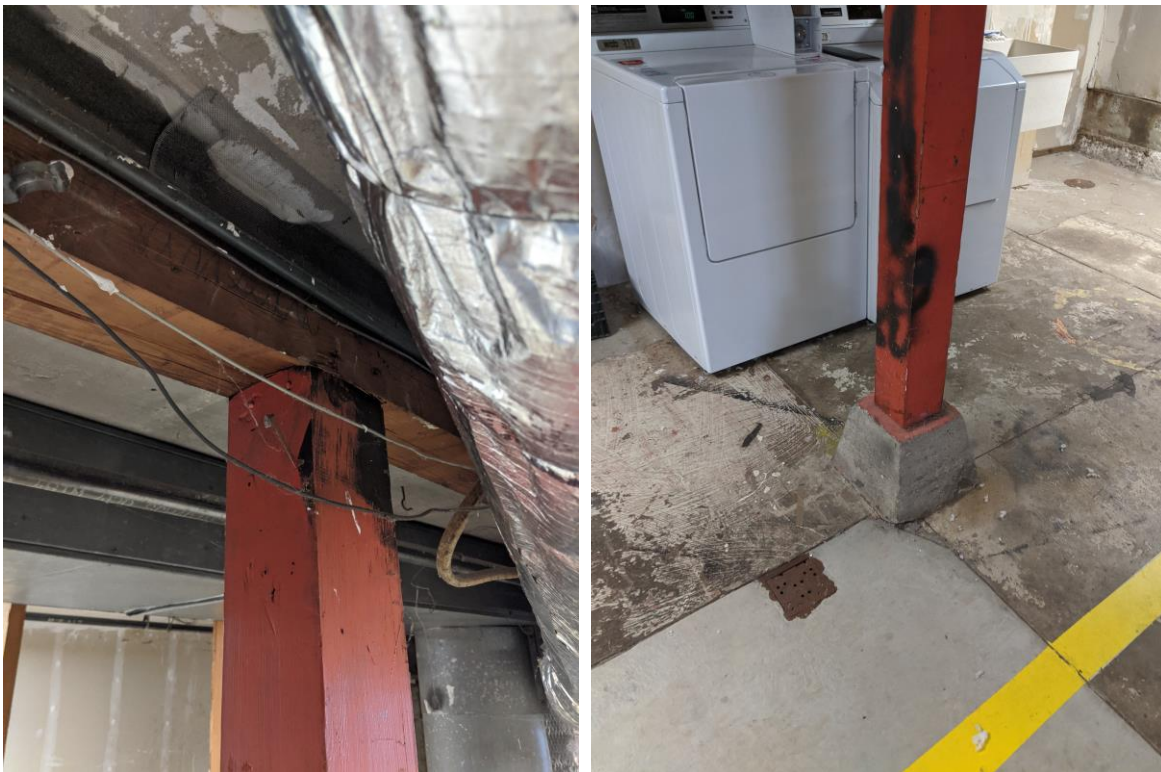
**Figure 9 – Top and Bottom of Interior Post**

Description
<b>C</b> <input type="radio"/>	<b>NC</b> <input checked="" type="radio"/>	<b>N/A</b> <input type="radio"/>	<b>U</b> <input type="radio"/>	<p>WOOD POSTS: There is a positive connection of wood posts to the foundation. (Commentary: Sec. A.5.3.3. Tier 2: Sec. 5.7.3.3)</p> <p><b>Comments:</b> Wood posts did not have positive connections to the foundation.</p>
<b>C</b> <input type="radio"/>	<b>NC</b> <input type="radio"/>	<b>N/A</b> <input type="radio"/>	<b>U</b> <input checked="" type="radio"/>	<p>WOOD SILLS: All wood sills are bolted to the foundation. (Commentary: Sec. A.5.3.4. Tier 2: Sec. 5.7.3.3)</p> <p><b>Comments:</b> All exterior wood sills in the basement space were concealed by plaster. However, based on the age of the building it is anticipated the wood sill bolting is not adequate.</p>
<b>C</b> <input type="radio"/>	<b>NC</b> <input checked="" type="radio"/>	<b>N/A</b> <input type="radio"/>	<b>U</b> <input type="radio"/>	<p>GIRDER-COLUMN CONNECTION: There is a positive connection using plates, connection hardware, or straps between the girder and the column support. (Commentary: Sec. A.5.4.1. Tier 2: Sec. 5.7.4.1)</p> <p><b>Comments:</b> Wood posts did not have positive connections to girders.</p>

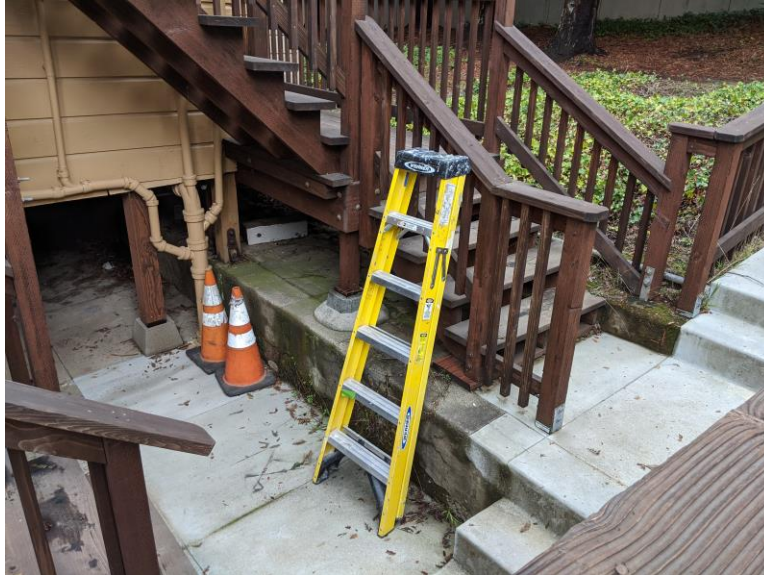
Foundation system: Existing foundation drawings are not available. It is presumed there are continuous footings below bearing walls. During the site visit on December 10, 2019 continuous concrete stem wall footings were observed around the ground floor level. The rear portion is supported on wood posts on isolated footings at the two eastern-most corners.

**Figure 10 – Exterior Wood Stairs and Elevated Rear Addition on Posts**

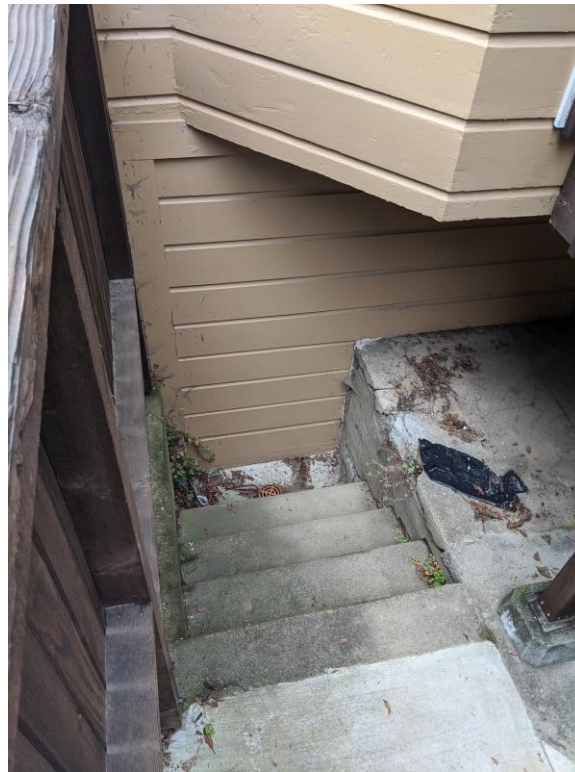
**Figure 11 – Infill of Original Rear Basement Egress Door per 1988 Drawings**
