4-8-2020

UCSF Building Seismic Ratings
1468 5TH AVENUE

CAAN #2053
1468 5th AVENUE, SAN FRANCISCO, CA 94122
UCSF Campus: Parnassus

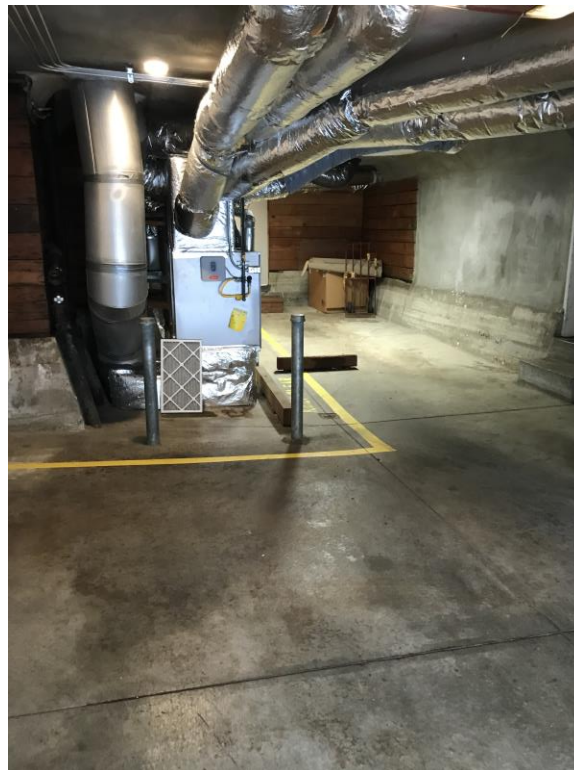
Figure 5 – Garage Interior, Looking East

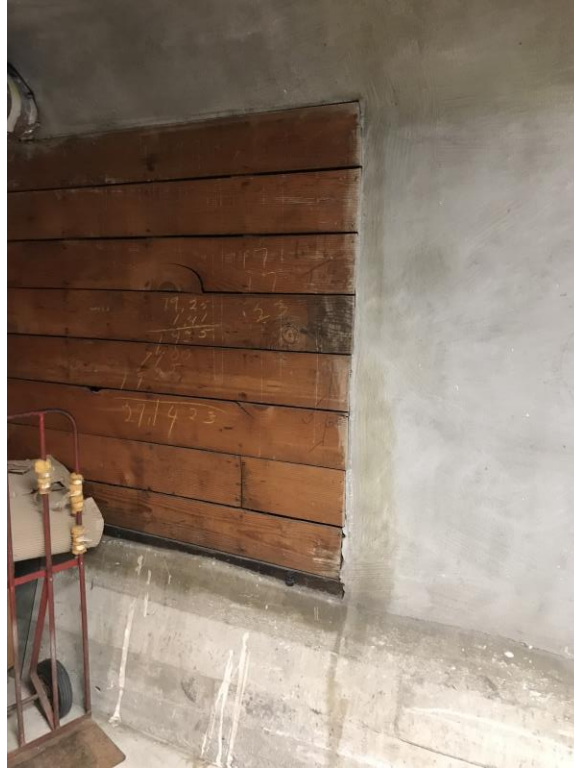
Figure 6 – Southeast Corner of Utility Space with Stucco and Straight Sheathing

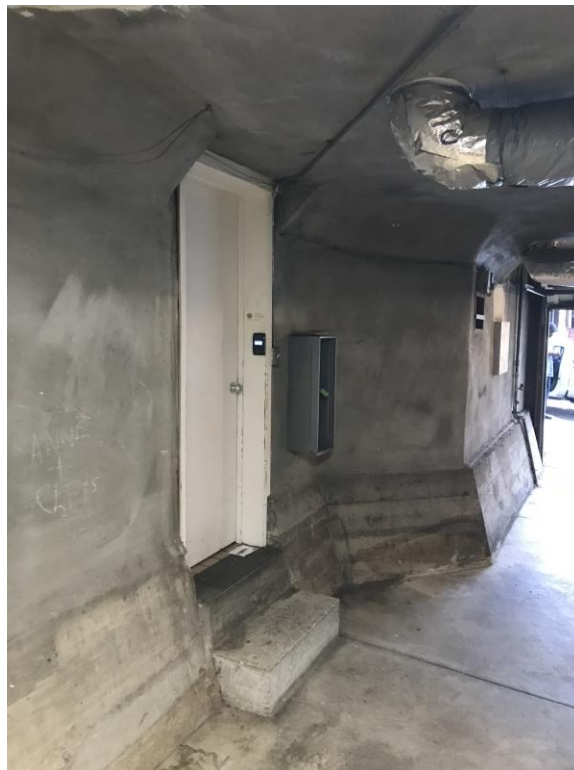
Figure 7 – Garage Wall Opposite Entry and Interior Stairwell

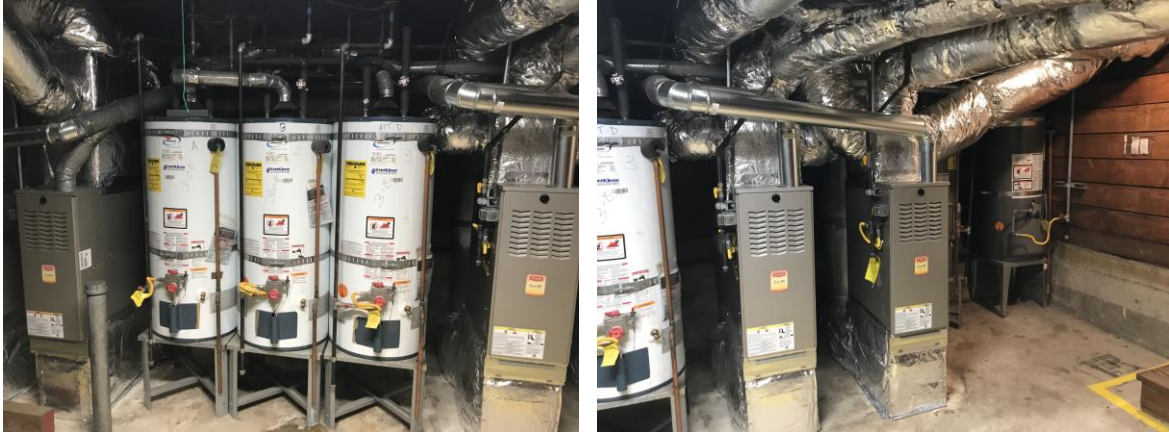
The water heaters in the basement were anchored to the wall. Flexible connections were used on all water heaters and furnaces.

Figure 8 – Water Heaters and Furnaces in Utility Area

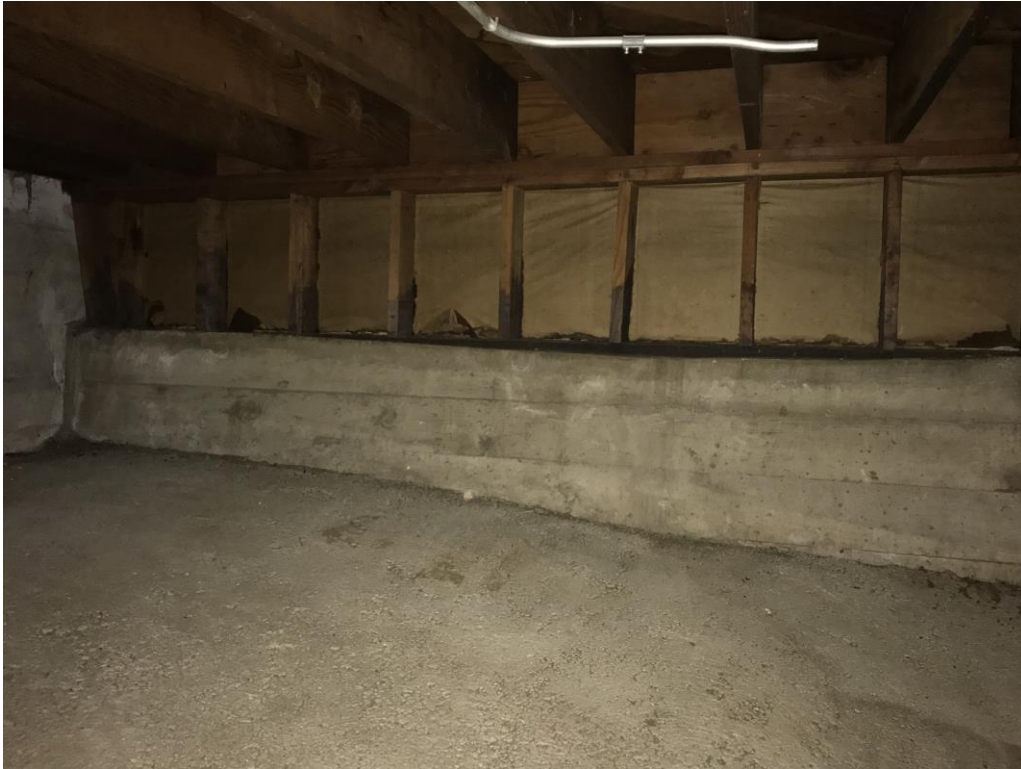
Figure 12 – Southeast Corner of Crawlspace

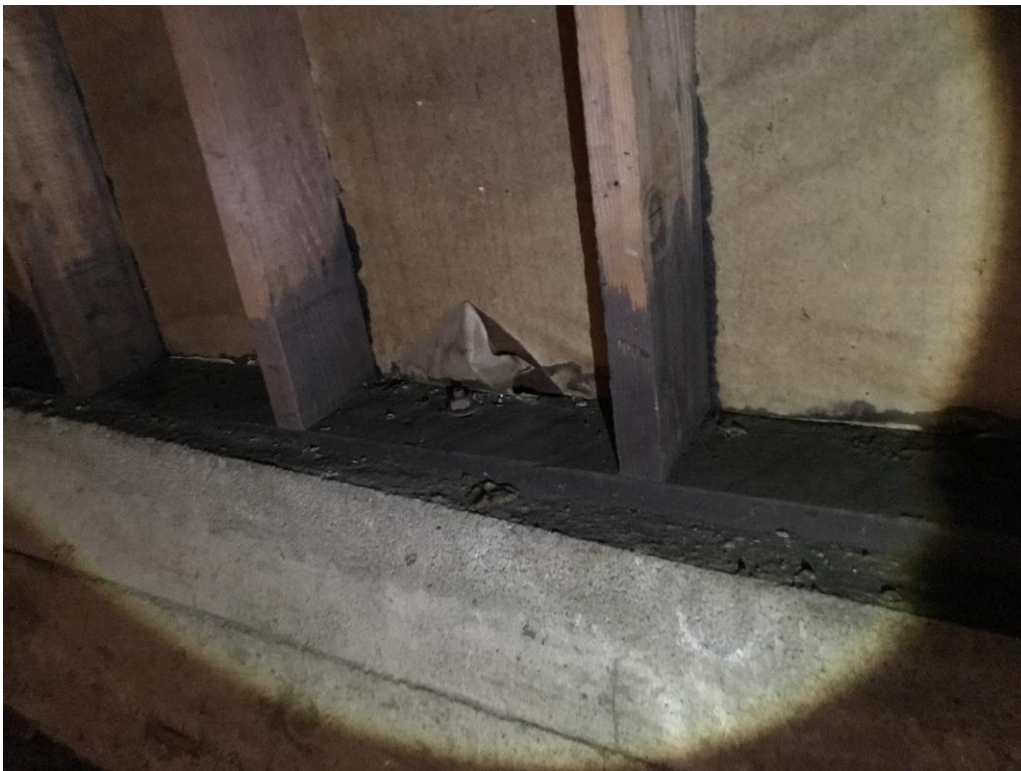
- The building is built to the property line with virtually no separation between the neighboring buildings to the north and south.
- The basement cripple walls were sheathed with a mixture of stucco/plaster, gyp board, straight sheathing, and sheet metal. Based on the age of construction it is assumed the anchor bolts for the sill plate are not adequate. In the crawlspace, where anchor bolts were seen, they were at 4 ft on center.

Figure 13 – Existing Mudsill Anchor at Crawlspace Cripple Wall

C	NC	N/A	U	<p>WOOD SILLS: All wood sills are bolted to the foundation. (Commentary: Sec. A.5.3.4. Tier 2: Sec. 5.7.3.3)</p> <p>Comments: At the one area the sills could be seen, anchor bolts were present but spaced at 4-foot on center.</p>
<input checked="" type="radio"/>	<input type="radio"/>	<input type="radio"/>	<input type="radio"/>	
C	NC	N/A	U	<p>GIRDER-COLUMN CONNECTION: There is a positive connection using plates, connection hardware, or straps between the girder and the column support. (Commentary: Sec. A.5.4.1. Tier 2: Sec. 5.7.4.1)</p> <p>Comments: No interior wood posts were observed.</p>
<input type="radio"/>	<input type="radio"/>	<input type="radio"/>	<input checked="" type="radio"/>

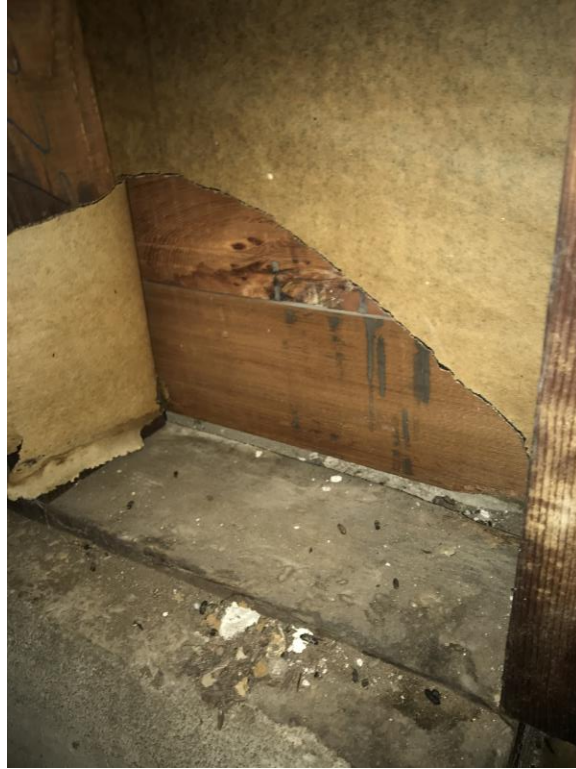
Figure 14 – Straight Sheathing at South Cripple Wall

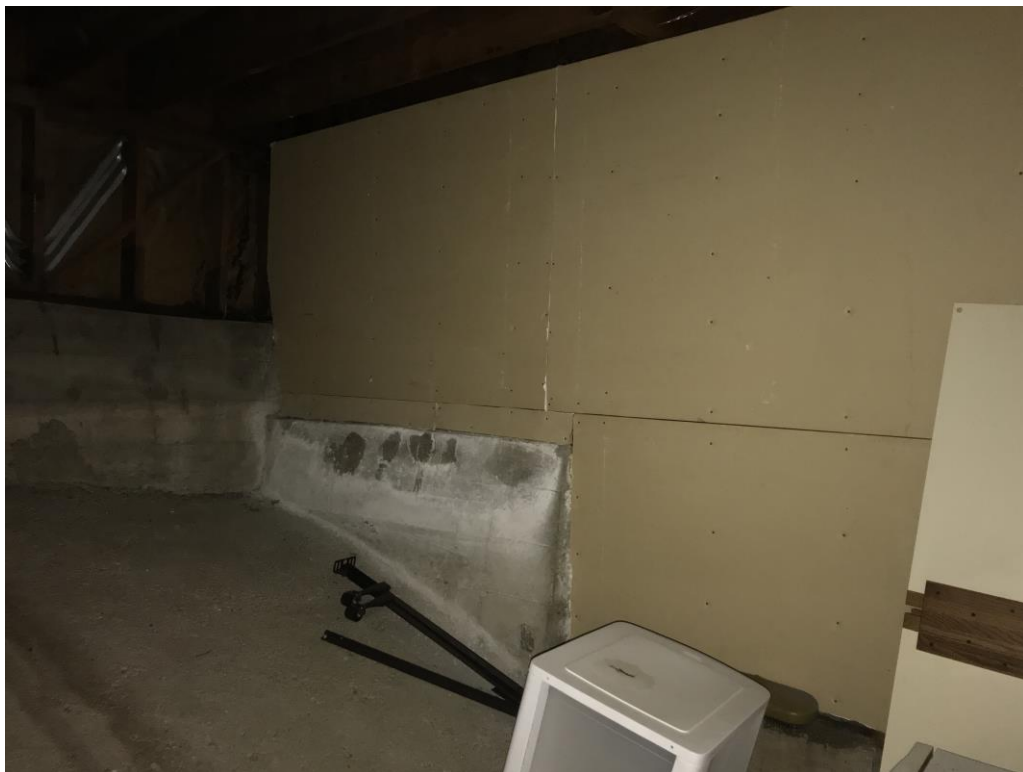
Figure 15 – Southwest Corner of Crawlspace

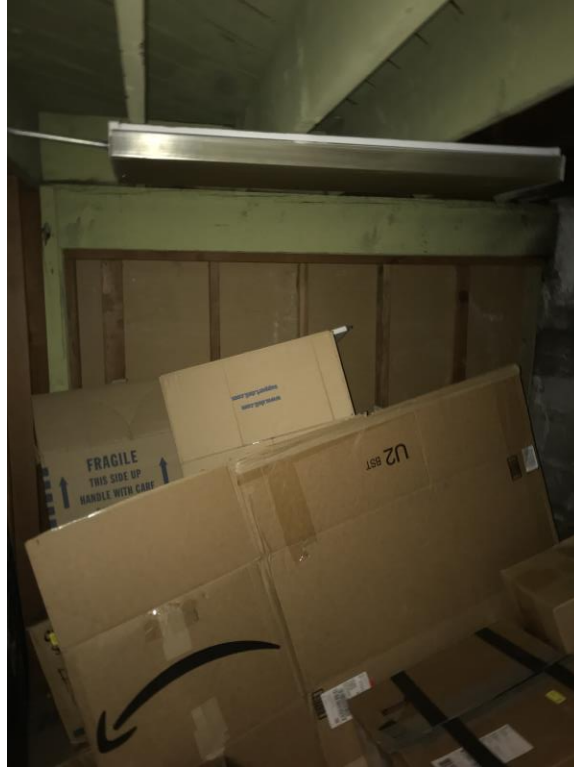
Figure 13 – North Partition Wall of Crawlspace with Diagonal Sheathing Visible
