UCSF Building Seismic Ratings

1464 5TH AVENUE

CAAN #2054

1464 5th AVENUE, SAN FRANCISCO, CA 94122

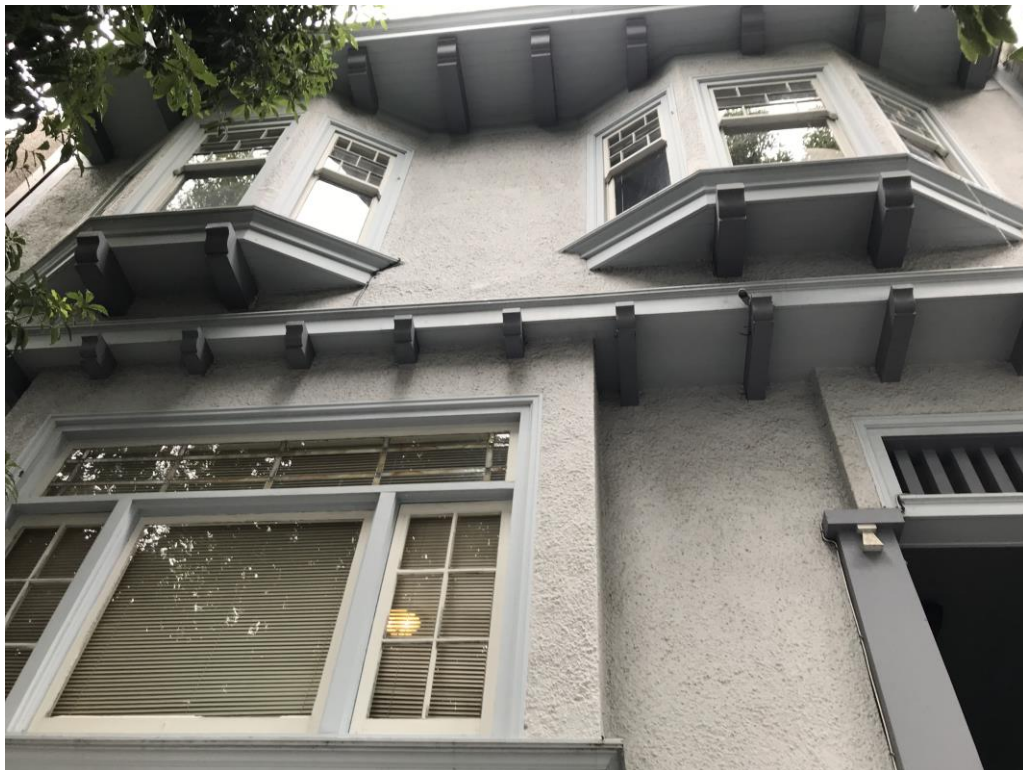
Figure 6 – West (Front) Exterior Wall

Building Condition: What could be observed of the structure of the building appeared to be in fair condition; however, all of the interior structure was concealed behind finishes. The wood siding, trim, and rear deck looked to be in good condition. The stucco on the street-side wall was in good condition, with no visible cracking.

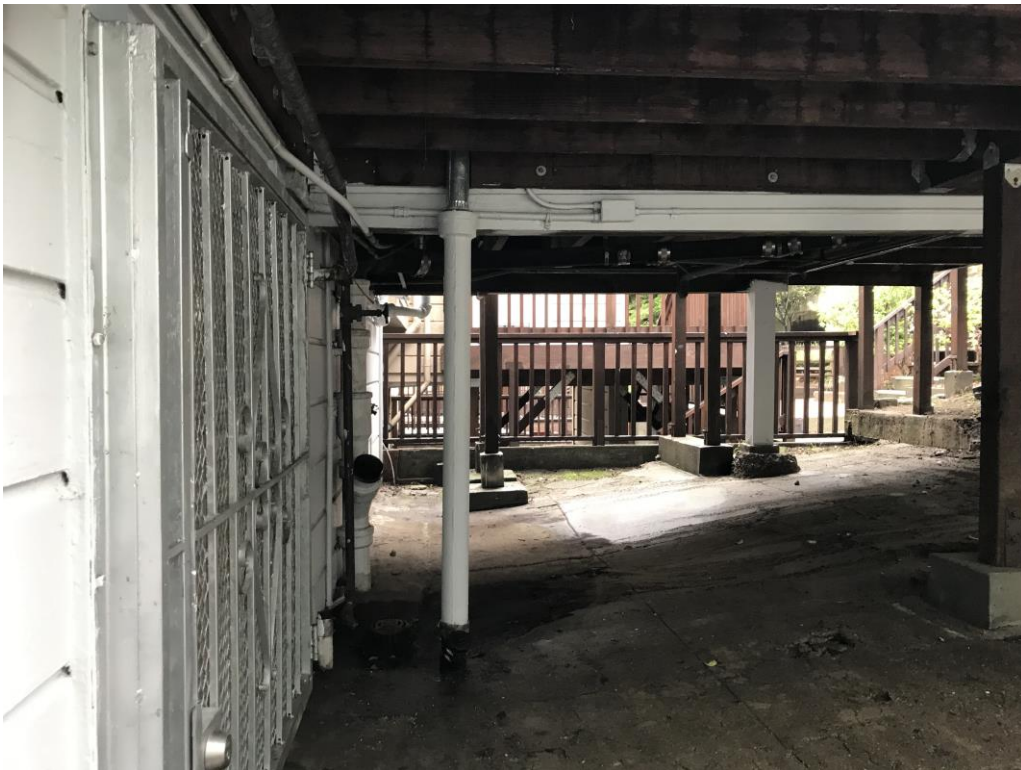
Figure 8 – Underside of Deck and Rear Addition

Foundation system: Existing foundation drawings are not available. It is presumed there are continuous footings below bearing walls. During the site visit on December 12, 2019 continuous concrete stem wall footings were observed around the ground floor level. The rear portion is supported on wood posts on isolated footings at the two eastern-most corners.

C <input type="radio"/>	NC <input type="radio"/>	N/A <input type="radio"/>	U <input checked="" type="radio"/>	<p>WOOD SILLS: All wood sills are bolted to the foundation. (Commentary: Sec. A.5.3.4. Tier 2: Sec. 5.7.3.3)</p> <p>Comments: All wood sills in the basement space were concealed by plaster. However, based on the age of the building it is anticipated the wood sill bolting is not adequate.</p>
C <input type="radio"/>	NC <input type="radio"/>	N/A <input type="radio"/>	U <input checked="" type="radio"/>	<p>GIRDER-COLUMN CONNECTION: There is a positive connection using plates, connection hardware, or straps between the girder and the column support. (Commentary: Sec. A.5.4.1. Tier 2: Sec. 5.7.4.1)</p> <p>Comments: No interior wood posts were observed. The exterior posts supporting the rear bath and study do not seem to be positively connected to the girders.</p>

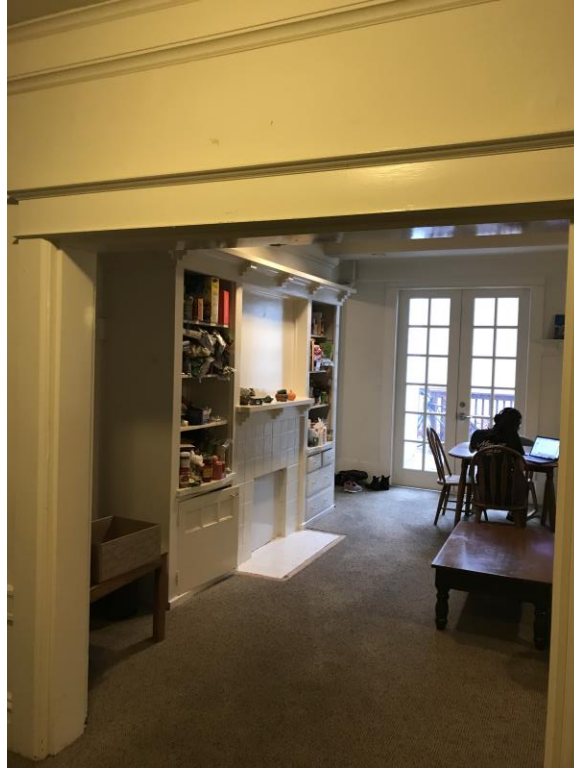
Figure 9 – Closed Off Fireplace in First Floor Living

It appeared the chimney had been replaced with a sheet metal flue. The facilities maintenance technician assisting with the site visit noted that the units have fireplaces, but they had been blocked off. One was observed on the first floor living room.
