4-8-2020

**UCSF Building Seismic Ratings**  
**1454 5<sup>TH</sup> AVENUE**

CAAN #2056  
1454 5<sup>th</sup> AVENUE, SAN FRANCISCO, CA 94122  
UCSF Campus: Parnassus

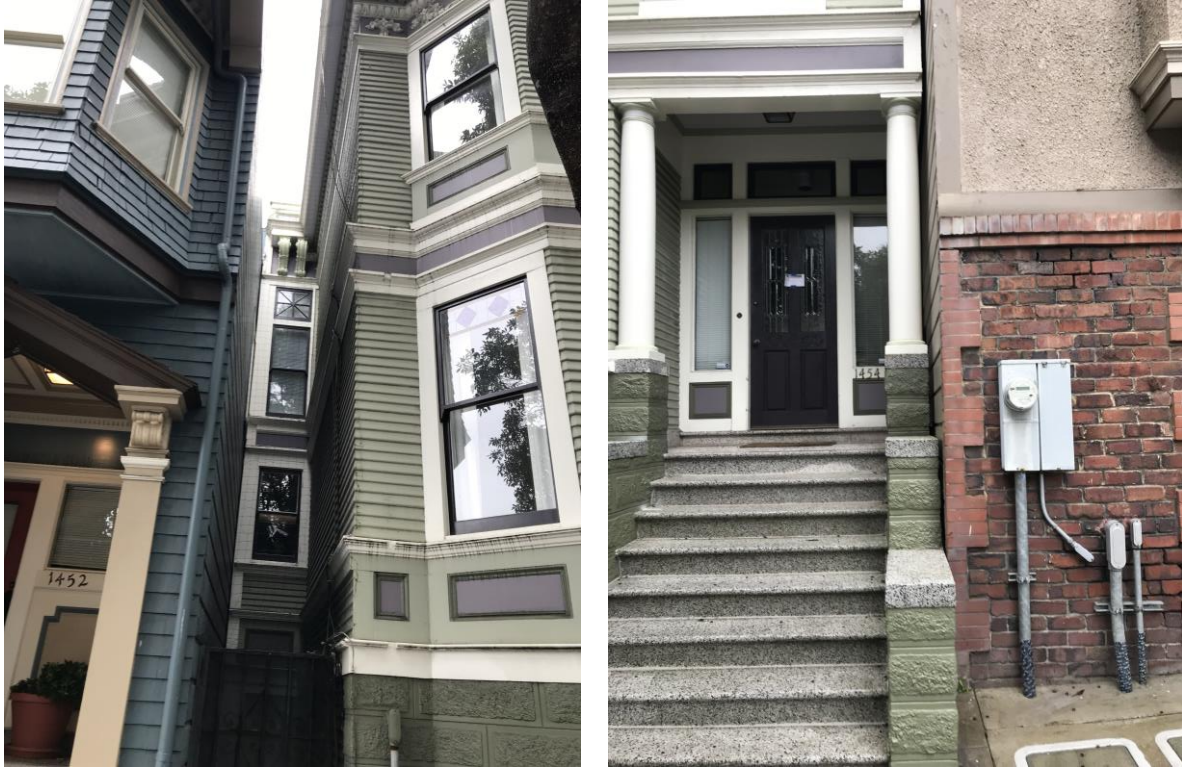
**Figure 4 - Building Separation to the North (Left) and South (Right)**

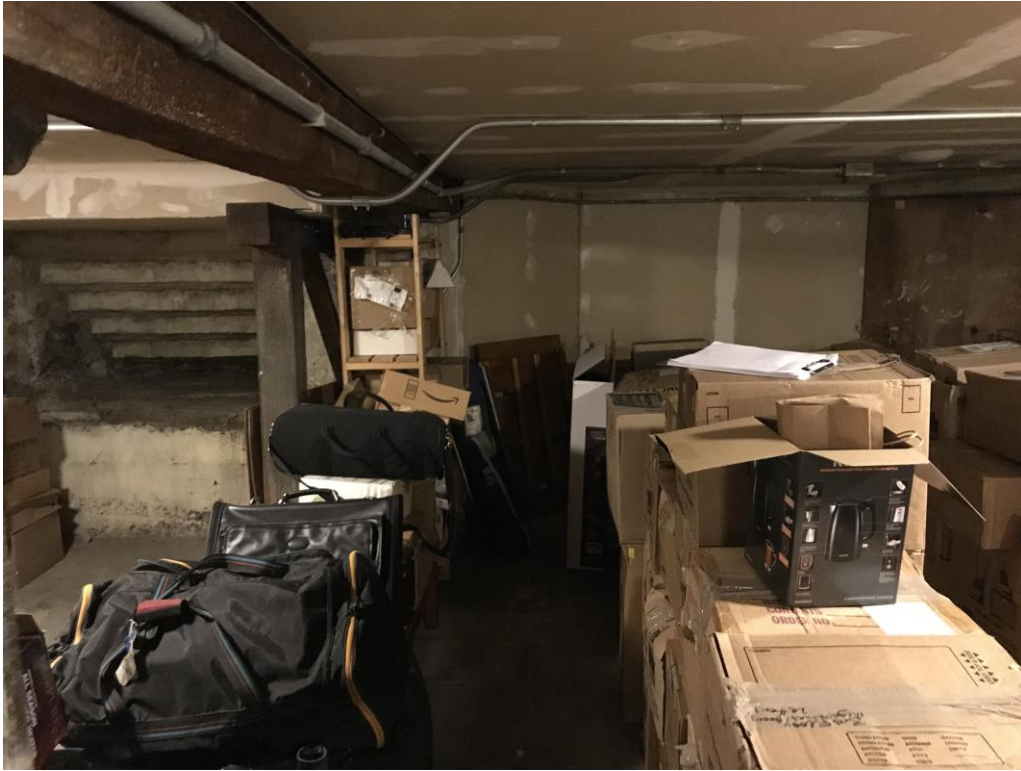
**Figure 5 – West (Front) Basement Wall**

Building Condition: What could be observed of the structure of the building appeared to be in fair condition; however, most of the structure was concealed behind finishes. The concrete stem walls in the basement were poorly consolidated in some areas and some cracks were observed. A portion of the rear slab on grade looked to be buckled and badly cracked. The wood siding was in good condition.

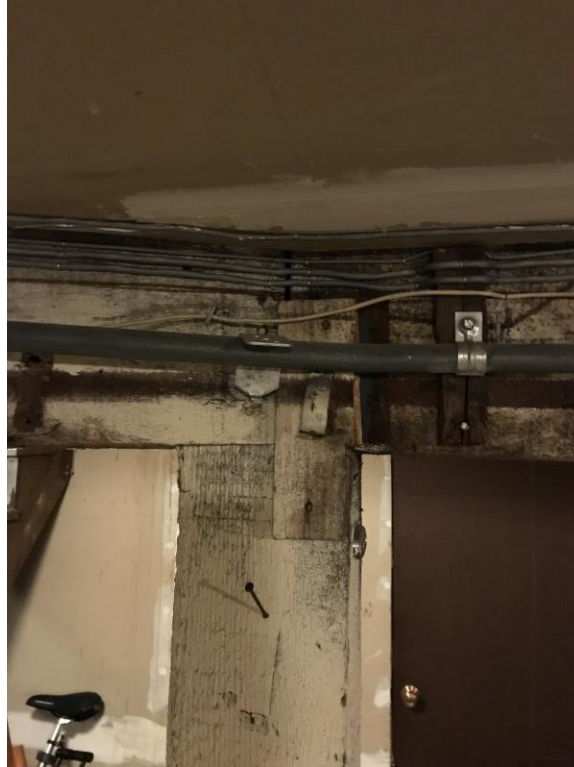
**Figure 10 – Top of Basement Post**

<b>C</b>	<b>NC</b>	<b>N/A</b>	<b>U</b>	<input type="radio"/>	<input checked="" type="radio"/>	<input type="radio"/>	<input type="radio"/>	<p>GIRDER-COLUMN CONNECTION: There is a positive connection using plates, connection hardware, or straps between the girder and the column support. (Commentary: Sec. A.5.4.1. Tier 2: Sec. 5.7.4.1)</p> <p><b>Comments:</b> Girders did not have positive connections to the posts.</p>

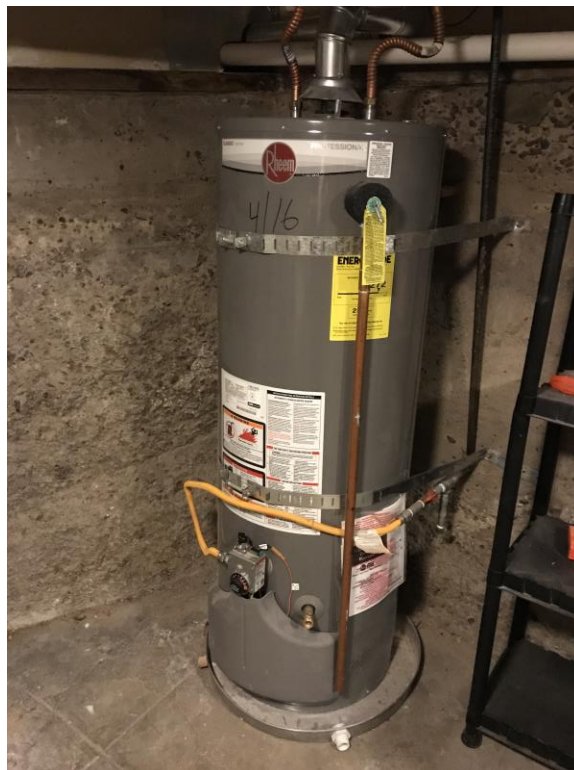
The water heater in the basement is anchored to the wall.

**Figure 11 – Anchored Water Heater**

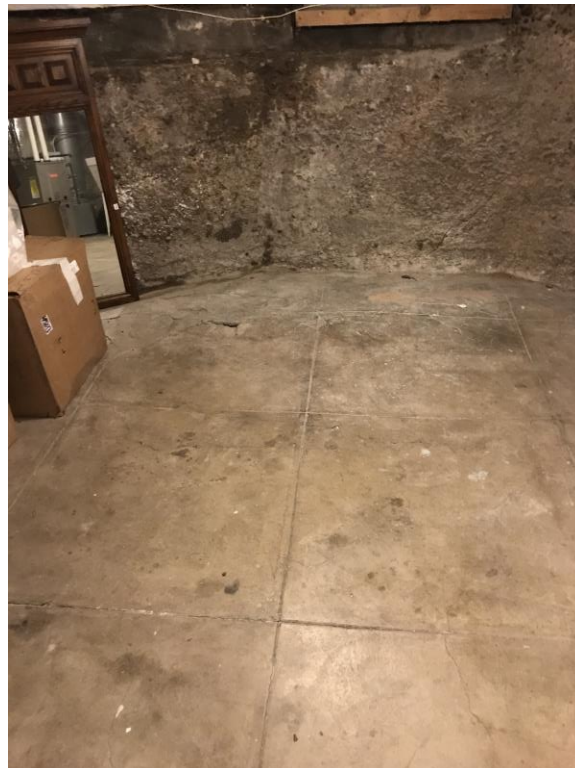
**Figure 13 – Buckling in Basement Slab on Grade**

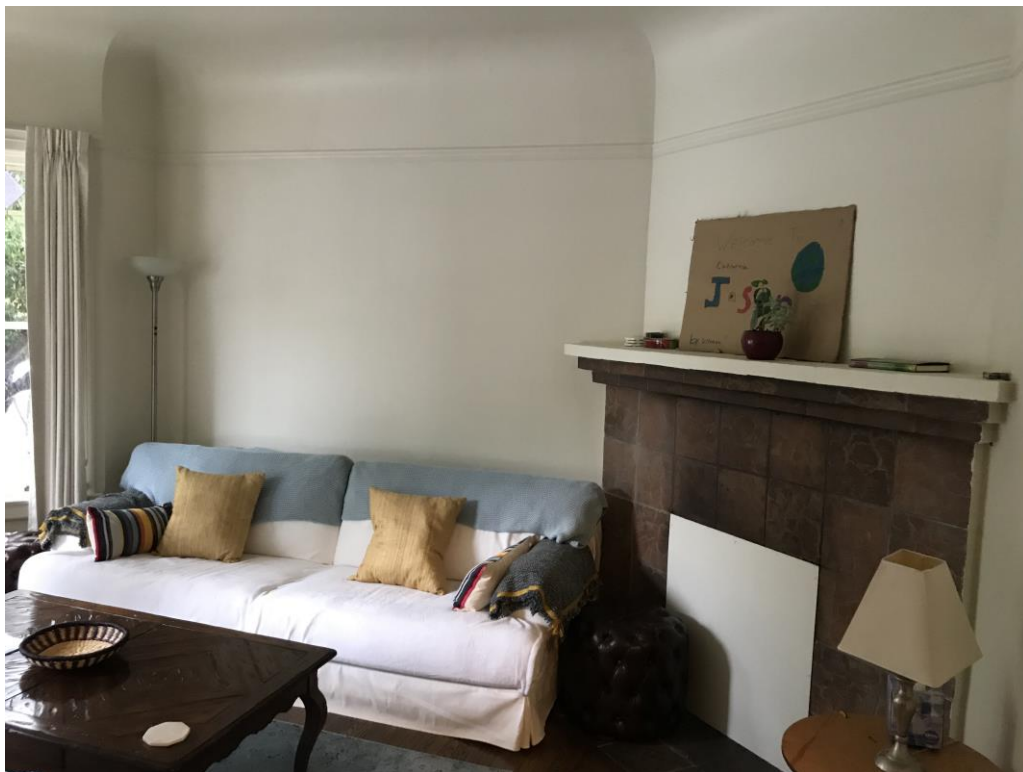
It appeared the chimney had been replaced with a sheet metal flue. Two blocked off fireplaces were observed at the first floor.

**Figure 15 – Blocked Off Fireplace**
