## UCSF Building Seismic Ratings

### 1420 5<sup>TH</sup> AVENUE

CAAN #2061

1420 5<sup>TH</sup> AVENUE, SAN FRANCISCO, CA 94122

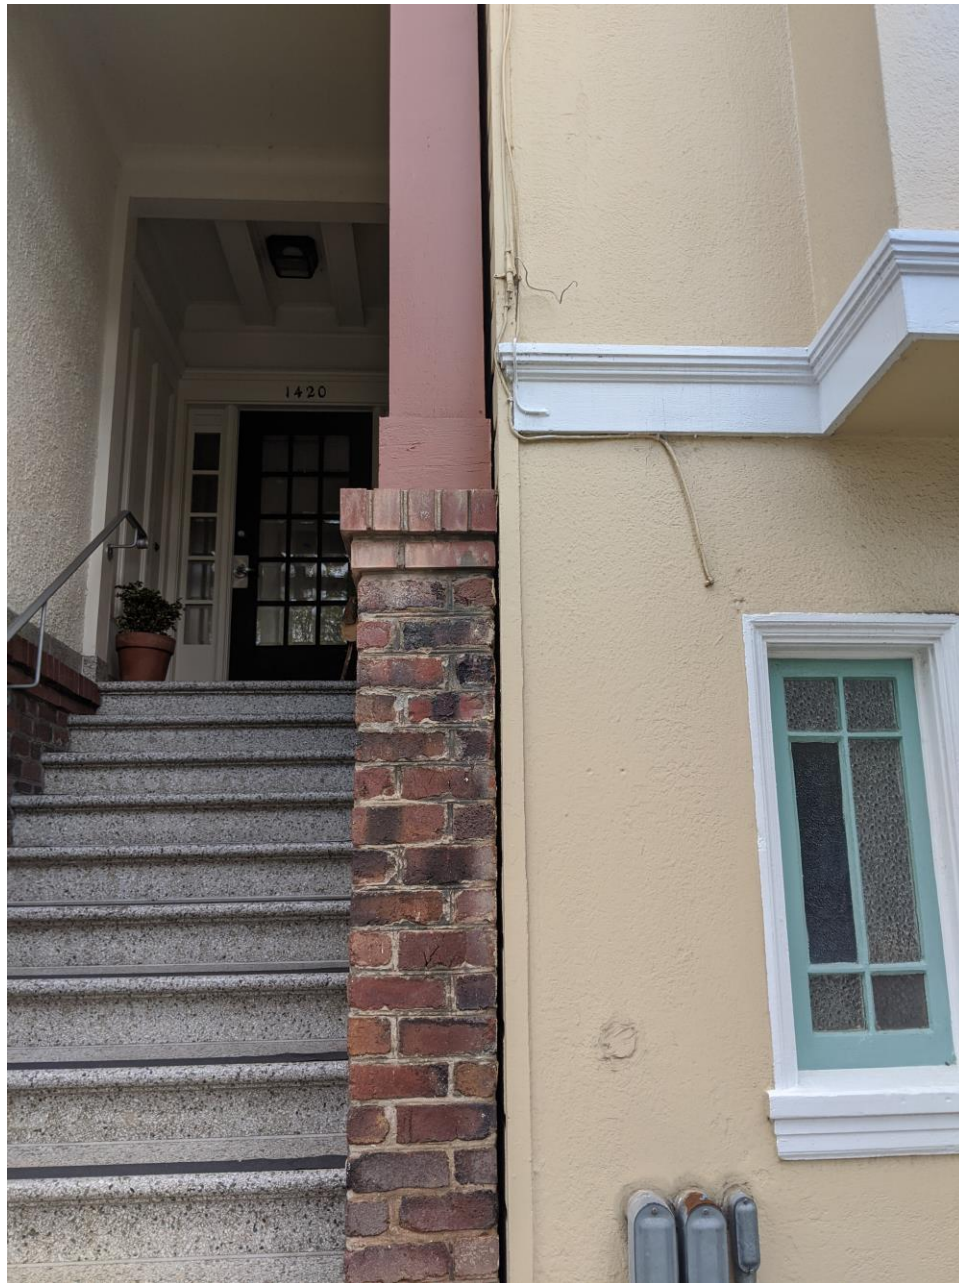
**Figure 5 - Building Separation to the South (1420 is Left)**

- The building is built to the property line with virtually no separation between the neighboring building to the south. To the north is an empty lot.
- The garage cripple walls were all sheathed and bolts for new holdowns could be seen. It is very likely anchor bolts were added to the existing mudsills. Therefore, the ground floor should have good seismic performance even though the transverse direction does not pass the Tier 1 Quick Check.

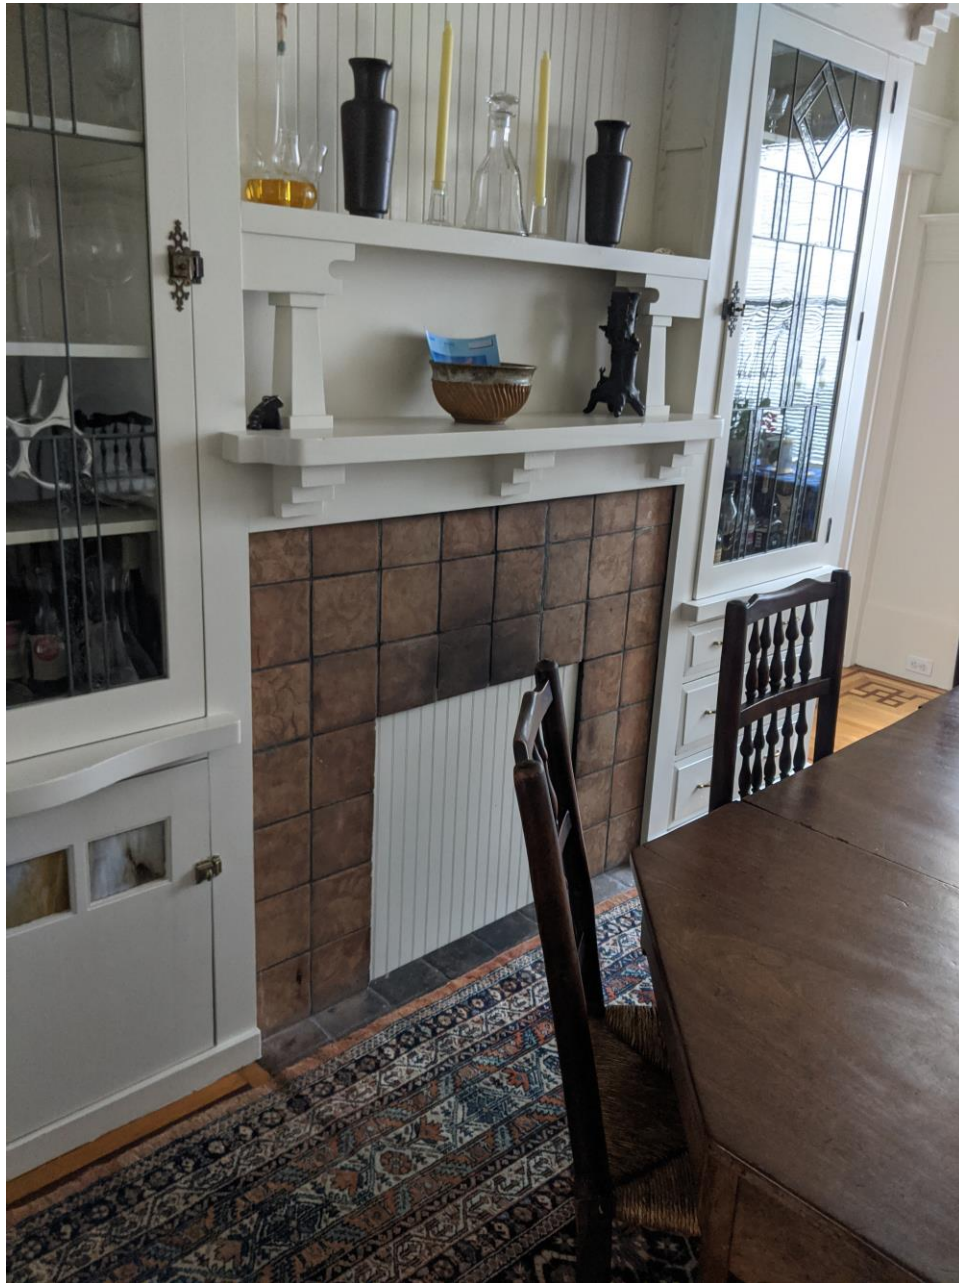
**Figure 8 – Closed Off Fireplace**

It appeared the chimney had been replaced with a sheet metal flue. The facilities maintenance technician assisting with the site visit noted that the units have fireplaces, but they had been blocked off.

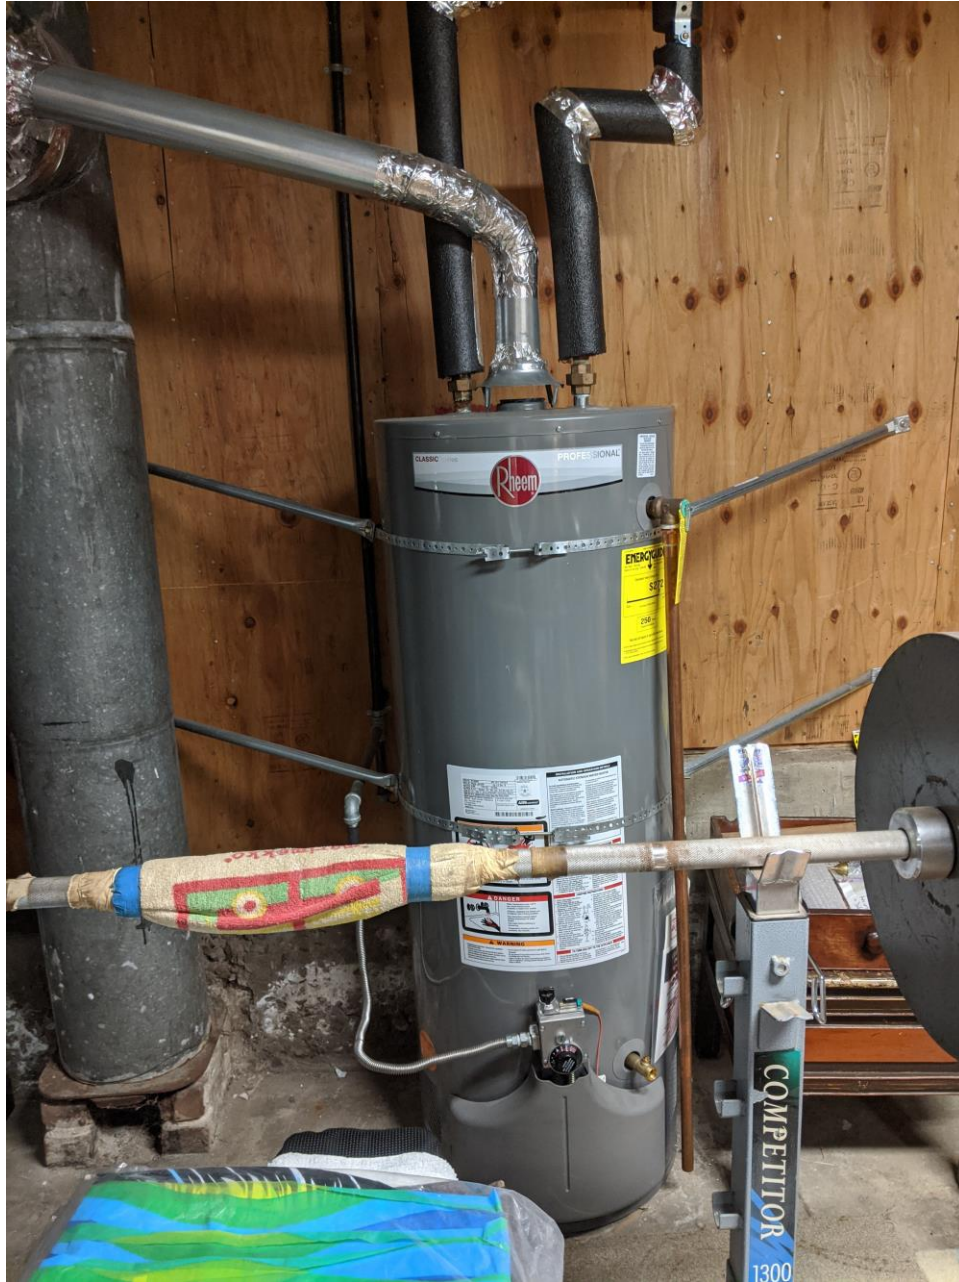
Figure 14 – Anchored Water Heater

The water heater in the basement is strapped to the wall and had flex connections to the gas line. Bracing of the furnace was not observed.
