UCSF Building Seismic Ratings
1422-24 5th AVENUE

CAAN #2062

1422-24 5th AVENUE, SAN FRANCISCO, CA 94122

UCSF Campus: Parnassus

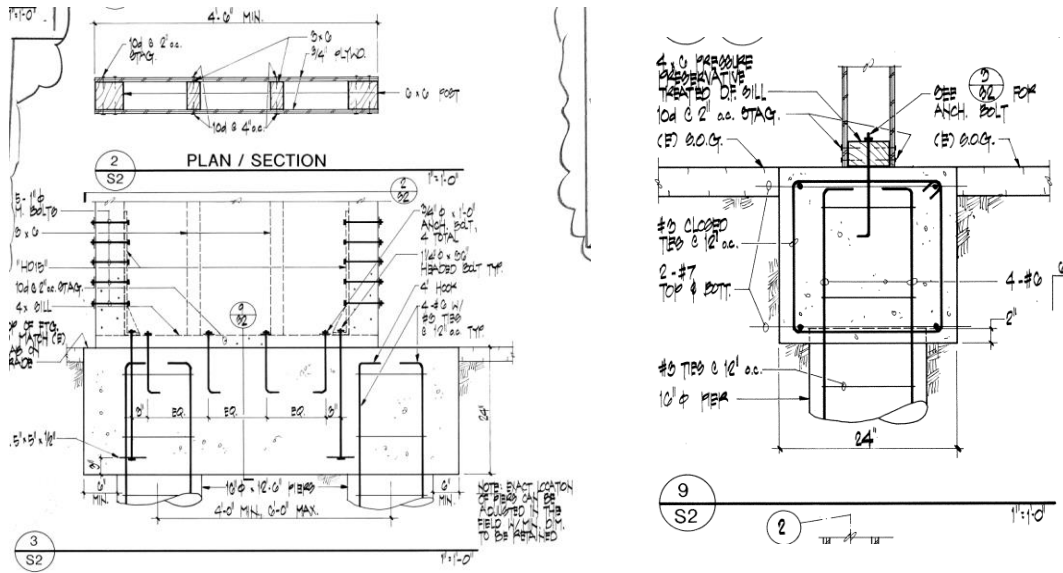
Figure 4 - Details for Shear Wall on Gridline 1

Building Condition: Good. The structure in the ground floor appeared to be reasonably well protected and well maintained. There was some damage observed to the gypsum board sheathing at the transverse plywood shear wall on Gridline 1.

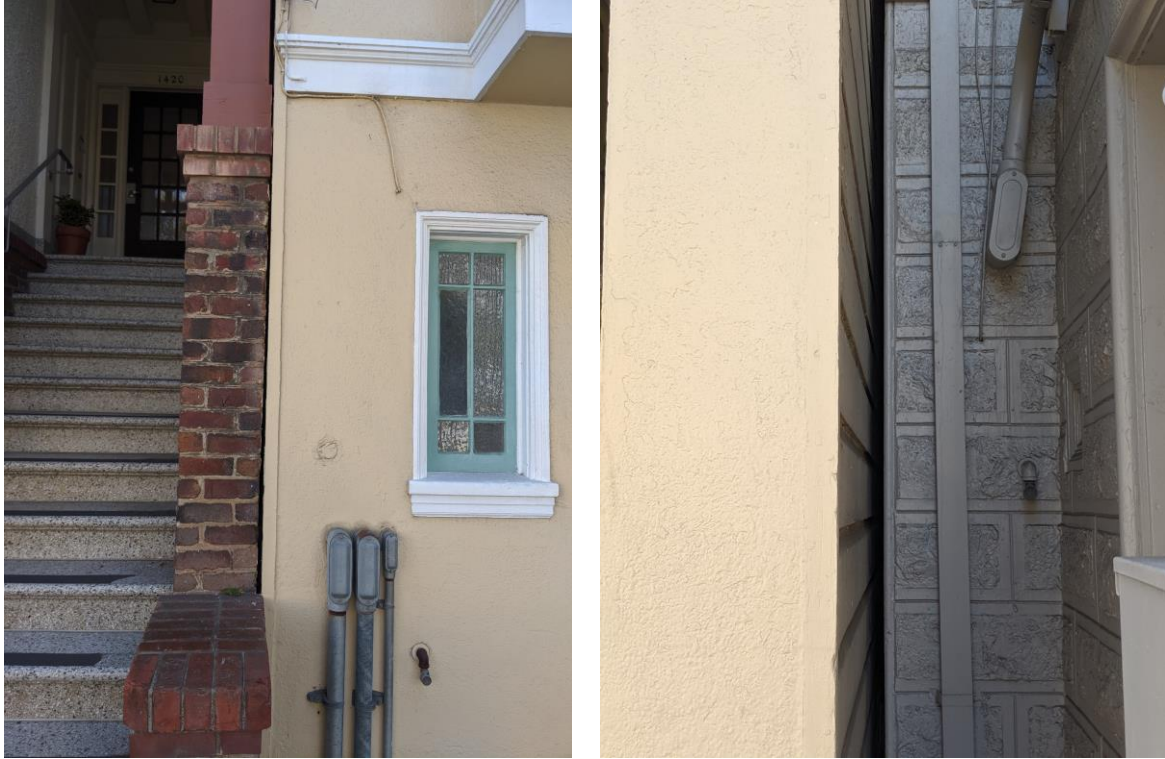
Figure 8 - Building Separation to the North (Left) and South (Right)

- Based on the age of construction, the walls between levels are not expected to be detailed to transfer shear and overturning forces between levels.
- The building is built to the property line with virtually no separation between the neighboring buildings to the north and south. The floor levels of the building to the north and south align with the floor levels of the subject building.

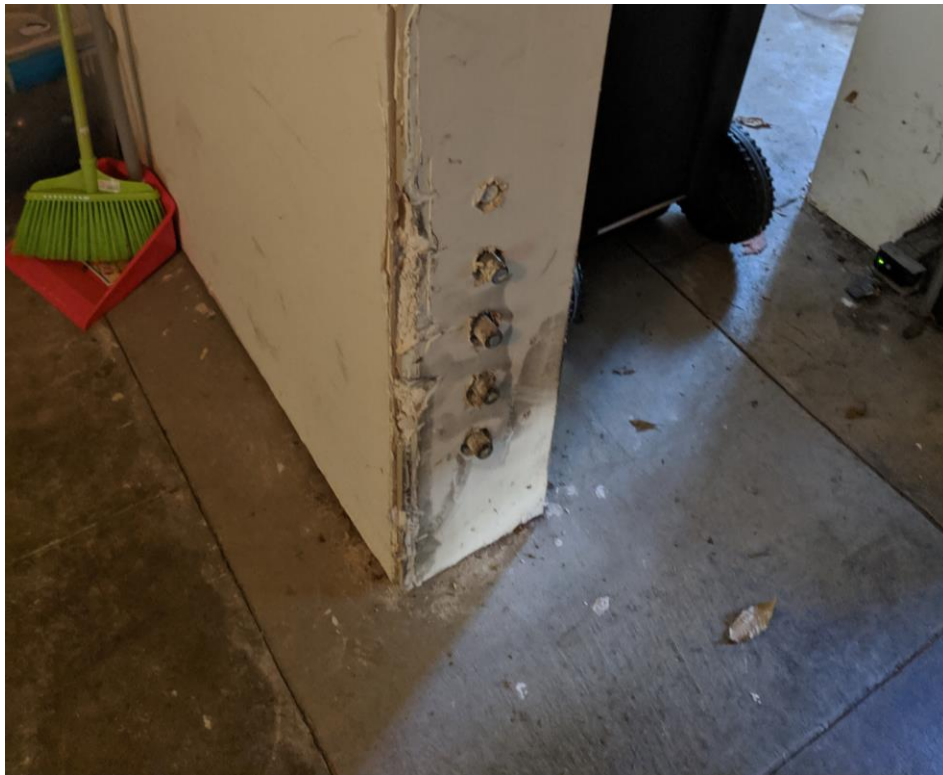
Figure 9 - Hold-down Bolts to Vertical stud and Extent of Foundation Element below Wall on Gridline 1

Foundation system: Existing foundation drawings are not available. It is presumed there are continuous footings below bearing walls and isolated footings below columns in the ground level. The two transverse shear walls added during the 1997 retrofit each received new foundation elements. The shear wall on Line 1 has a 24” square continuous footing over (2)-16” diameter x 12’-6” deep drilled piers. The shear wall on Line 2 has a continuous 16” square footing.

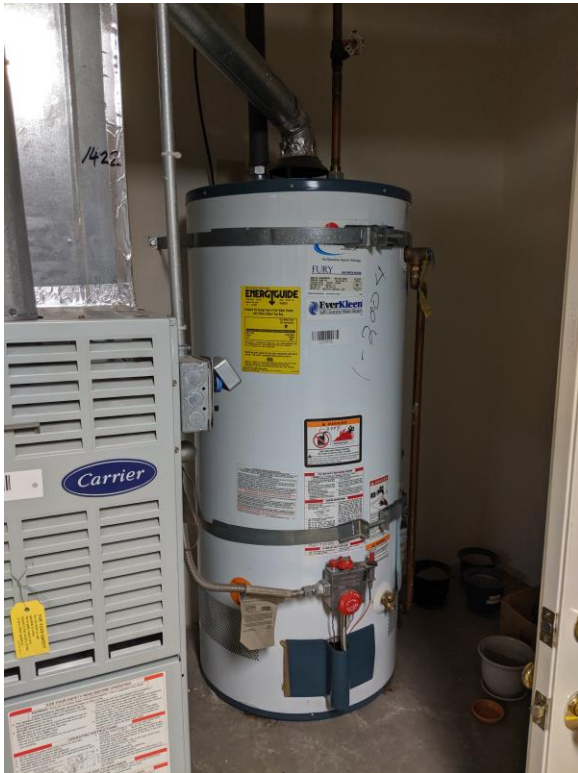
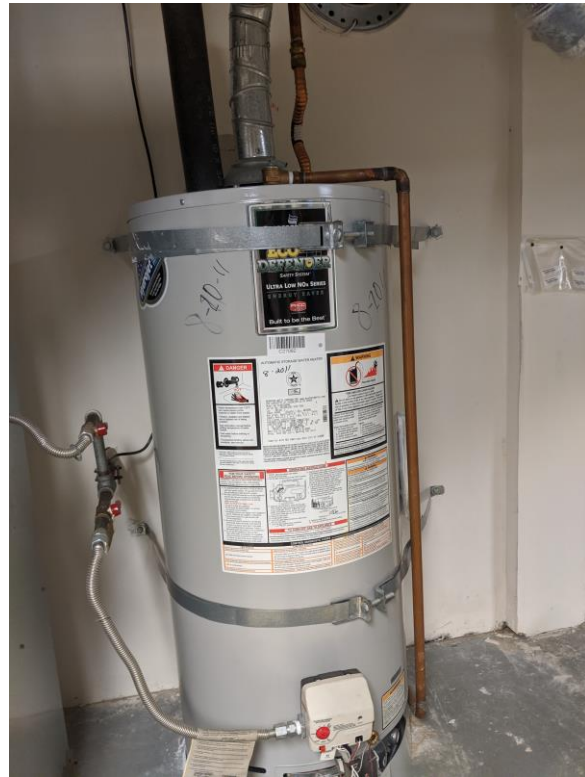
Figure 10 - Water Heaters

The water heaters in the ground floor were anchored to the wall.

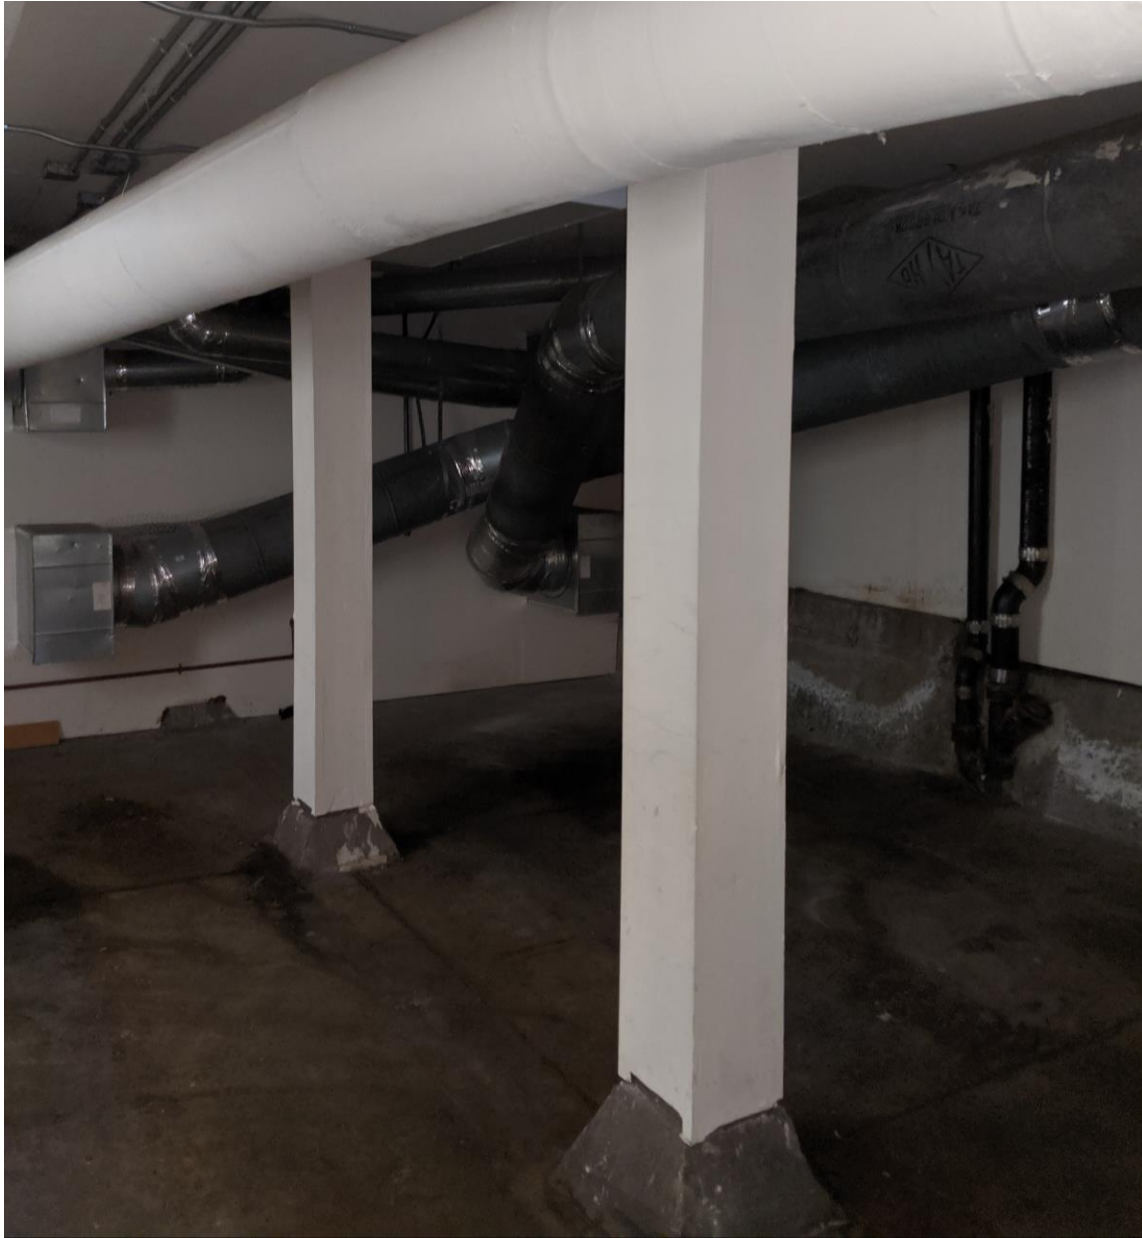
Figure 11 - Garage

Structural system for lateral forces: Drawings showing the existing framing are not available. It is presumed based on the age of the building that a sheathed diaphragm distributes load to the interior and exterior wood framed walls sheathed with gypsum board and/or plaster. The ceiling in the ground floor was concealed, so it was not possible to observe if the sheathing was straight or diagonal. The ground floor underwent a voluntary seismic retrofit in 1997. The retrofit consisted of adding three lines of shear resistance in the transverse direction – one shear wall towards the front of the building, one shear wall towards the middle and anchoring the existing framing into a concrete retaining wall at the rear of the building. In the longitudinal direction, shear walls were added along three lines of resistance – both exterior walls of the building and along the interior wall between the garage and corridor parallel to the garage and mechanical space.
