UCSF Building Seismic Ratings

1452 5TH AVENUE

CAAN #2064

1452 5TH AVENUE, SAN FRANCISCO, CA 94122

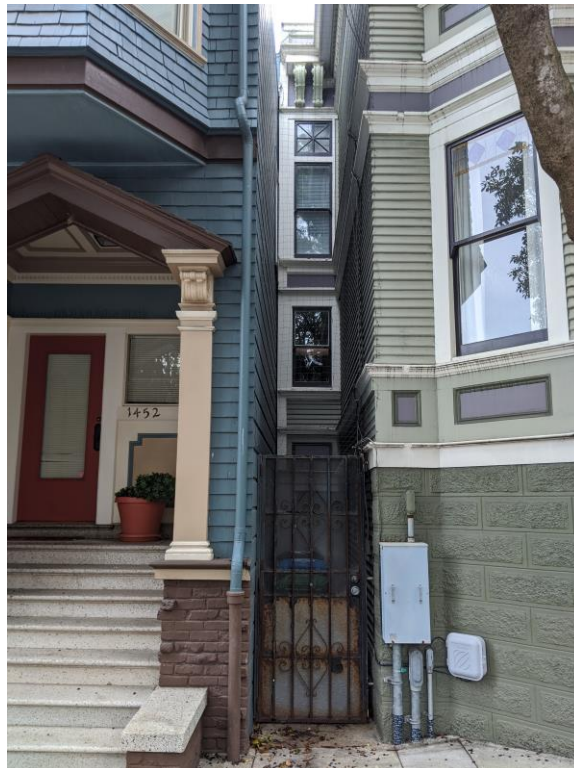
Figure 5 – Building Separation to the South

- The building is built to the property line with virtually no separation between the neighboring building to the south. To the north is an empty lot.
- The garage cripple walls looked to have straight sheathing on the exterior, except for the front wall, which had diagonal sheathing. Walls were only sheathed on one side at the basement level. Based on the age of construction it is assumed the anchor bolts for the sill plate are not adequate.

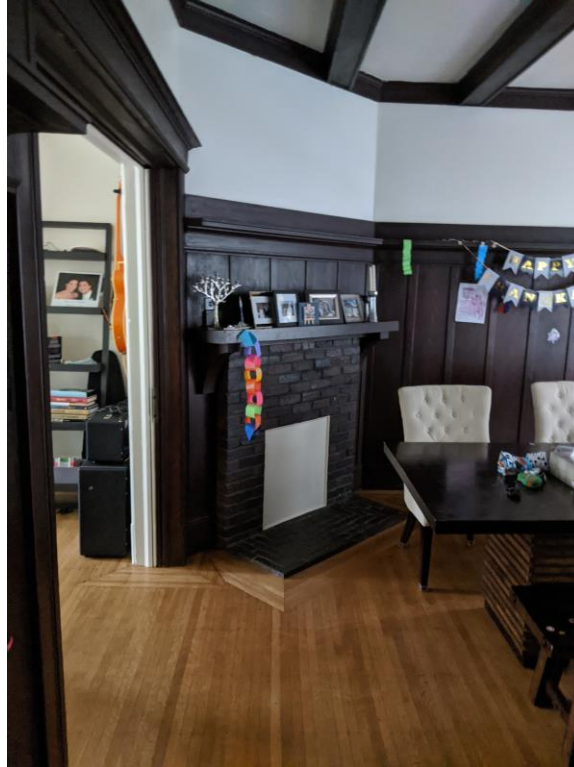
Figure 6 - Closed Off Fireplace

It appeared the chimney had been replaced with a sheet metal flue. Two blocked off fireplaces were observed at the first floor.

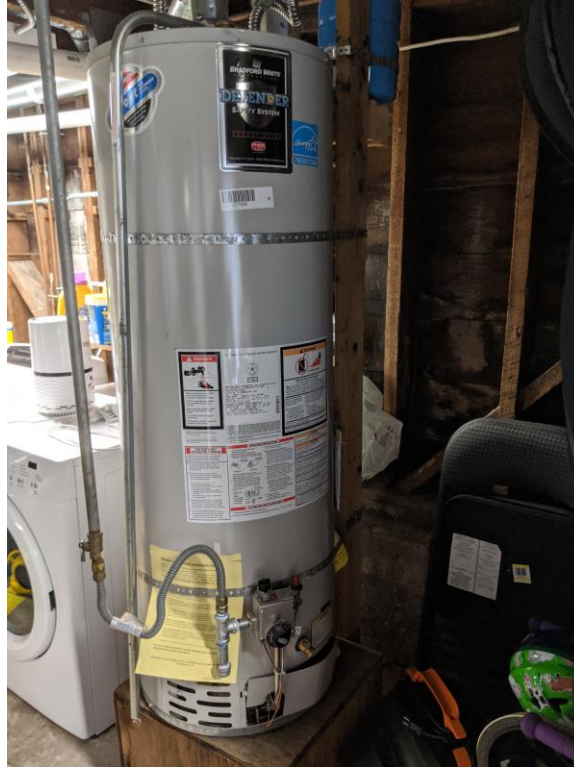
Figure 8 – Anchored Water Heater

The water heater in the basement is anchored to the wall.

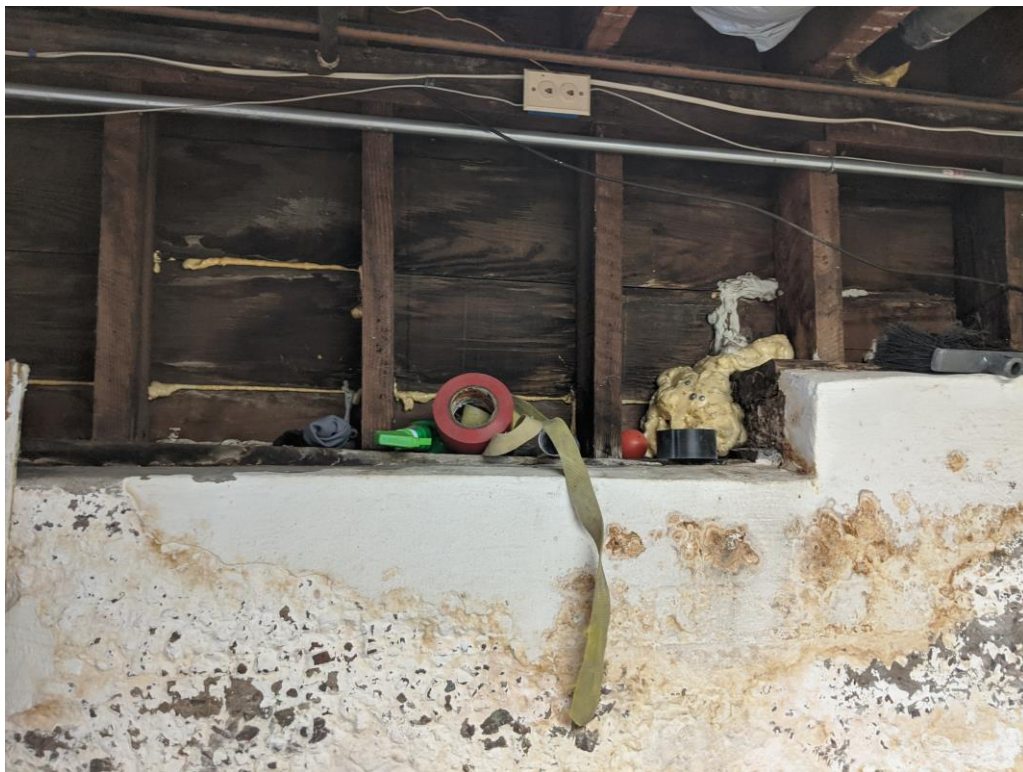
Figure 11 – North Cripple Wall with Straight Sheathing

Structural system for lateral forces: Drawings showing the existing framing are not available. It is presumed based on the age of the building that a sheathed diaphragm distributes load to the interior and exterior wood framed walls sheathed with gypsum board and/or plaster. Two-by-six let-in bracing was observed at the south exterior wall at both corners. The front, west wall had diagonal sheathing and all others had straight sheathing. The first floor was sheathing was straight. No evidence of seismic upgrading was observed.

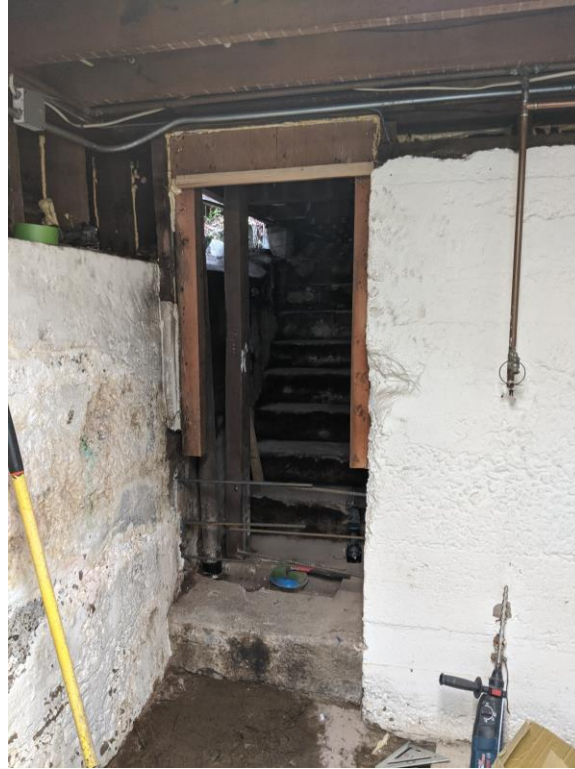
Figure 12 – Work in Progress at Former East Egress Door

Building Condition: What could be observed of the structure of the building appeared to be in fair condition; however, most of the structure was concealed behind finishes. The concrete stem walls in the basement were poorly consolidated in some areas and some spalling was observed. The wood siding was in good condition. During the site visit, we observed work in progress at the rear egress door. The area drain at the base of the stairs was not draining sufficiently and water would flow into the basement. To block this, facilities was installing an approximately 30-inch tall concrete stem wall in the existing doorway.
