4-8-2020

UCSF Building Seismic Ratings
1428 5TH AVENUE

CAAN #2065
1428 5th AVENUE, SAN FRANCISCO, CA 94122
UCSF Campus: Parnassus

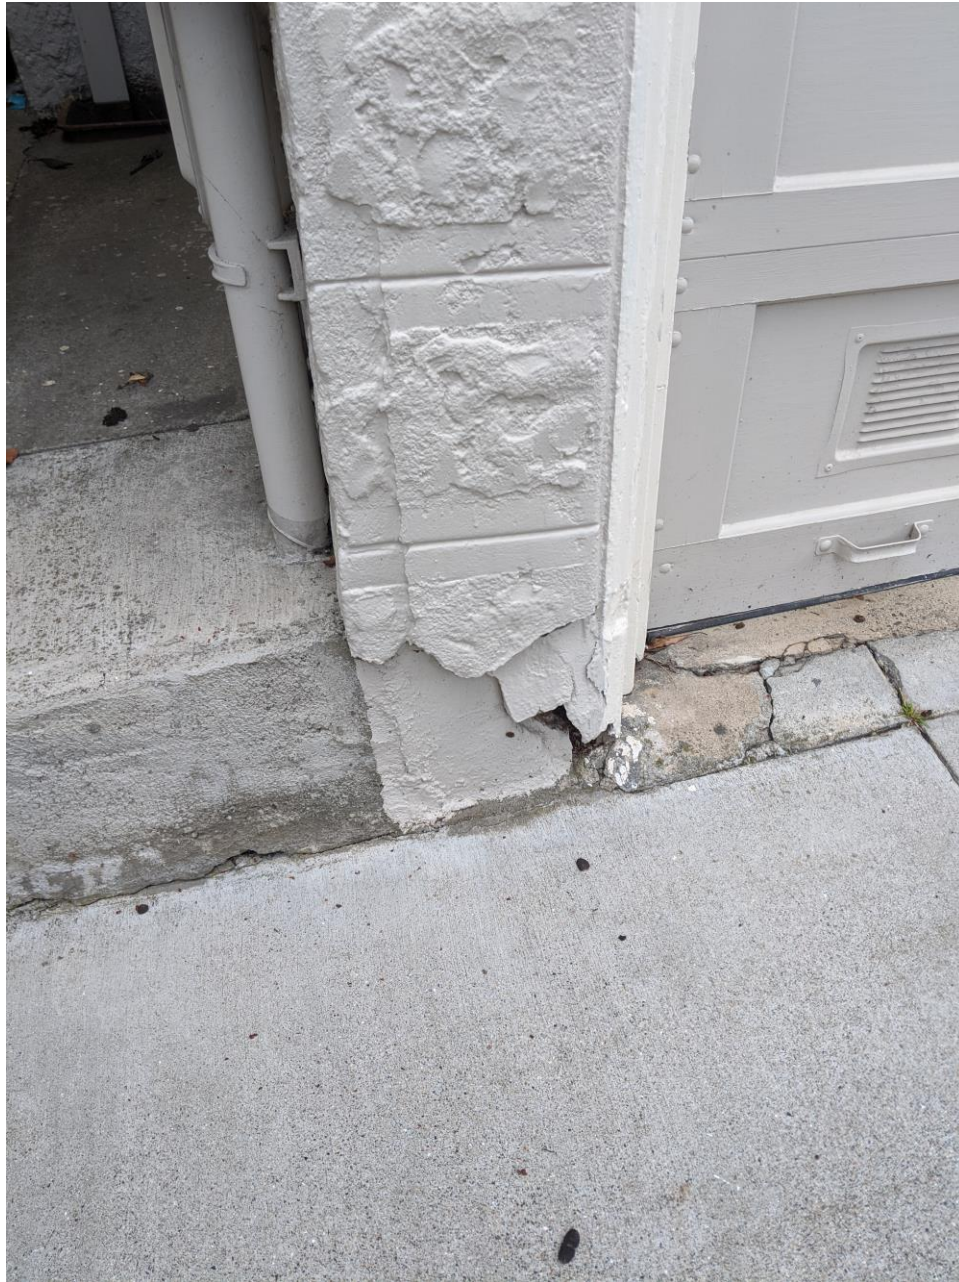
Building Condition: What could be observed of the structure of the building appeared to be in fair condition; however, most of the structure was concealed behind finishes. The concrete stem walls in the utility space were poorly consolidated in many areas and some spalling was observed. It appeared the basement slab had been lowered 12 to 18 inches at some point. Some posts bear on new concrete pedestals. Other posts were stacked on pieces of lumber of the same size down to top of slab. These pieces are sistered with a full length 2x acting as a splint. It seems these posts are supported on isolated footings below the slab given there are no signs of settlement. Exterior footings were benched, suggesting no underpinning or strengthening of the foundations was done. At these locations, the concrete below the previous slab was especially poorly consolidated. The wood siding was in good condition. The rear deck and stairs were in good condition.

Figure 5 – Damage to Northwest Corner Veneer

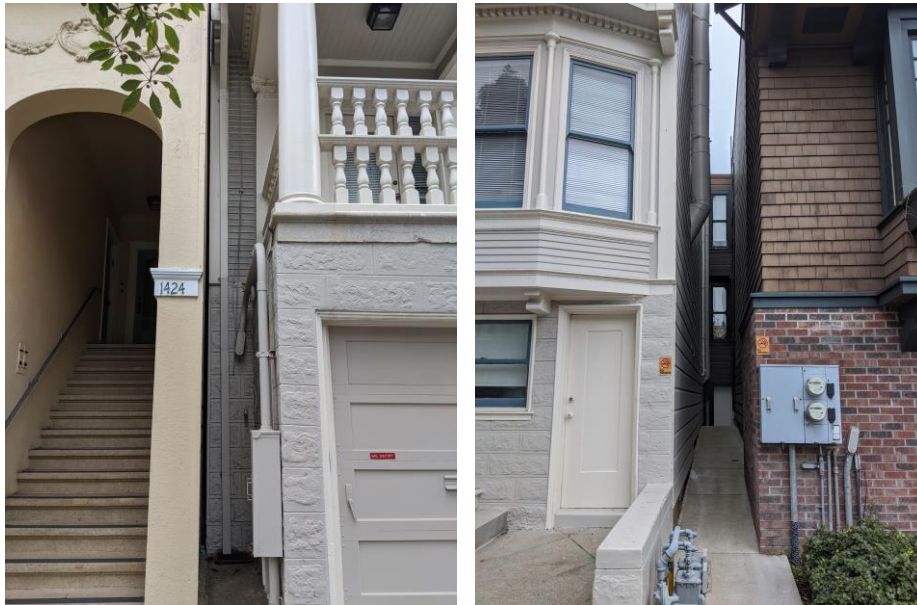
Figure 6 - Building Separation to the North (Left) and South (Right)

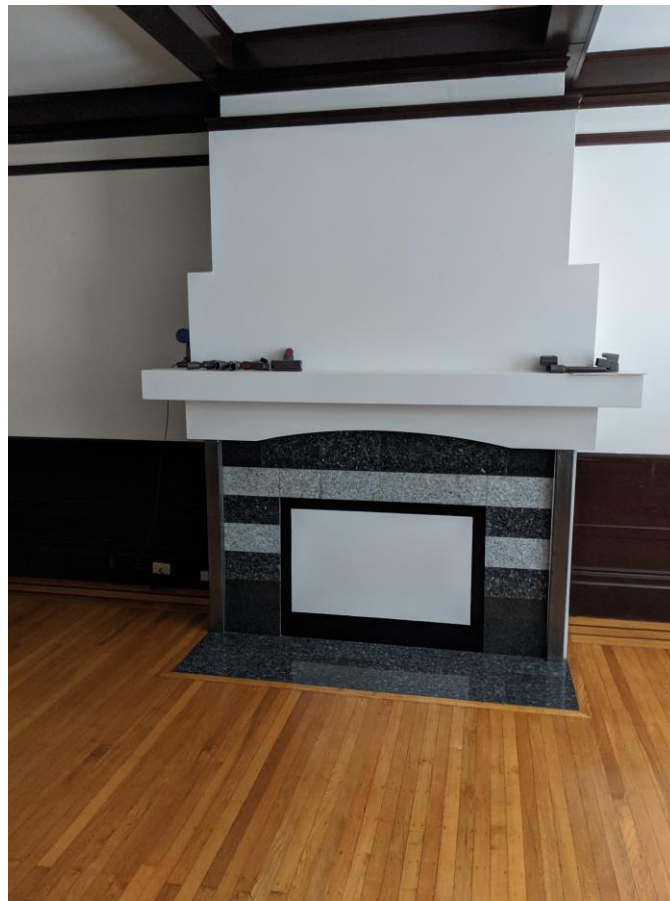
It appeared the chimney had been replaced with a sheet metal flue. The facilities maintenance technician assisting with the site visit noted that the units have fireplaces, but they had been blocked off.

Figure 7 – Closed Off Fireplace at First Floor

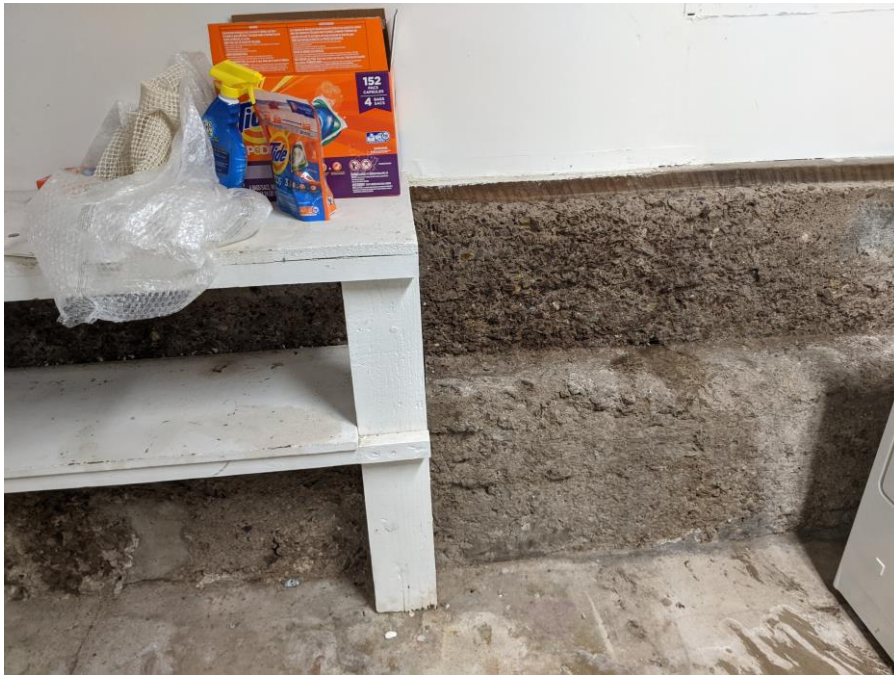
Foundation system: Existing foundation drawings are not available. It is presumed there are continuous footings below bearing walls. During the site visit on December 10, 2019 continuous concrete stem wall footings were observed around the ground floor level. The support of the rear first floor addition and bay window described above is unclear, but their undersides are exposed, without an enclosed crawl space. It is possible the floor joists cantilever east-west. Alternatively, they may be supported on wood posts on isolated footings at the two eastern-most corners.

Figure 8 – Foundation Benching Along East Exterior Wall

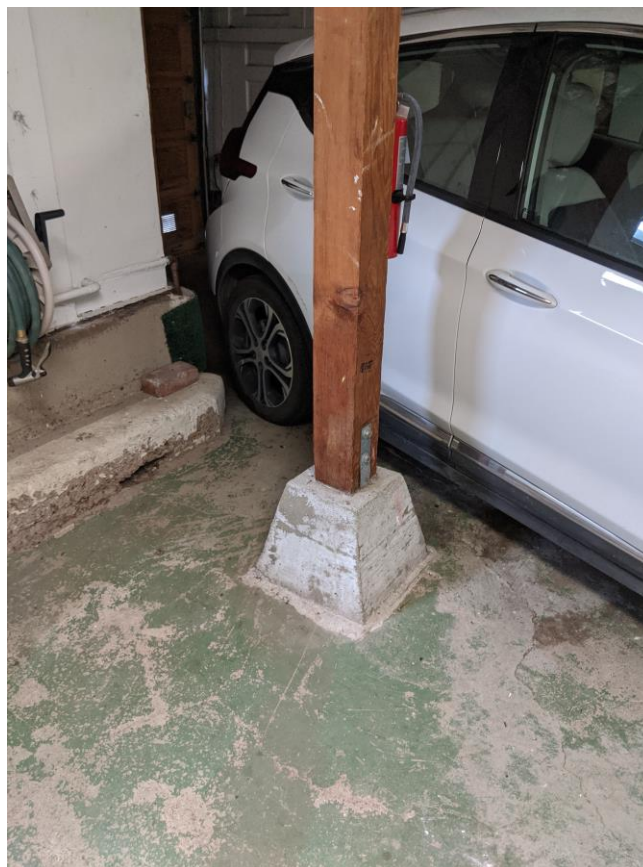
Figure 9 – Interior Basement Post on New Concrete Pedestal

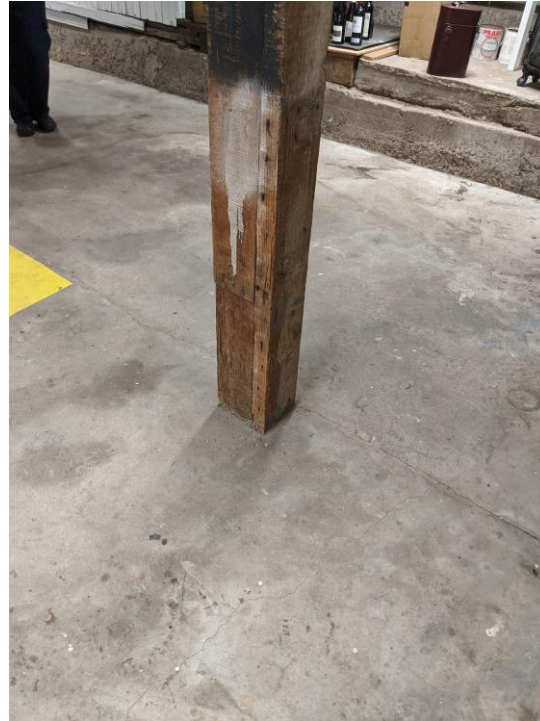
Figure 10 – Interior Basement Post on Blocking with 2x Splint

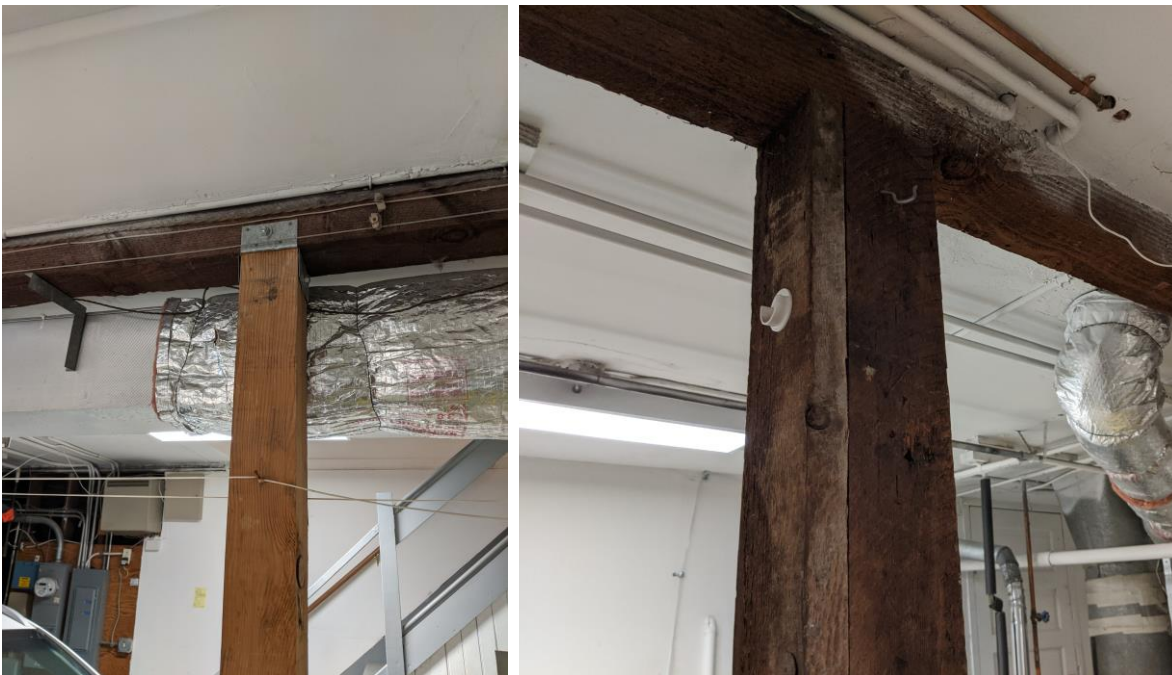
Figure 11 – Top of Interior Basement Posts

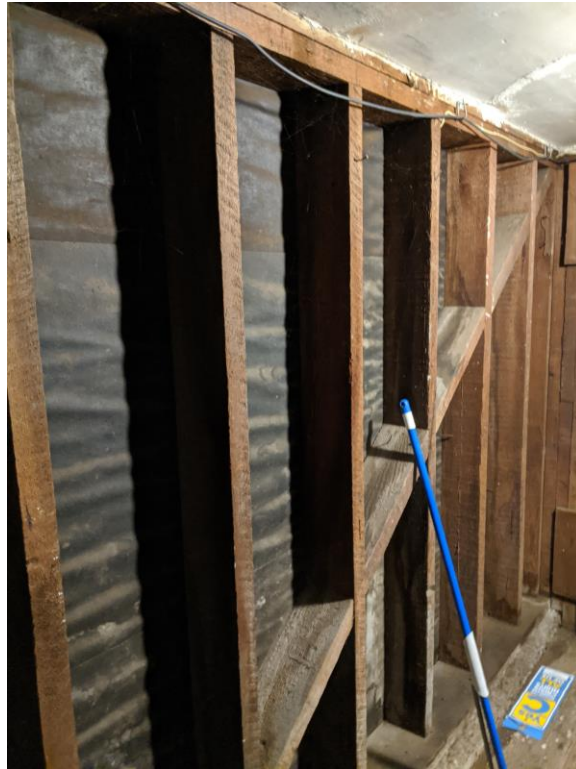
Figure 13 – Let-In Bracing at Basement Exterior Wall

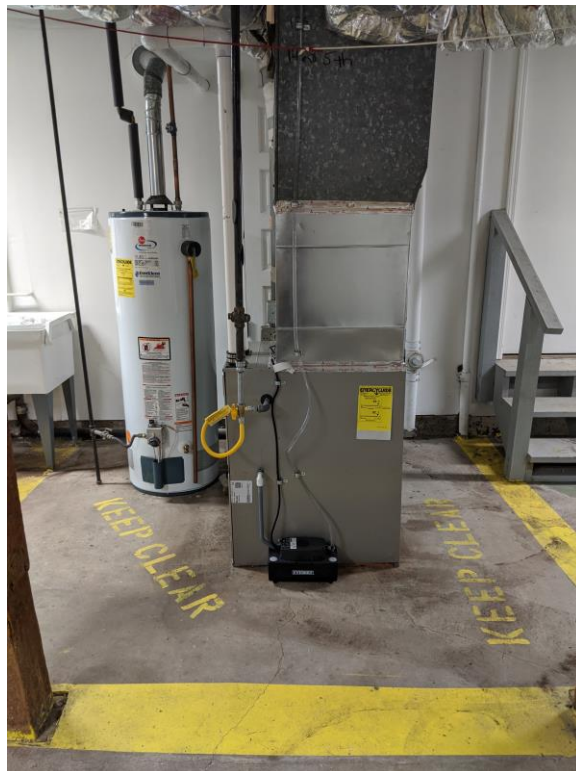
The water heater in the basement is not anchored to the wall. Bracing of the furnace was not observed.

Figure 14 – Unrestrained Water Heater and Furnace at Basement

P <input checked="" type="checkbox"/>	N/A <input type="checkbox"/>	<p>Unrestrained natural gas-fueled equipment such as water heaters, boilers, emergency generators, etc.</p> <p>Comments: The water heater was not anchored to the wall.</p>
P <input type="checkbox"/>	N/A <input type="checkbox"/>	<p>Other:</p> <p>Comments:</p>
P <input type="checkbox"/>	N/A <input type="checkbox"/>	<p>Other:</p> <p>Comments:</p>
P <input type="checkbox"/>	N/A <input type="checkbox"/>	<p>Other:</p> <p>Comments:</p>

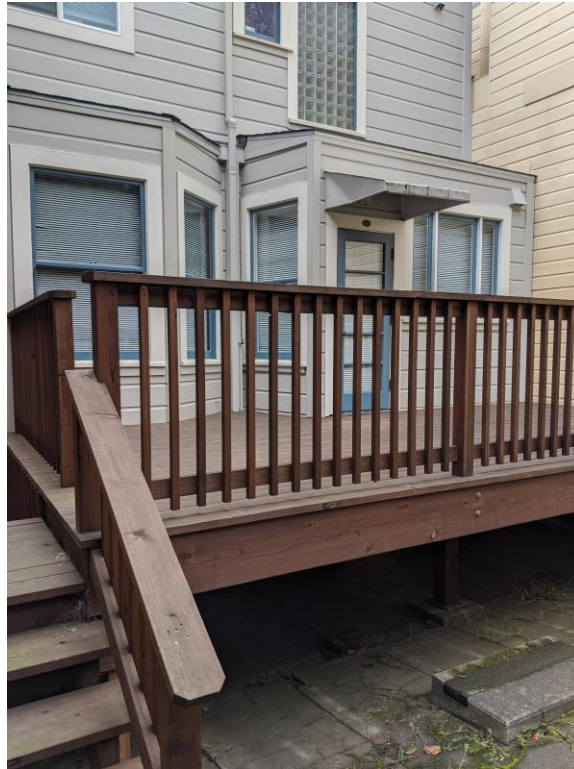
Figure 15 – Exterior Rear Deck

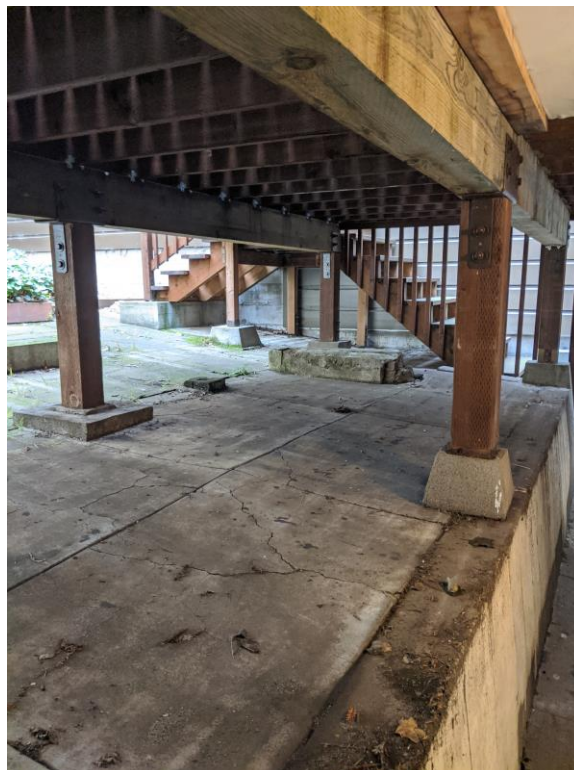
Figure 16 – Support of Rear Deck
