## UCSF Building Seismic Ratings

### Millberry Garage, Parnassus Avenue

CAAN# 2212.1

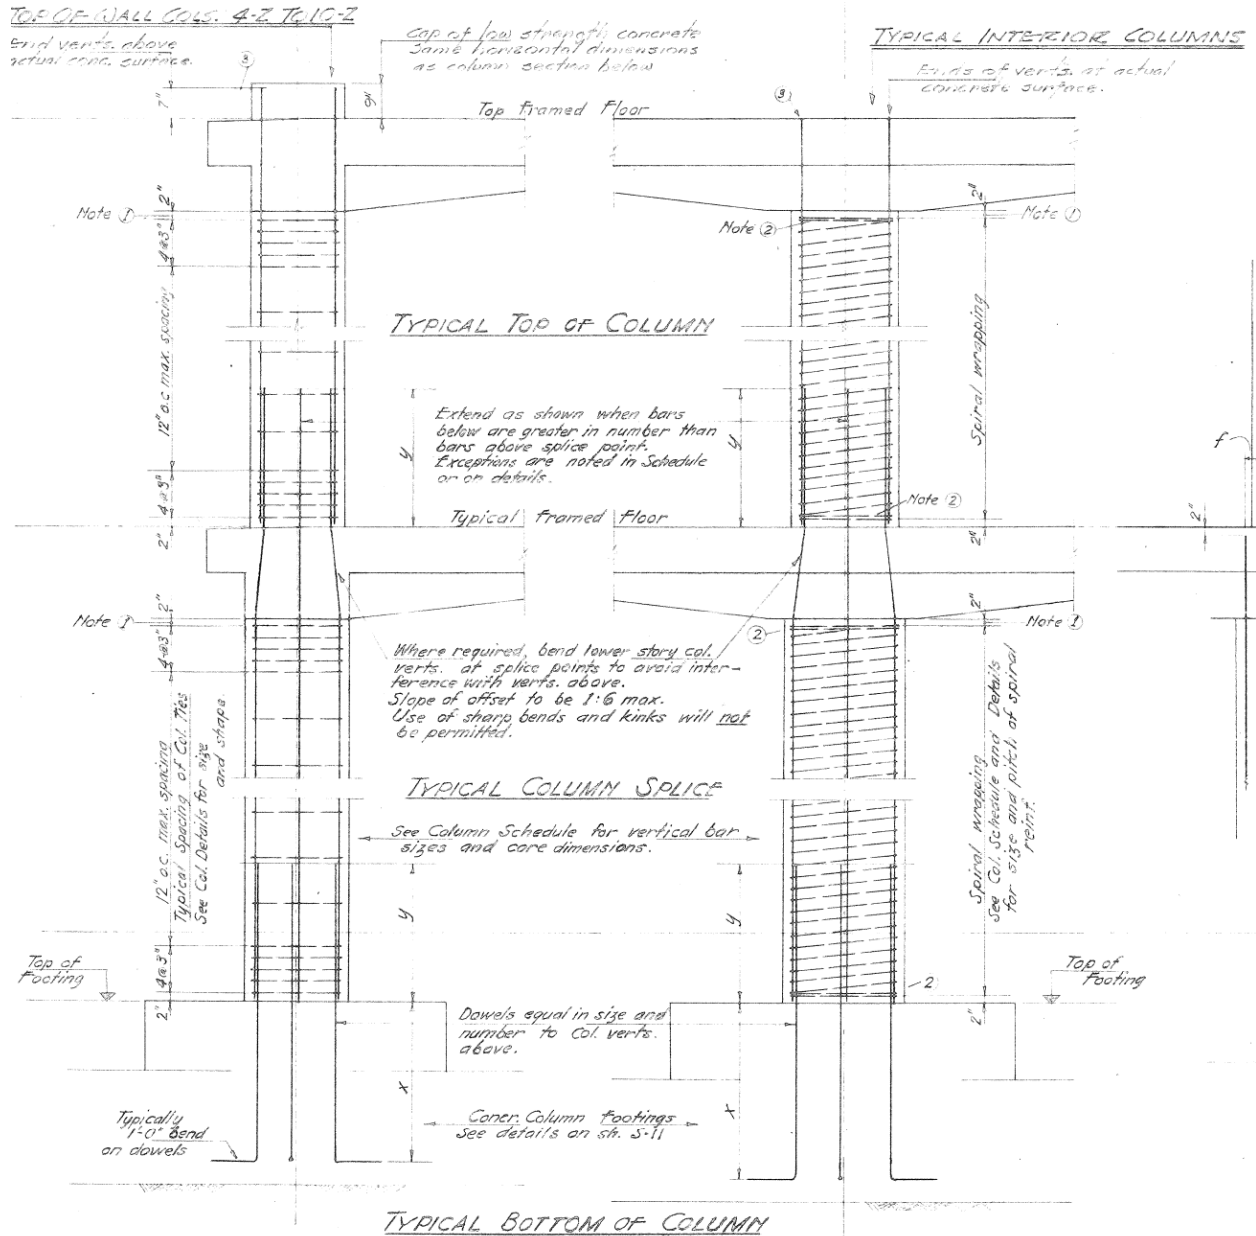
TYPICAL COLUMN DETAILS

- Garage column bar splices are insufficient for full development of reinforcing.
- Rectangular column stirrups are spaced too far apart through the column length to develop the probable column flexural strength.

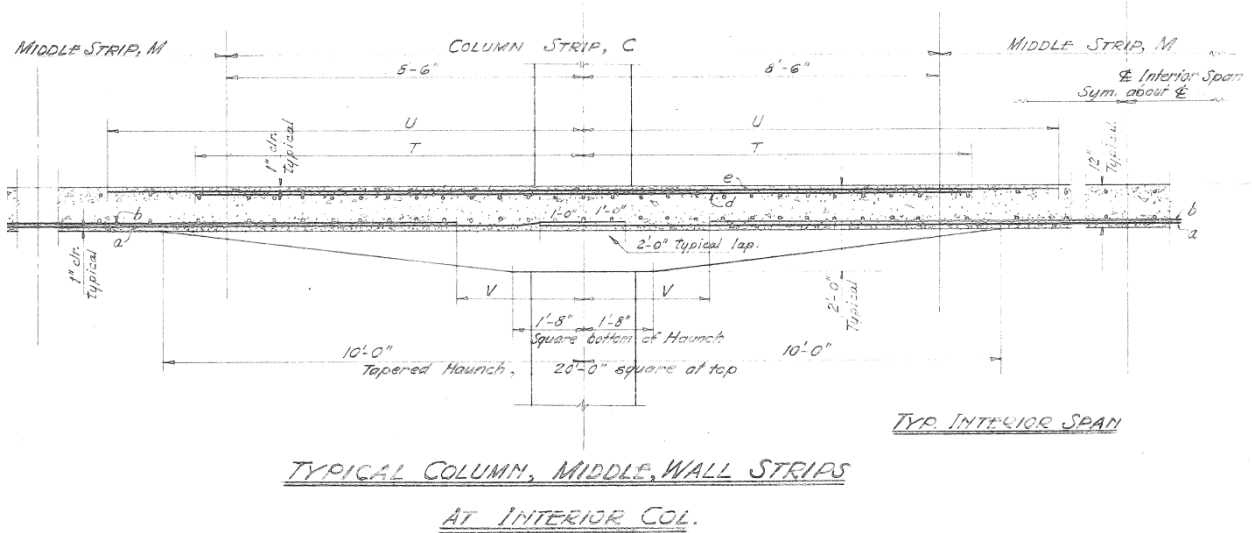
**Slab-Column Detail**

- Garage flat slab and spandrel beam bottom steel is not continuous through the joint, but is lapped within the column diameter dimension. This lap length is insufficient for full reinforcing development, resulting in limited positive flexural capacity and force-controlled brittle failures.

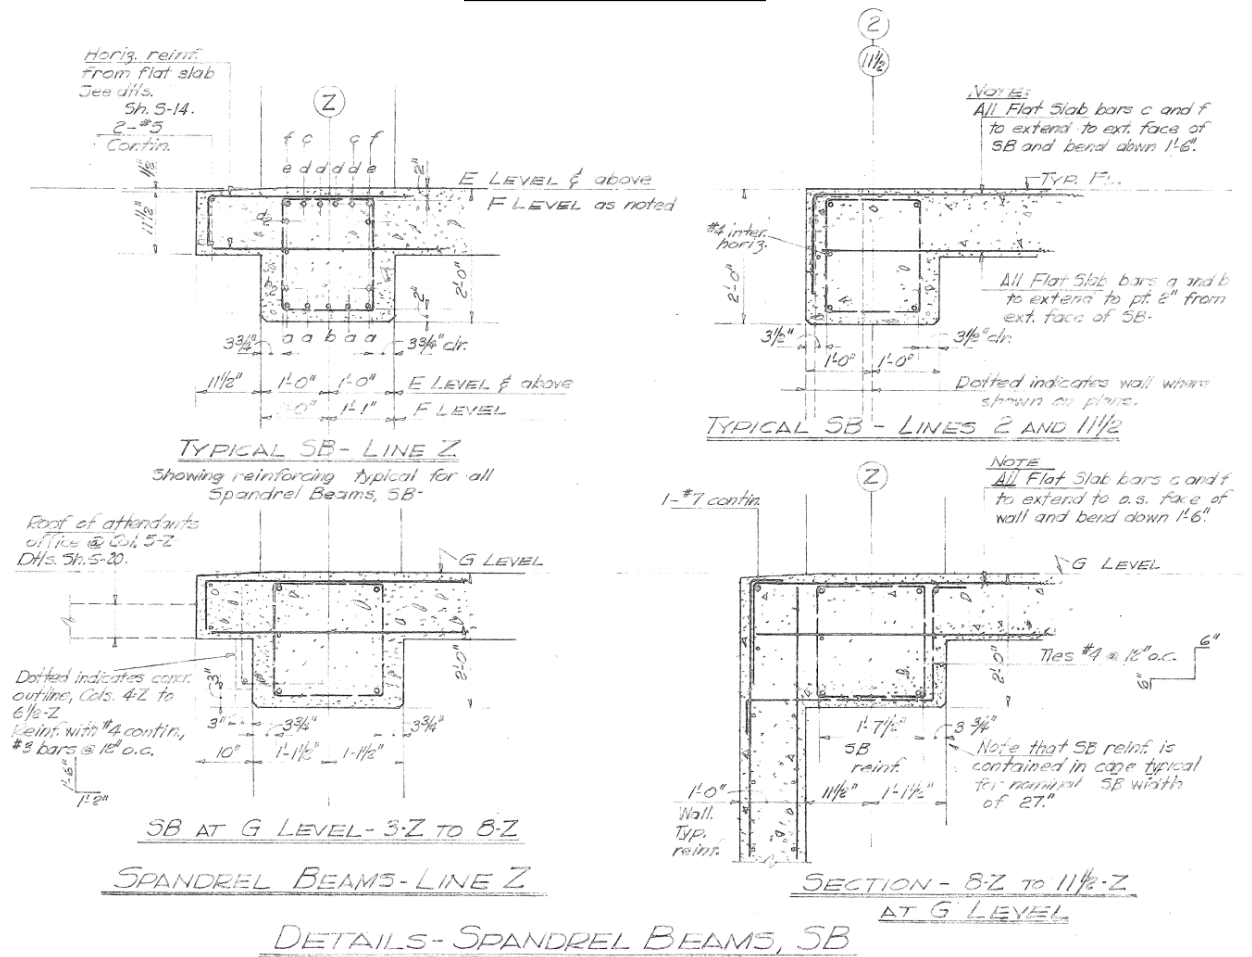
**Frame Beam Details**

- Beam column joints, at spandrel beams, do not have ties within the joint.
- The steep grade results in a flexible frame on the north side relative to the southern walls, causing a torsional response in the E-W direction.

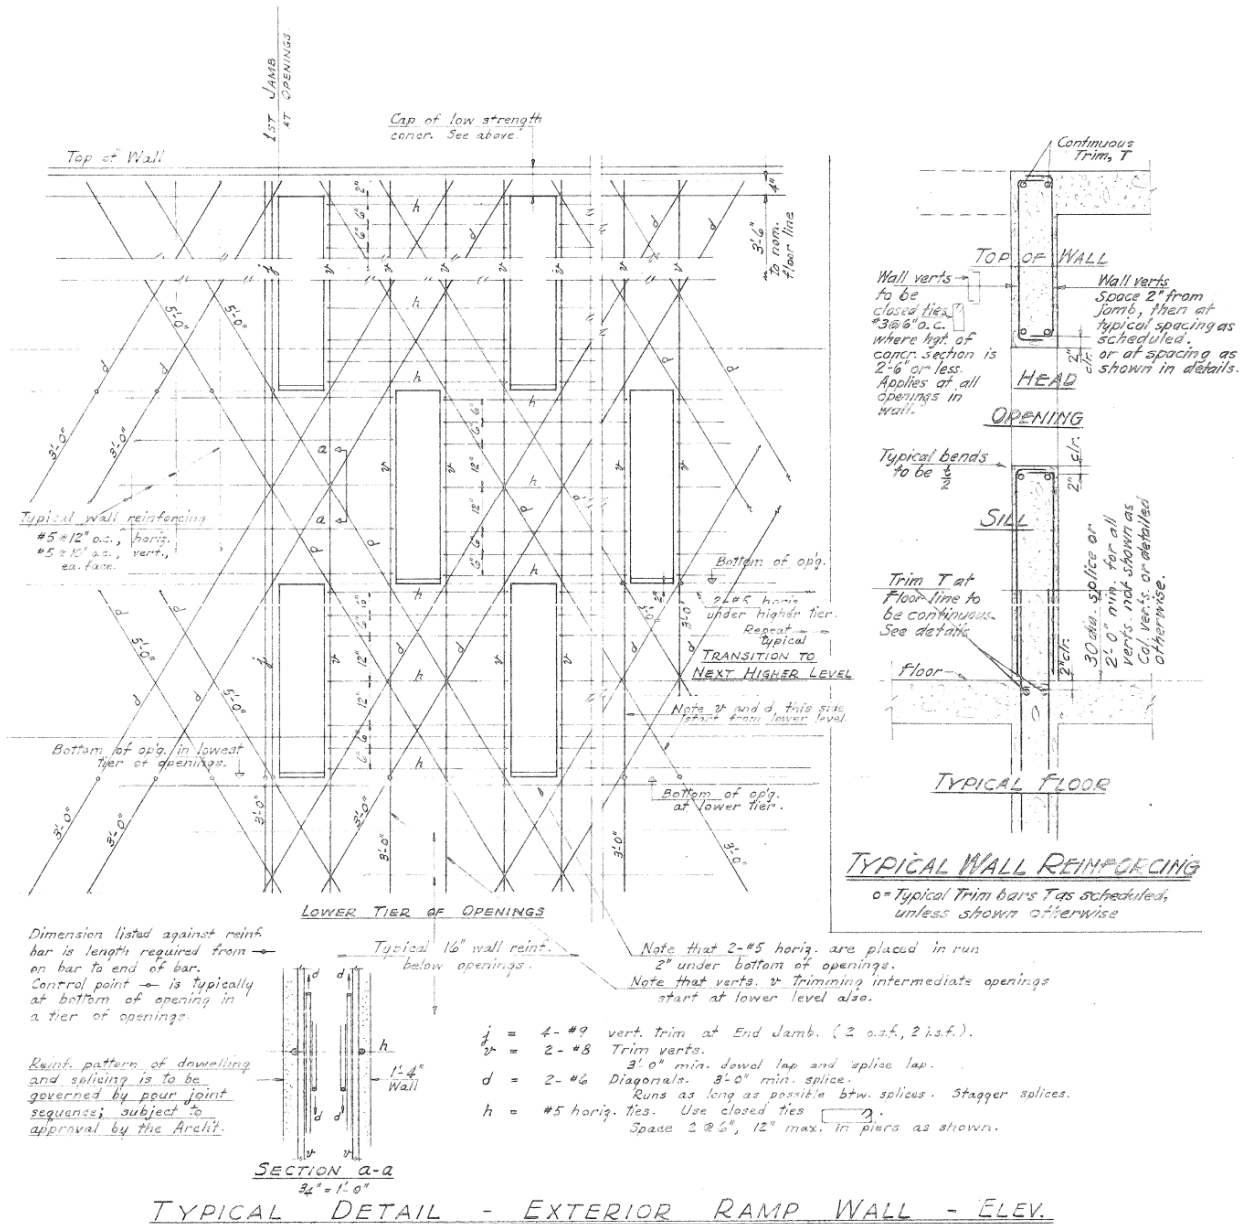
Punched Exterior Ramp Wall Elevation

- Exterior ramp walls are connected to the main floor diaphragm via short segments of thin ramp slabs, limiting the force that can be transferred to the walls.

- Horizontal wall segments in the punched ramp walls lack sufficient reinforcing to couple the vertical piers.
