Date: 2020-11-03

UCSF Building Seismic Ratings

Millberry Union, Parnassus Avenue

CAAN# 2212.2

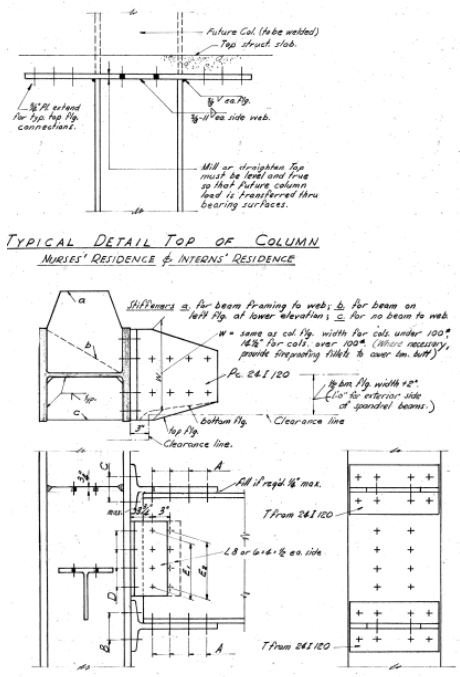
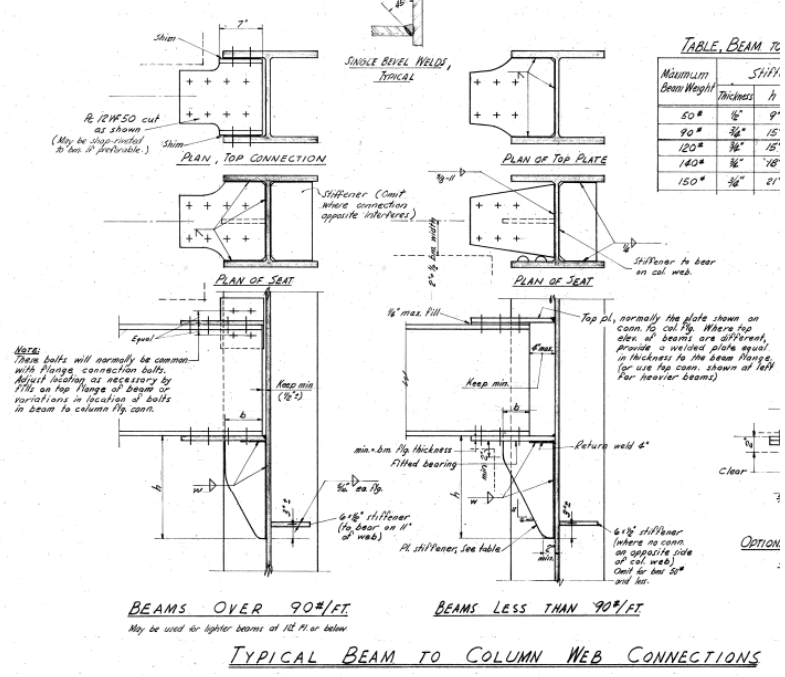
Building Moment Frame Detail

- The buildings fail the drift check for steel moment frames.
- The buildings fail the column axial stress check.
- The buildings rely upon both frames and concrete walls, creating a situation where walls may interfere with the efficacy of concrete frames (or vice versa).
- The moment resisting connections in the buildings cannot develop the strength of adjoining members or panel zones.

Description
C	NC	N/A	U	<p>MOMENT-RESISTING CONNECTIONS: All moment connections are able to develop the strength of the adjoining members or panel zones based on 110% of the expected yield stress of the steel in accordance with AISC 341, Section A3.2. (Commentary: Sec. A.3.1.3.4. Tier 2: Sec. 5.5.2.2.1)</p> <p>Comments: The majority of the bolted flange tees yield in tension and bolts between the tees and beam flange fail in shear before developing 110% of the expected flexural strength of the beam.</p>
<input type="radio"/>	<input checked="" type="radio"/>	<input type="radio"/>	<input type="radio"/>	
C	NC	N/A	U	<p>PANEL ZONES: All panel zones have the shear capacity to resist the shear demand required to develop 0.8 times the sum of the flexural strengths of the girders framing in at the face of the column. (Commentary: Sec. A.3.1.3.5. Tier 2: Sec. 5.5.2.2.2)</p> <p>Comments: Very few of the columns pass this check.</p>

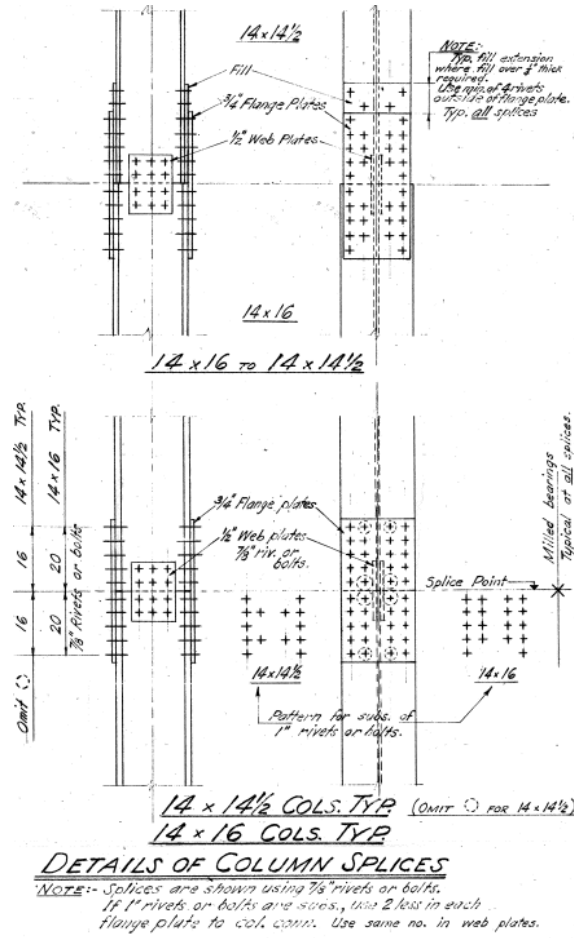
Building Moment Frame Column Splice

<input type="radio"/>	<input checked="" type="radio"/>	<input type="radio"/>	<input type="radio"/>	
C	NC	N/A	U	<p>COLUMN SPLICES: All column splice details located in moment-resisting frames include connection of both flanges and the web. (Commentary: Sec. A.3.1.3.6. Tier 2: Sec. 5.5.2.2.3)</p> <p>Comments: Webs and flanges are spliced with bolted plates.</p>
<input checked="" type="radio"/>	<input type="radio"/>	<input type="radio"/>	<input type="radio"/>	
C	NC	N/A	U	<p>STRONG COLUMN—WEAK BEAM: The percentage of strong column—weak beam joints in each story of each line of moment frames is greater than 50%. (Commentary: Sec. A.3.1.3.7. Tier 2: Sec. 5.5.2.1.5)</p> <p>Comments: Many columns at the east tower do not pass this check.</p>
<input type="radio"/>	<input checked="" type="radio"/>	<input type="radio"/>	<input type="radio"/>	
C	NC	N/A	U	<p>COMPACT MEMBERS: All frame elements meet section requirements in accordance with AISC 341, Table D1.1, for moderately ductile members. (Commentary: Sec. A.3.1.3.8. Tier 2: Sec. 5.5.2.2.4)</p> <p>Comments: About 15% of the frame members do not pass this check.</p>

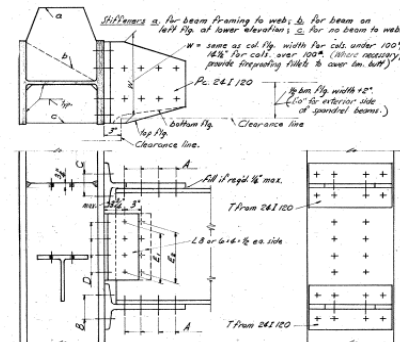
TYPICAL BEAM TO COLUMN FLANGE CONNECTIONS

Zx	d	$1.1F_{ye}Z_x/d$	Bolt Check	Tee Check
18WF105	224.71	18.32	489.8	NG	NG
18WF50	99.95	18.00	221.7	OK	OK
18WF55	110.71	18.12	244.0	OK	OK
18WF70	143.15	18.00	317.6	OK	OK
18WF77	158.86	18.16	349.3	NG	OK
18WF85	175.96	18.32	383.5	NG	NG
21WF112	275.34	21.00	523.5	NG	NG
21WF127	315.17	21.24	592.5	NG	NG
21WF142	354.02	21.46	658.7	NG	NG
21WF63	144.27	21.00	274.3	OK	OK
21WF68	157.79	21.13	298.2	OK	OK
21WF73	170.25	21.24	320.1	OK	OK
21WF82	189.28	20.86	362.3	NG	OK
21WF96	224.12	21.14	423.3	NG	NG
24WF100	274.96	24.00	457.5	NG	NG
24WF110	304.21	24.16	502.8	NG	NG
24WF120	332.89	24.31	546.8	NG	NG
24WF130	365.40	24.25	601.7	NG	NG
24WF145	412.79	24.49	673.0	NG	NG
24WF160	459.86	24.72	742.8	NG	NG
24WF76	198.25	23.91	331.1	NG	OK
24WF84	222.01	24.09	368.0	NG	OK
24WF94	250.60	24.29	412.0	NG	NG
27WF94	274.37	26.91	407.1	NG	NG
30WF210	726.52	30.38	954.9	NG	NG
33WF200	745.35	33.00	901.9	NG	NG
