DATE: 2020-02-11

UCSF building seismic ratings
Medical Sciences Building

CAAN #2252
513 Parnassus Avenue, San Francisco, CA 94143
UCSF Campus: Parnassus

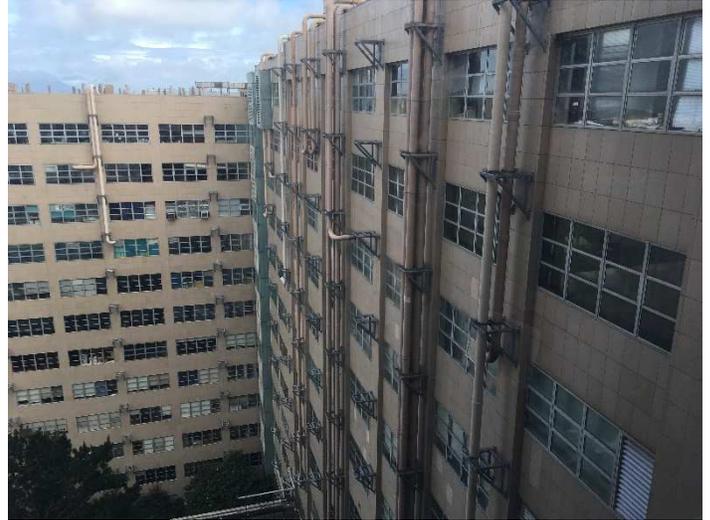
Photograph 2 Exterior view from southwest. Note deep spandrels along exterior faces are a significant part of the seismic system.

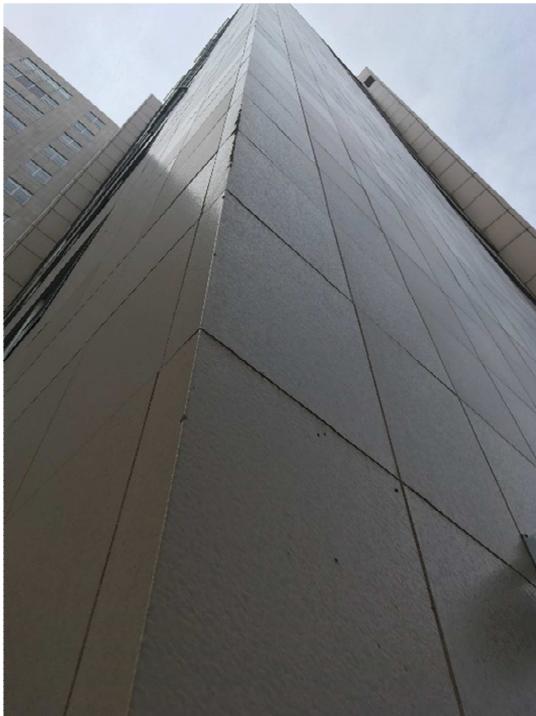
- Much of the building’s exterior façade consists of a heavy ceramic tile system, which did not appear to be jointed sufficiently to allow for significant building movement in a large seismic event. It is uncertain how the tiles are anchored to the structure. Passersby could potentially be exposed to tiles falling from great height.

Photograph 3 Typical ceramic tile cladding system.

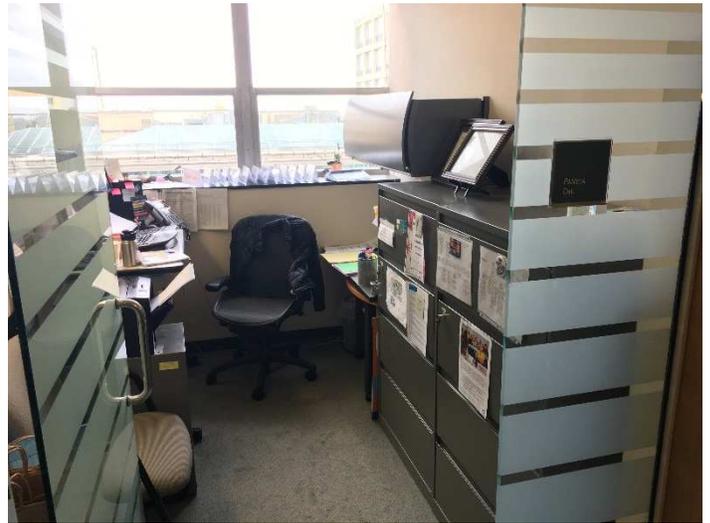
Photograph 6 Typical office space, furniture mostly low.

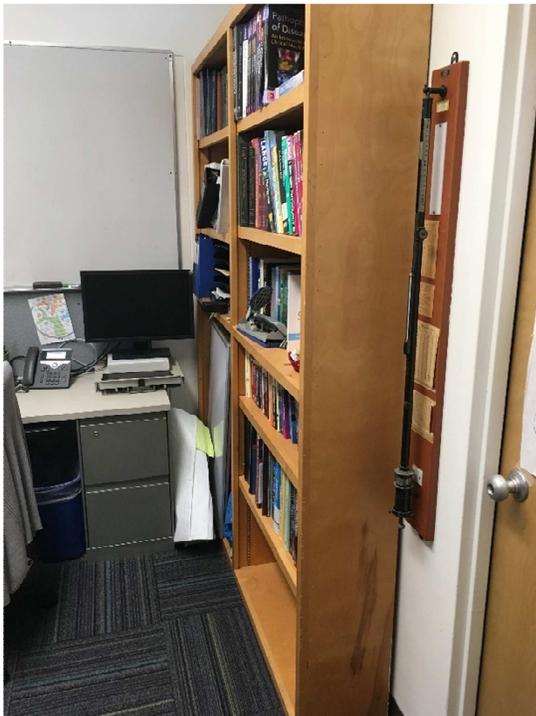
- Falling hazards appeared to be low in most offices. Furniture and bookshelves had a low profile, with some exceptions.
- Classrooms and meeting rooms typically featured large wall-mounted monitors which appeared to be anchored with a robust system. However, it could not be determined whether they are anchored to engineered structure within the wall.

Photograph 7 Tall, non-anchored bookshelves in some offices.

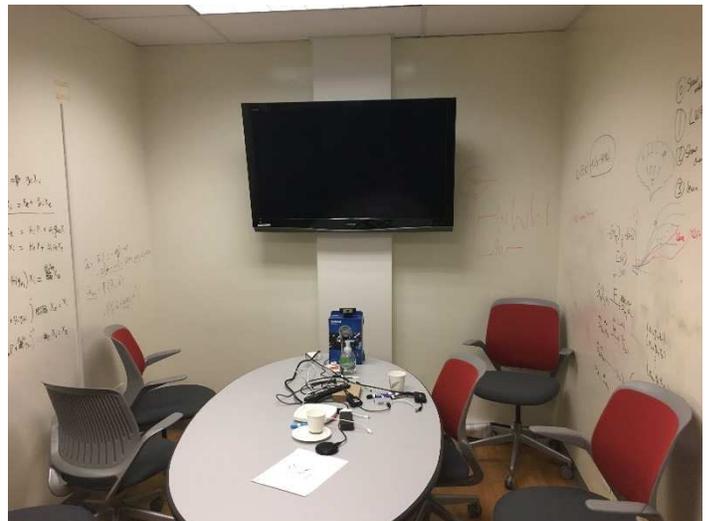
Photograph 8 Typical meeting room. Heavy monitors are anchored to walls using a standard system.

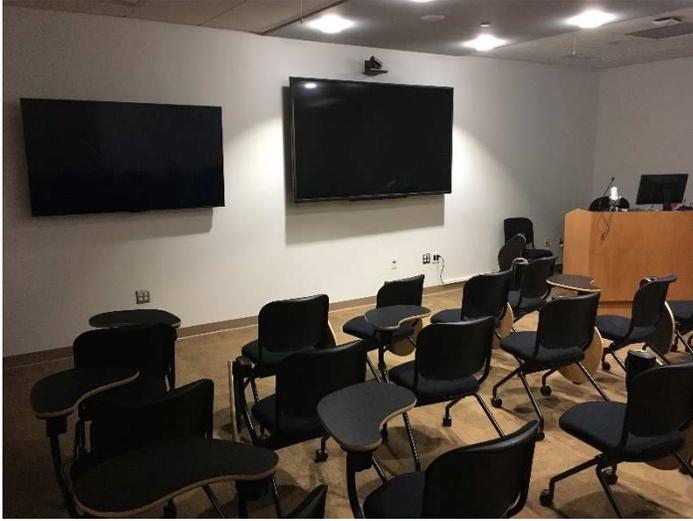
Photograph 9 Typical classroom. Heavy monitors anchored to wall using a standard system.

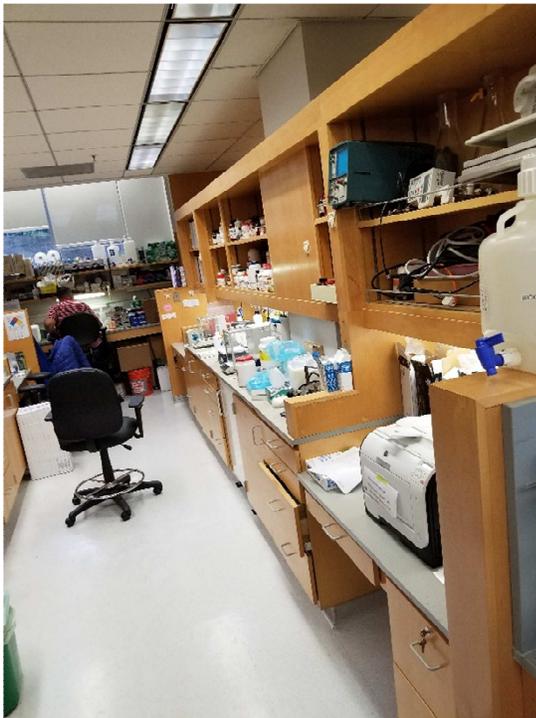
- Laboratory spaces contained many tall objects such as refrigerators and high storage shelves. Evidence of attention to falling hazards was present: high shelves generally had rails and a strapping system existed for restraining refrigerators. However, compliance was inconsistent: straps were not attached to some refrigerators, and anchorage of some restraints appeared to be ad hoc. Some large countertop equipment did not appear to be anchored.

Photograph 10 Typical laboratory space. Rails on high shelves, some heavy items not anchored.

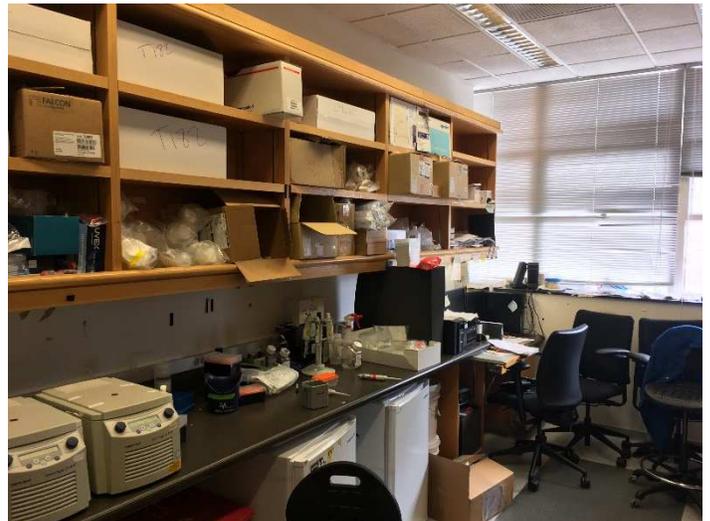
Photograph 11 Laboratory space having high shelving without rails.

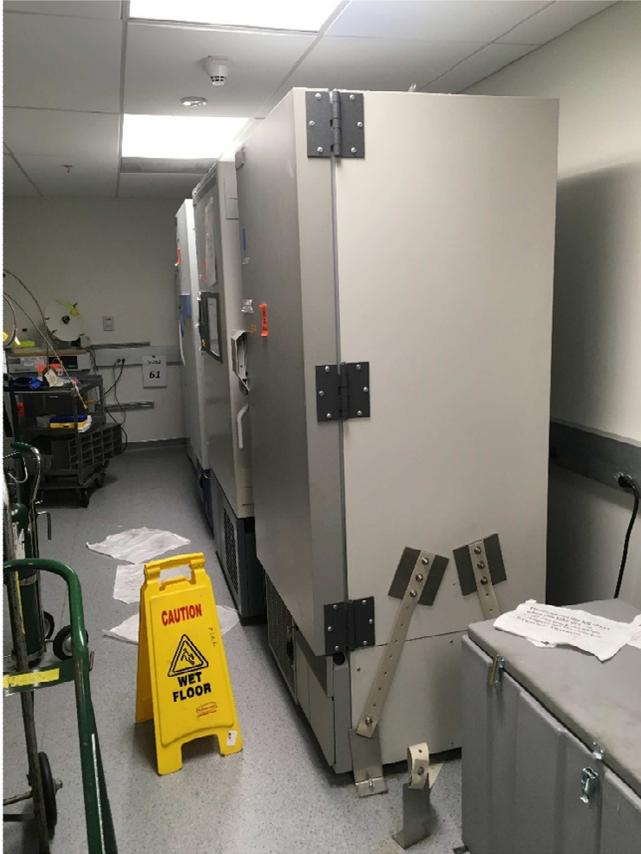
Photograph 12 Tall refrigerators often anchored by an engineered system.

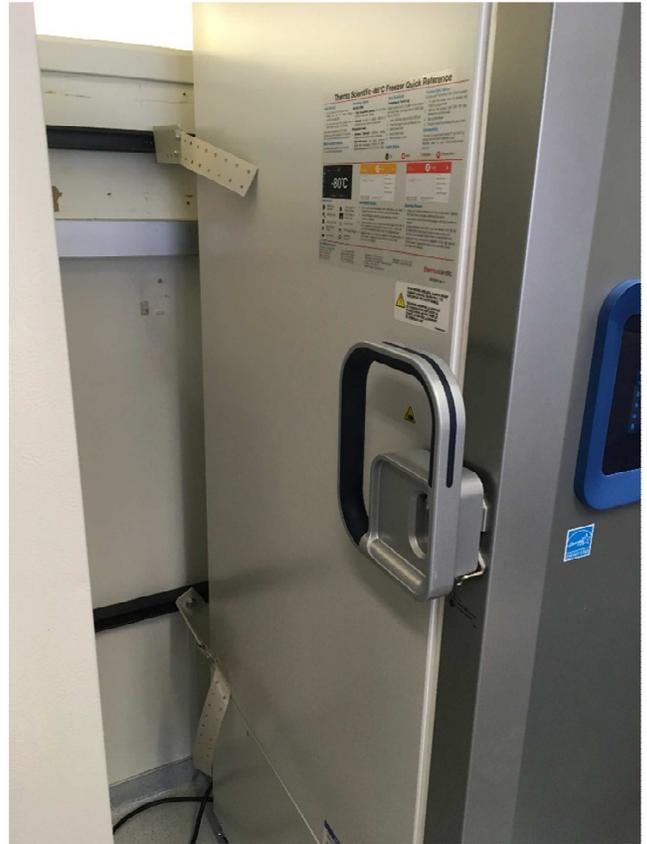
Photograph 13 Evidence of equipment anchorage not consistently utilized.

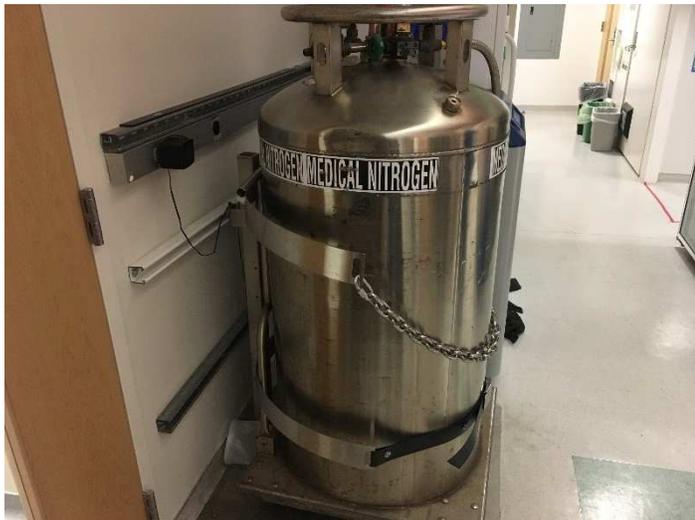
Photograph 14 Hazardous materials tanks with engineered bracing system.

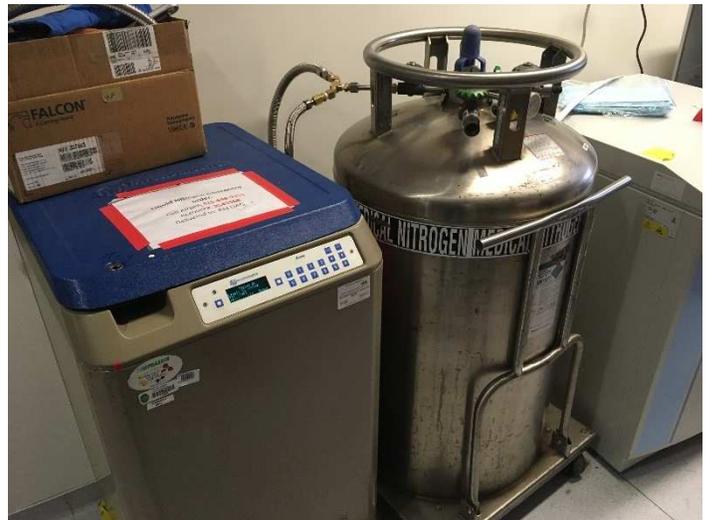
- Hazardous material treatment also appeared somewhat lax. Some liquid nitrogen tanks were observed to be unstrapped and resting on wheeled carts, with hoses attached to nearby stationary equipment. If these tanks were to move and rupture the hoses, a dangerous condition could result. Also, some low-level radioactive material was stored in a way that it could slide off of shelves.

Photograph 15 Evidence of hazardous materials tanks not properly braced, hoses that may rupture with movement.

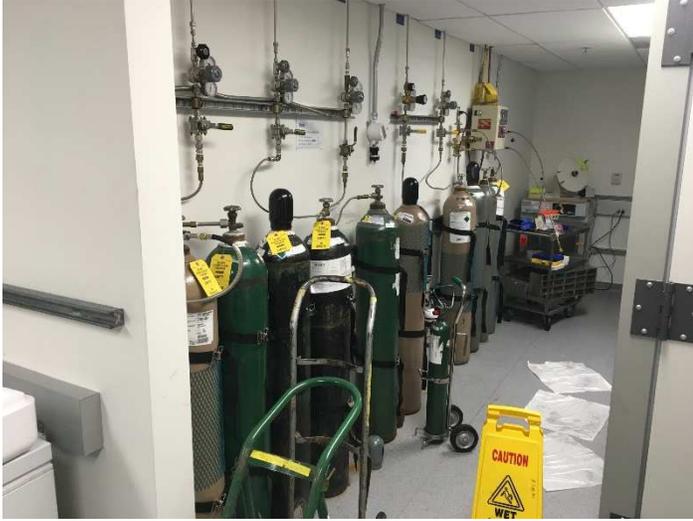
Photograph 16 Hazardous materials tanks with engineered anchorage system.

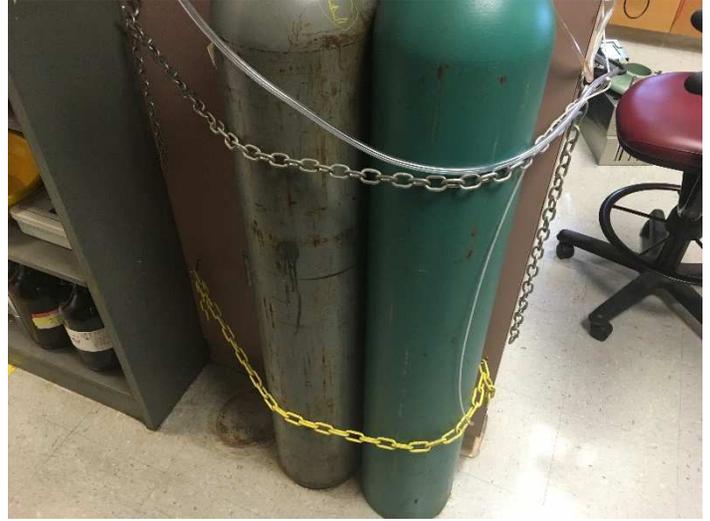
Photograph 17 Some tank anchorage does not appear to be engineered.

P <input checked="" type="checkbox"/>	N/A <input type="checkbox"/>	<p>Unrestrained hazardous material storage</p> <p>Comments: Restraints on hazardous materials throughout the building were very hit-or-miss. Some were restrained, some were not. Some were restrained but insufficiently.</p>
P <input type="checkbox"/>	N/A <input checked="" type="checkbox"/>	<p>Masonry chimneys</p> <p>Comments: No masonry chimneys are in the building.</p>
P <input type="checkbox"/>	N/A <input checked="" type="checkbox"/>	<p>Unrestrained natural gas-fueled equipment such as water heaters, boilers, emergency generators, etc.</p> <p>Comments: Unrestrained natural gas-fueled equipment was not identified during site visit.</p>
P <input type="checkbox"/>	N/A <input type="checkbox"/>	<p>Other:</p> <p>Comments:</p>
P <input type="checkbox"/>	N/A <input type="checkbox"/>	<p>Other:</p> <p>Comments:</p>
P <input type="checkbox"/>	N/A <input type="checkbox"/>	<p>Other:</p> <p>Comments:</p>

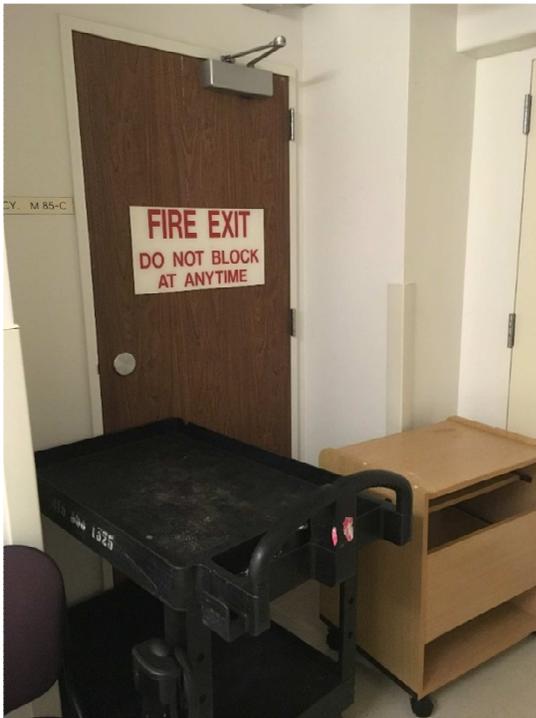
Photograph 18 Blocked exitway.
