UCSF Building Seismic Ratings

1332 3RD AVENUE

CAAN #2262

1332 3RD AVENUE, SAN FRANCISCO, CA 94122

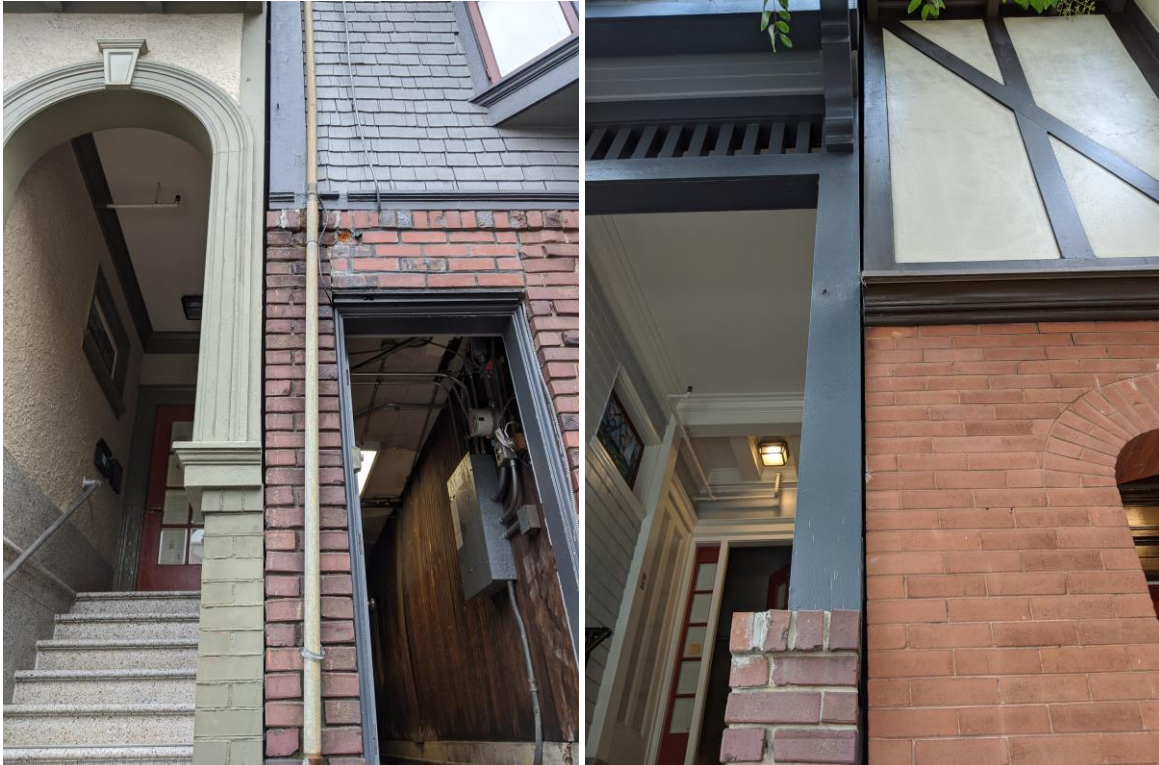
Figure 5 - Building Separation to the North (Left) and South (Right)

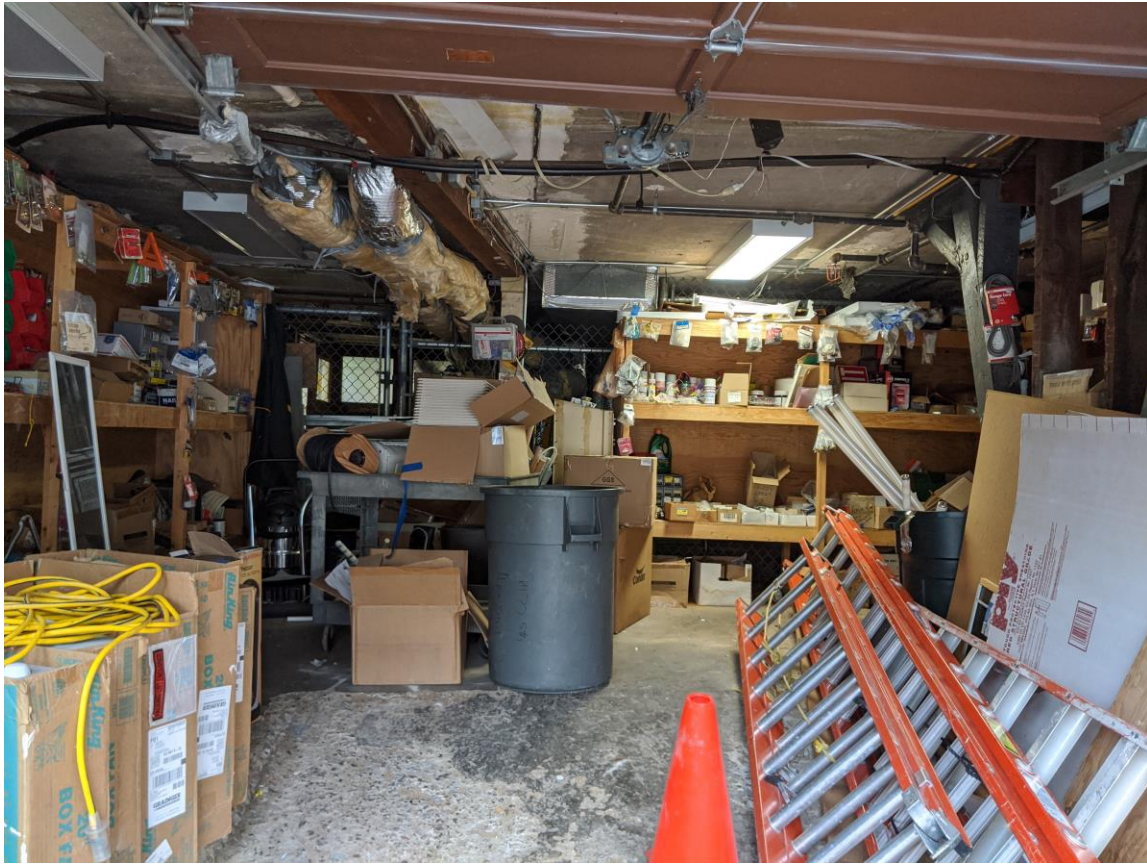
Figure 6 - Facilities Storage in Garage

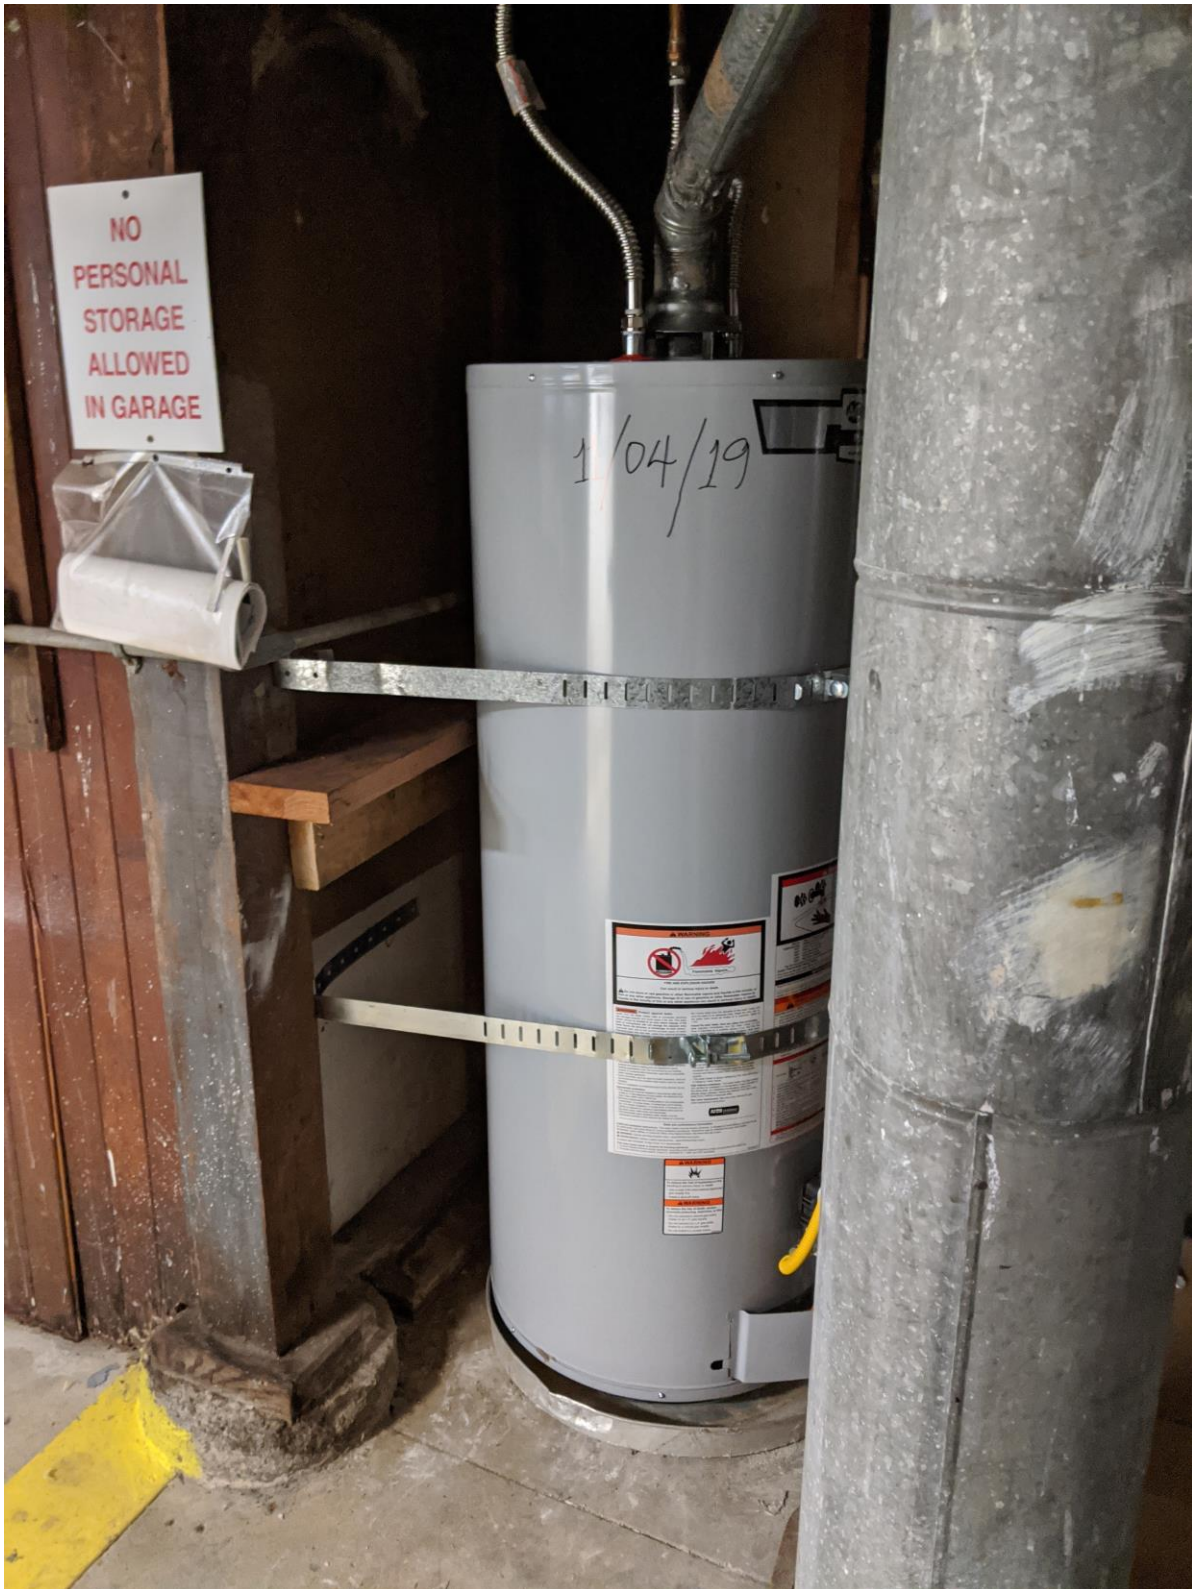
The water heater in the basement is strapped to the wall and had flex connections to the gas line. Bracing of the furnace was not observed, but it did have flex connections as well.

Figure 8 – Braced Water Heater in Basement

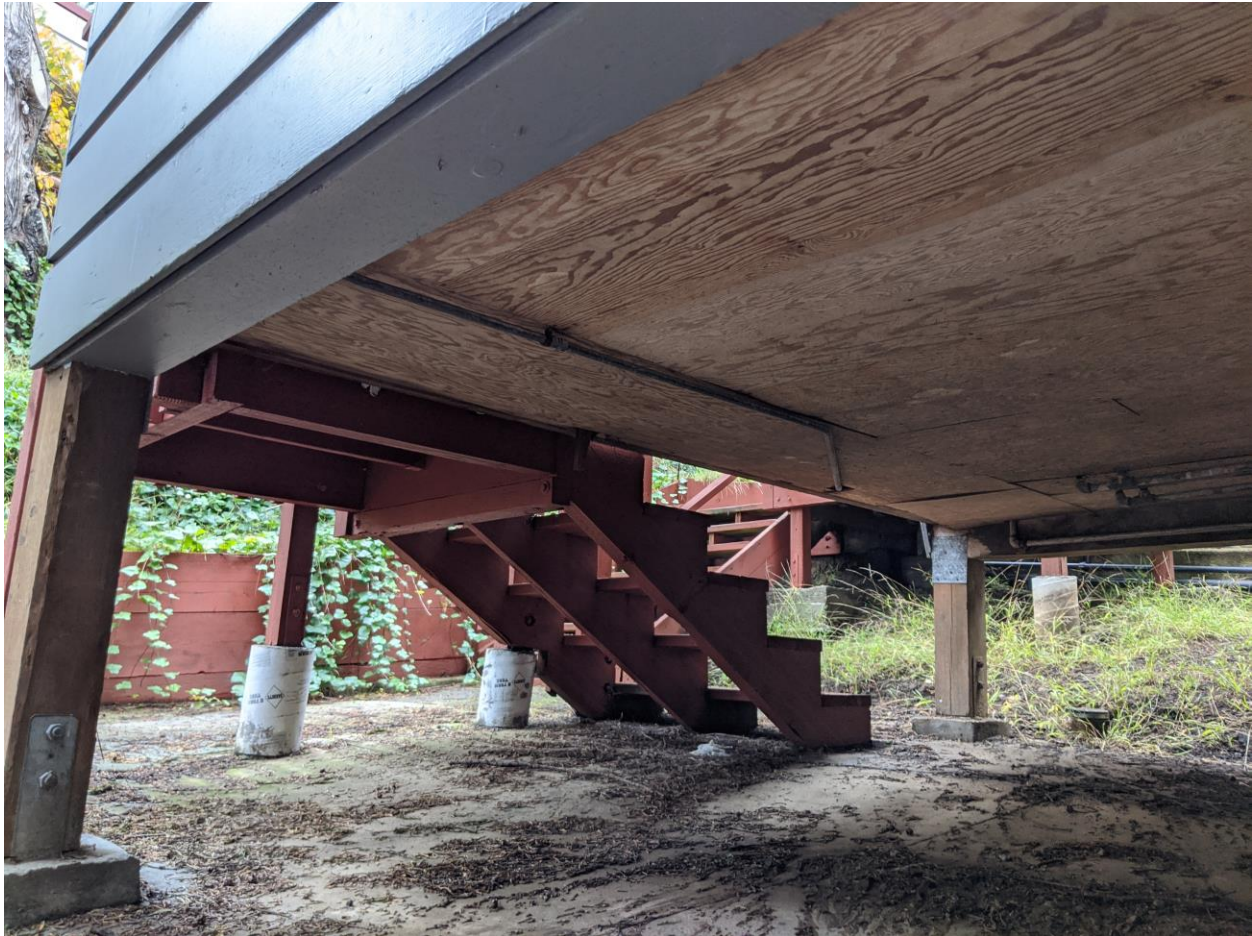
Figure 10 – Underside of First Floor Dining Room

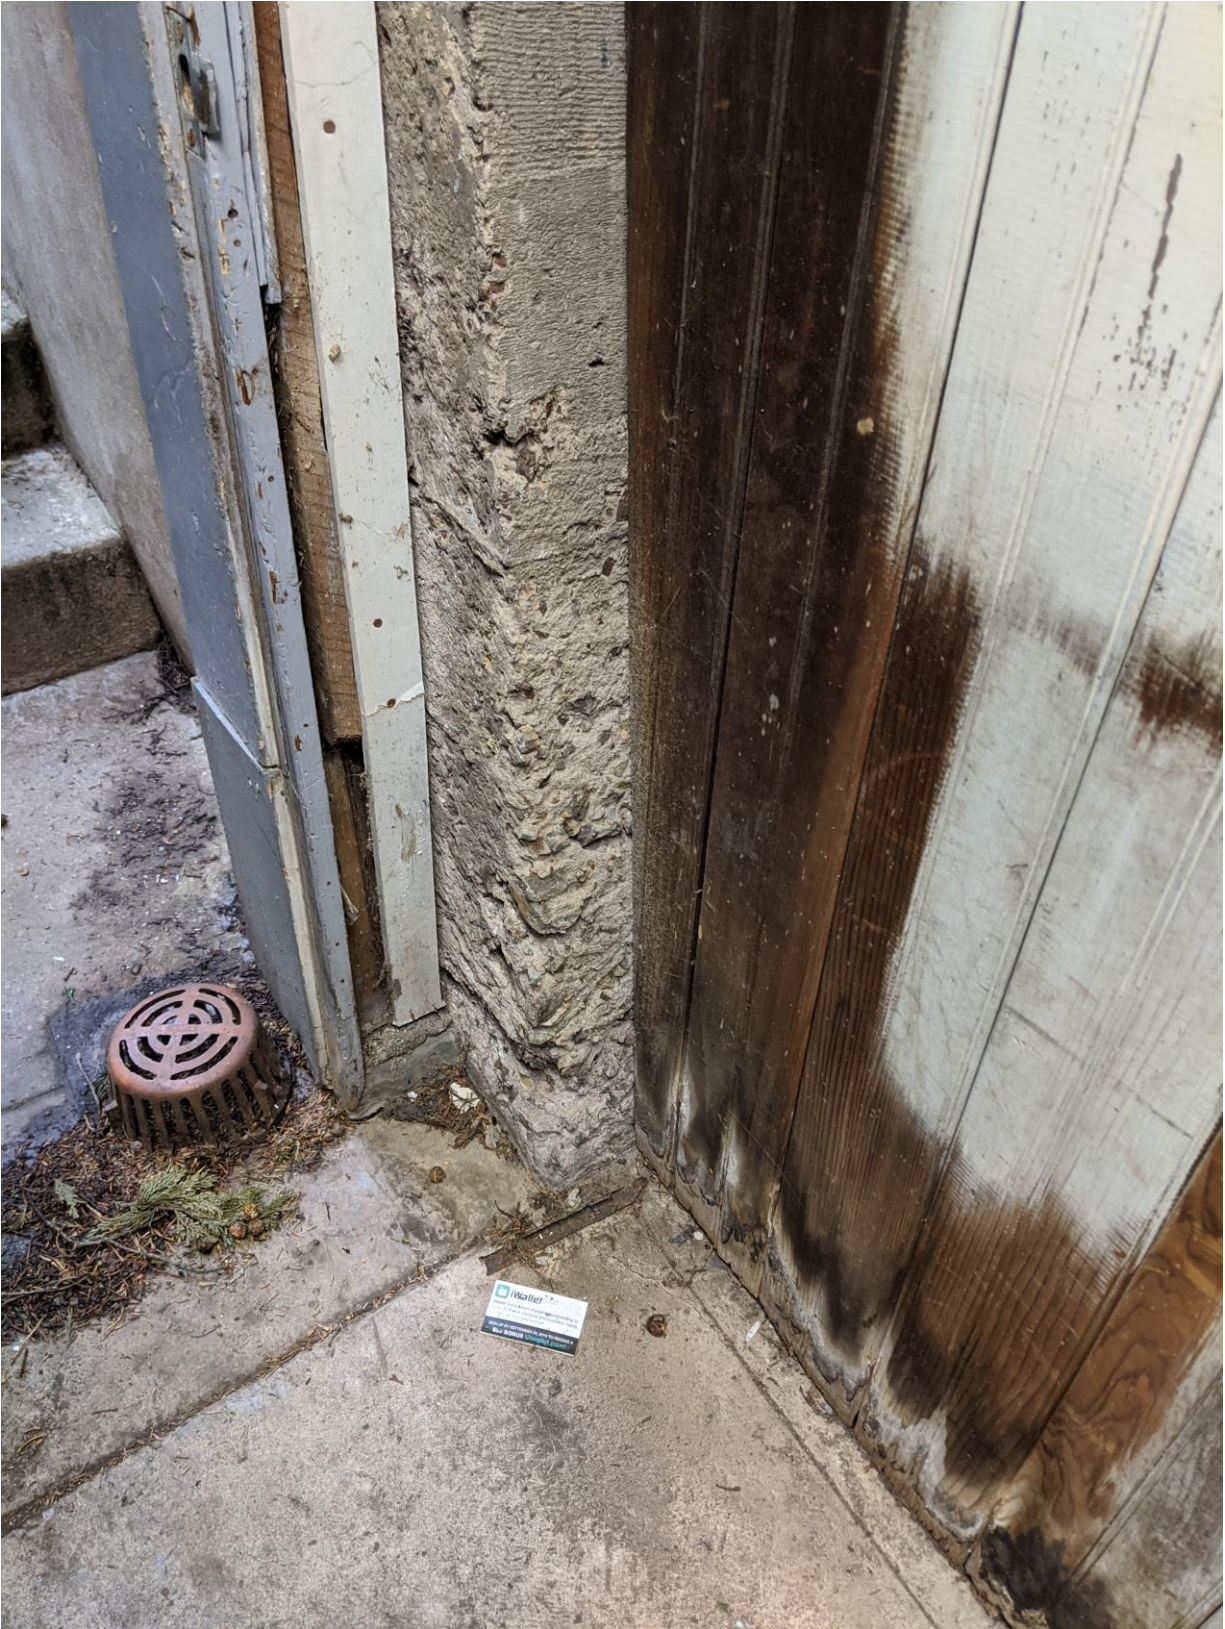
Foundation system: Existing foundation drawings are not available. It is presumed there are continuous footings below bearing walls. During the site visit on December 5th, 2019 continuous concrete stem wall footings were observed around the ground floor level. The dining room on the first floor at the rear of the building is supported on wood posts on isolated footings at the two eastern-most corners.

Figure 10 – Condition of East Basement Stem Wall
