DATE: 2019-06-25

**UCSF building seismic ratings**  
**Proctor Foundation**

CAAN #2246

95 Kirkham Street, San Francisco, CA 94122

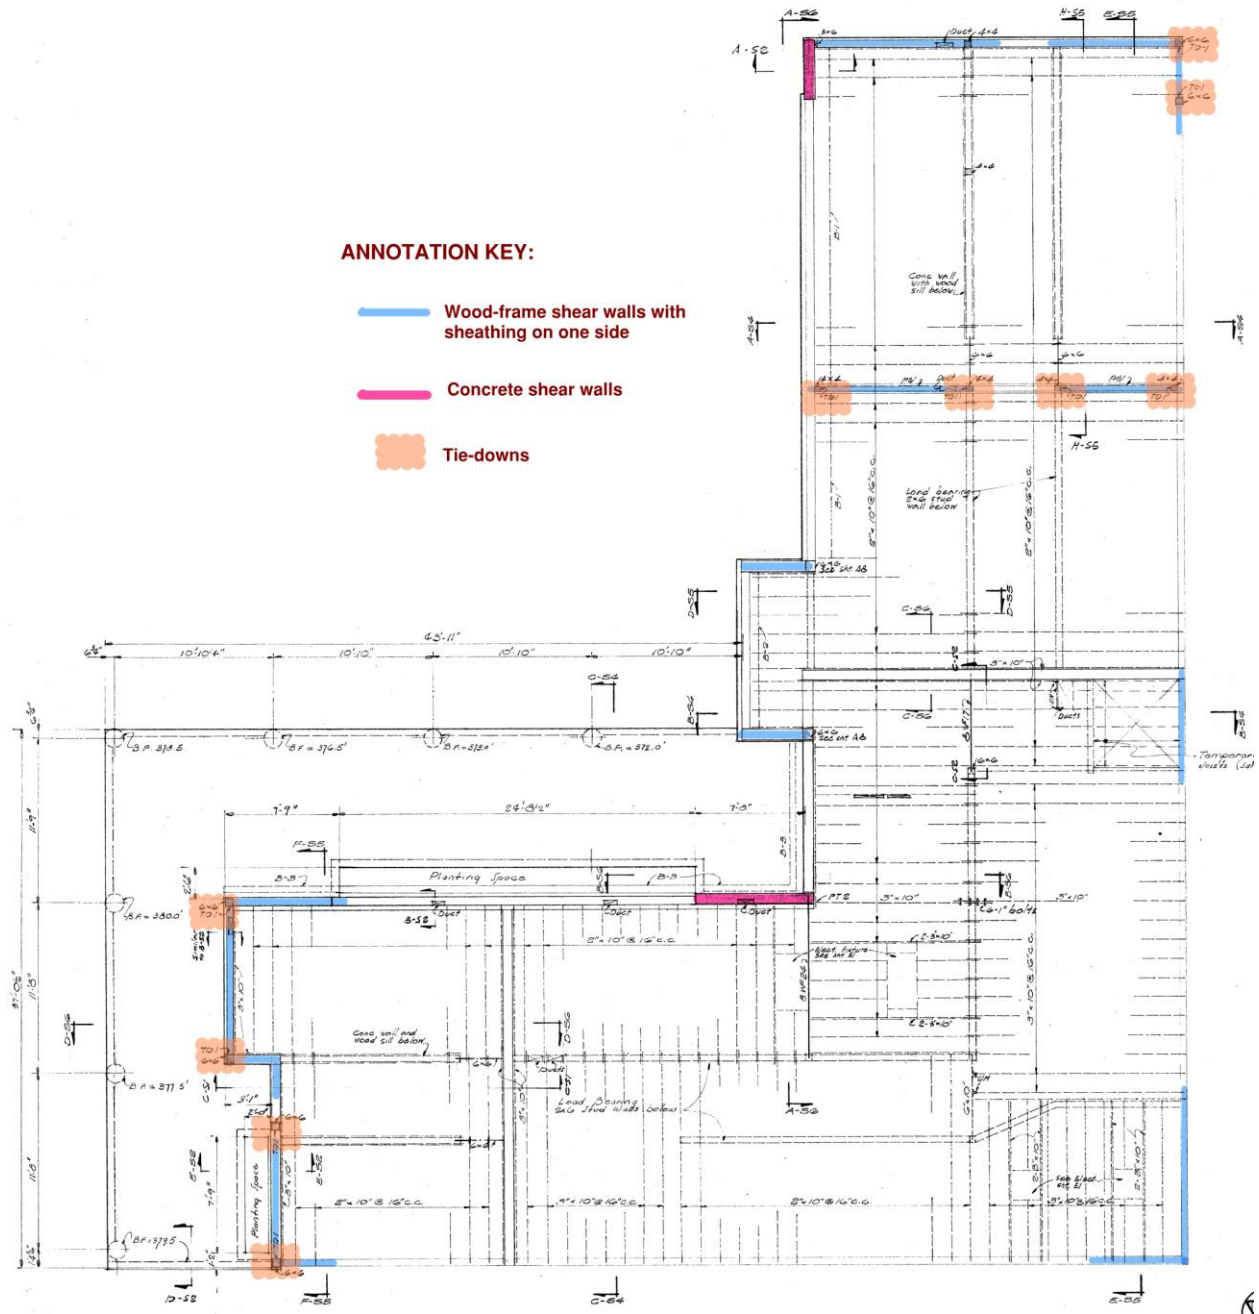
- The shear walls in the Proctor Foundation are severely overstressed per the Tier 1 Quick Check assessment. In the N-S direction, the maximum Tier 1 demand-to-capacity is 2.55, and in the E-W direction, the maximum demand-to-capacity is 1.57.

- The building contains a weak and soft story in the N-S direction. The length of shear wall reduces from 147 linear feet between the 3<sup>rd</sup> floor and roof to 52 linear feet between the 2<sup>nd</sup> and 3<sup>rd</sup> floors.

Shear walls between the second and third floor in the main building (1954 construction)

It is recommended that this structure be retrofit. The as-built condition contains limited lengths of shear resisting elements. It is unlikely that additional analysis will improve the rating without the addition of new walls.

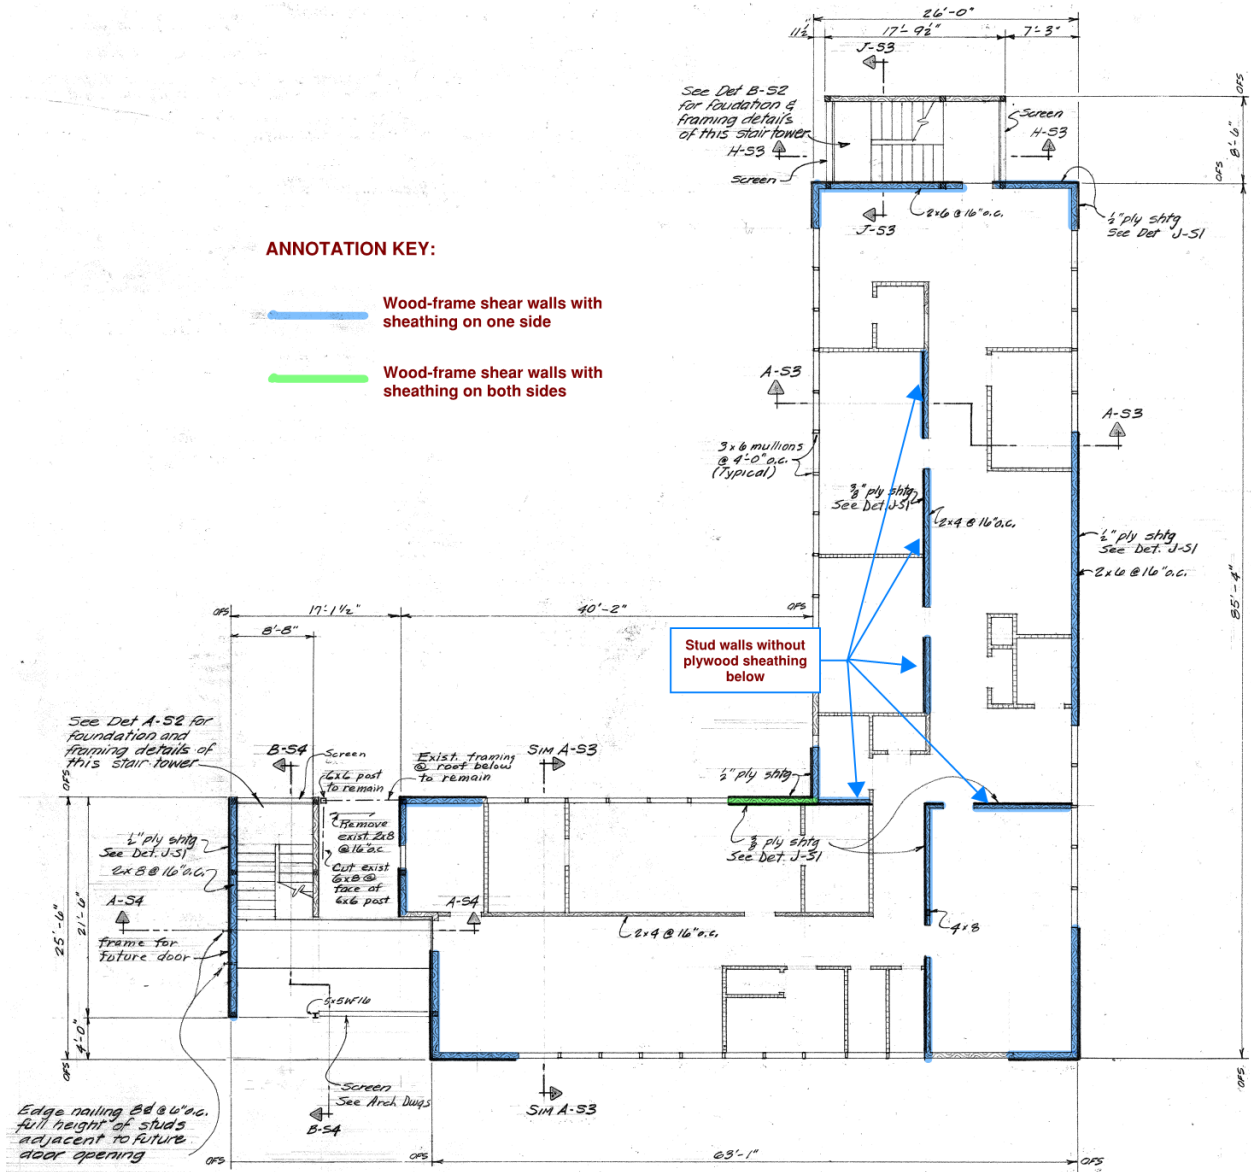
- Interior shear walls were added along the central corridors in the upper story addition in 1964. These walls align with stud walls below; however, the stud walls are interior partitions and do not contain plywood sheathing.

Shear walls between the third floor and the roof in the main building (1964 construction)

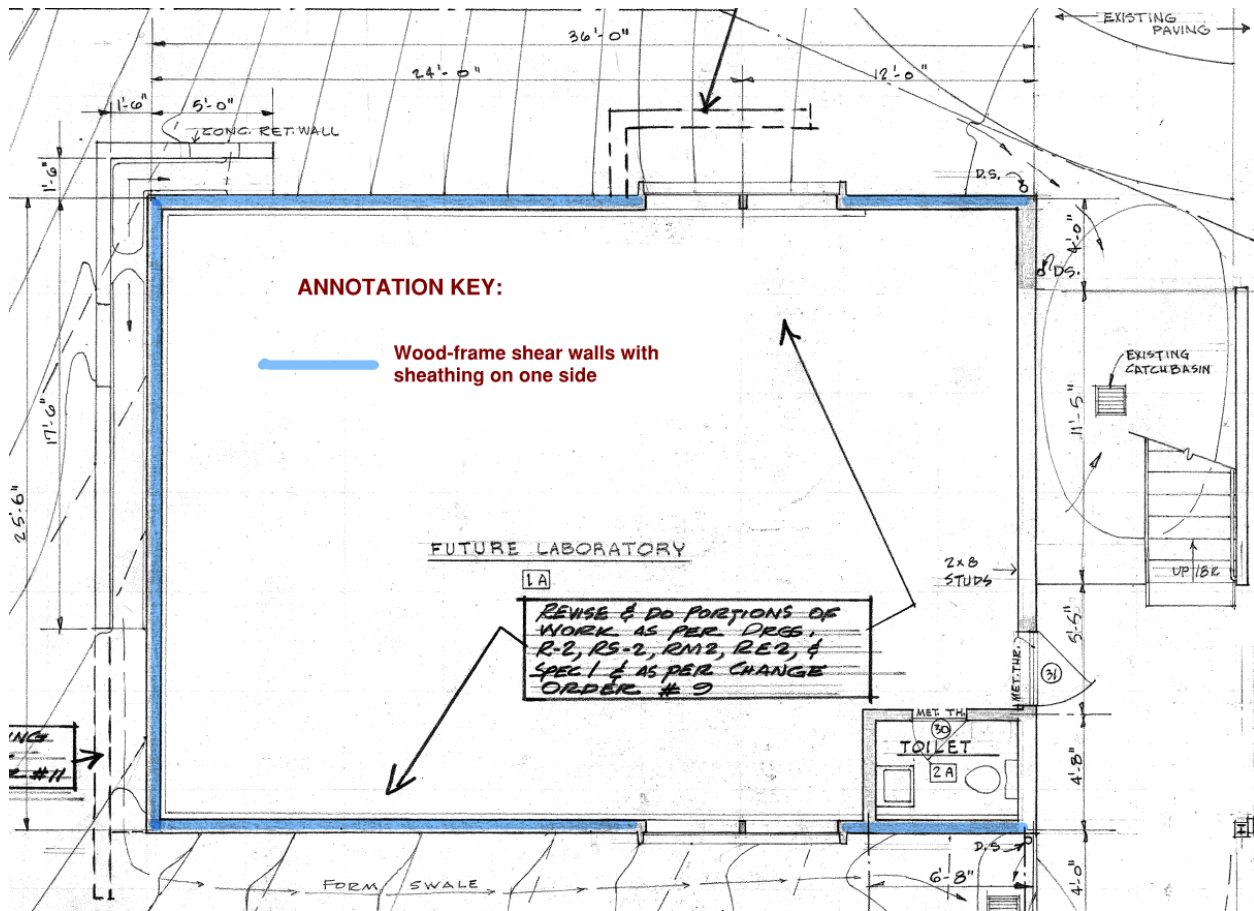
Shear walls between the second and third floor in the east wing (1964 construction). Note that the wall on the west (right) side is not shaded as the drawings have a bid alternate without plywood on this wall. There is stucco on the exterior.

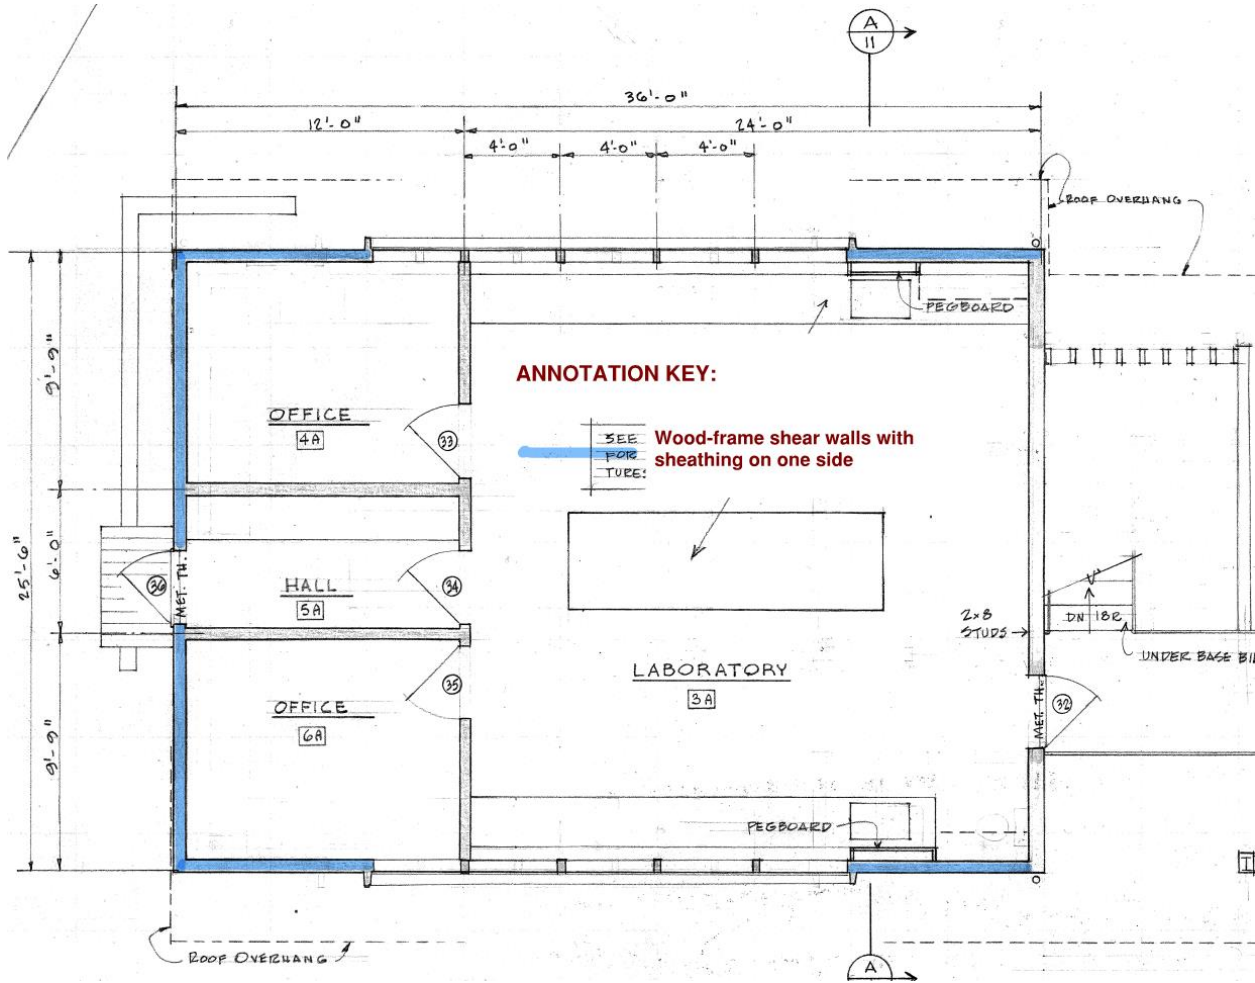
Shear walls between the third floor and the roof in the east wing (1964 construction). Note that the wall on the west (right) side is not shaded as the drawings have a bid alternate without plywood on this wall. There is stucco on the exterior.

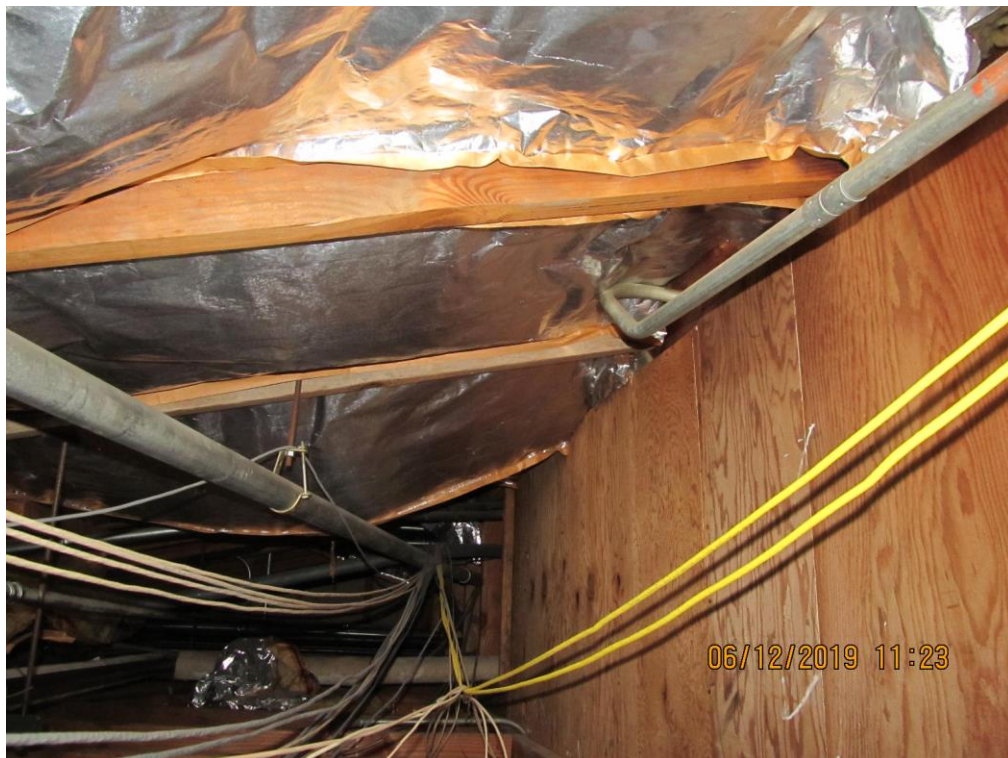
Interior shear wall at underside of roof

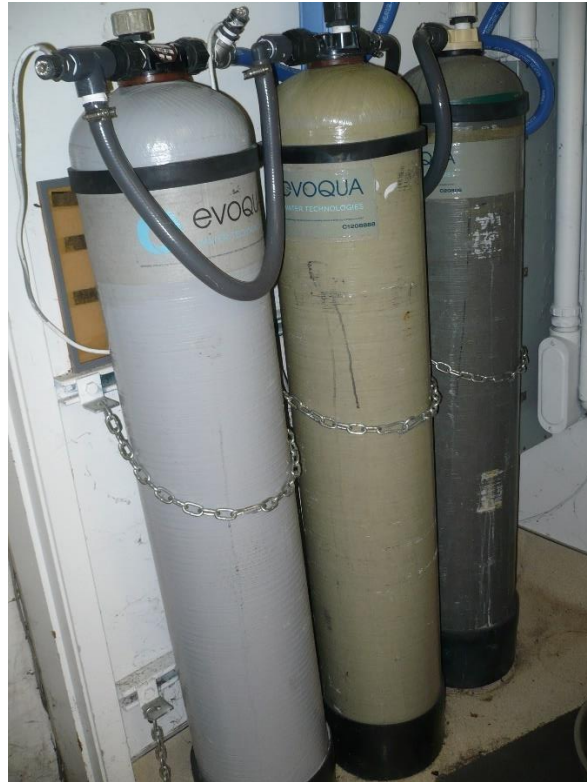
Chained tanks

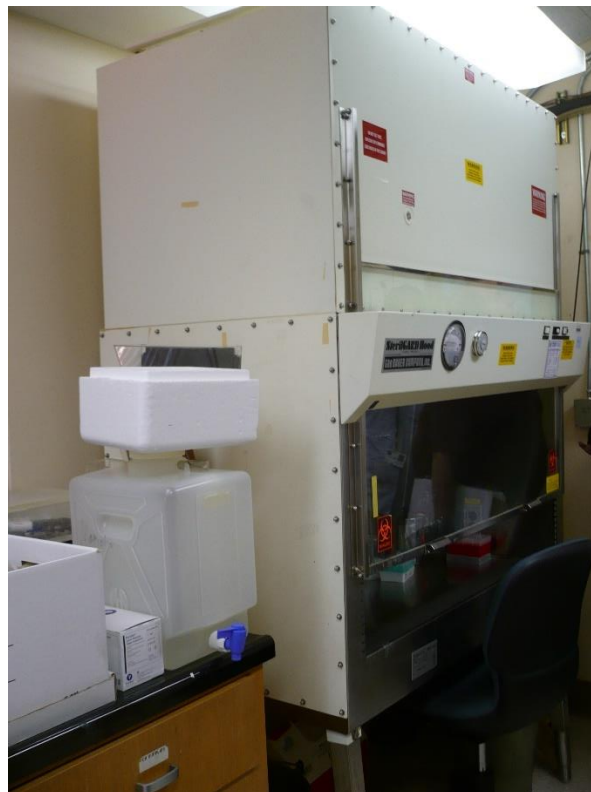
The majority of the lab equipment is unbraced including, but not limited to, refrigerators and fume hoods. Gas supply to the building is unknown as the boiler room was not accessible. No gas fueled equipment was observed; however, a gas meter is located on the north elevation. Access to the mechanical room was not available during the site visit.

Unbraced fume hood

Falling Hazards Risk: Moderate, lab equipment is unbraced.
