## UCSF Building Seismic Ratings

**1344 3<sup>RD</sup> AVENUE**

CAAN #2267

1344 3<sup>RD</sup> AVENUE, SAN FRANCISCO, CA 94122

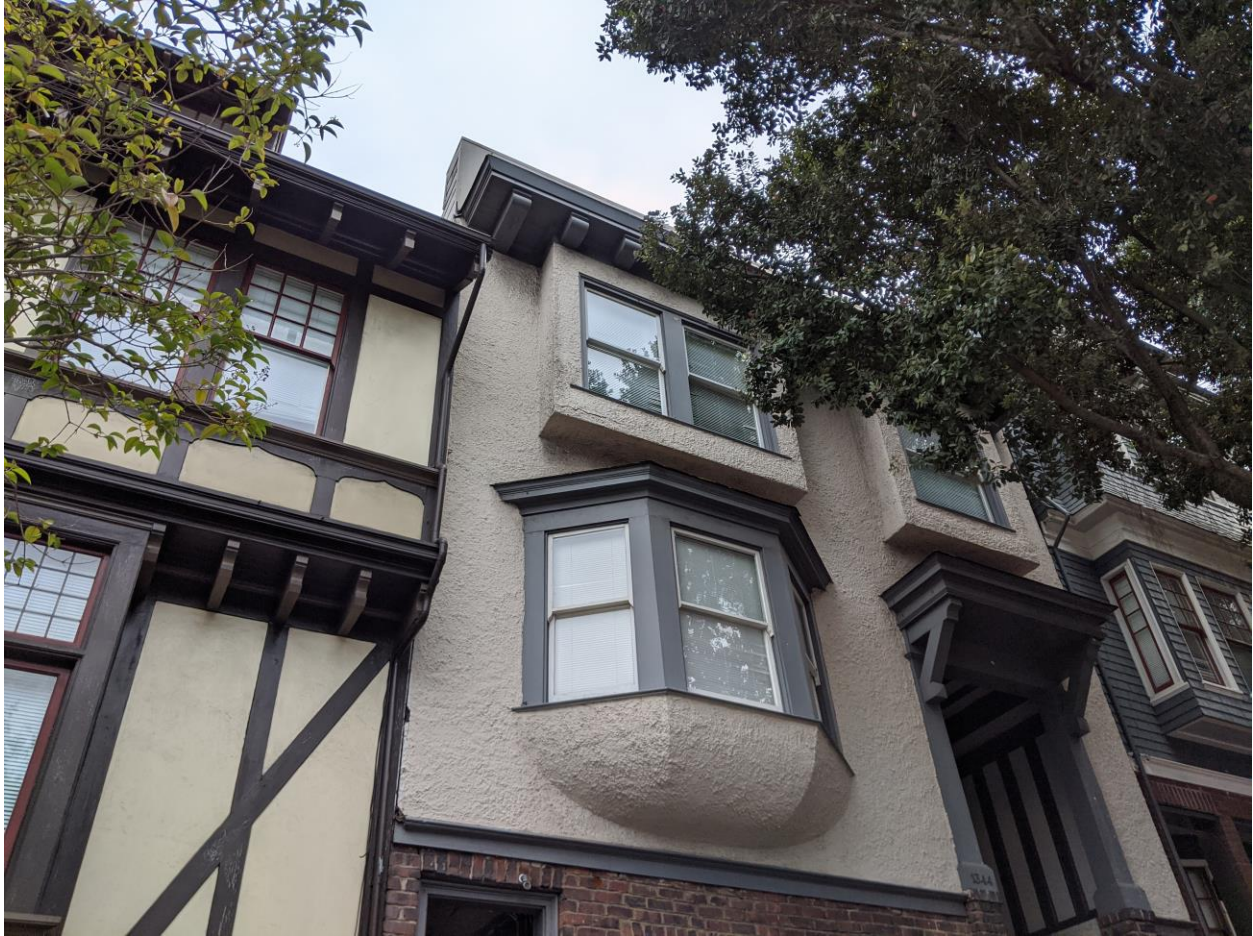
**Figure 5 – Front Wall Condition**

Building Condition: What could be observed of the structure of the building appeared to be in fair condition; however, most of the structure was concealed behind finishes. There was a large horizontal crack in the stucco under the front second floor window. The concrete stem walls were poorly consolidated in some areas and some spalling was observed. The rear wood exterior patio and stairs were in good condition, including connector hardware. The rear wood siding was aged and looked to need maintenance.

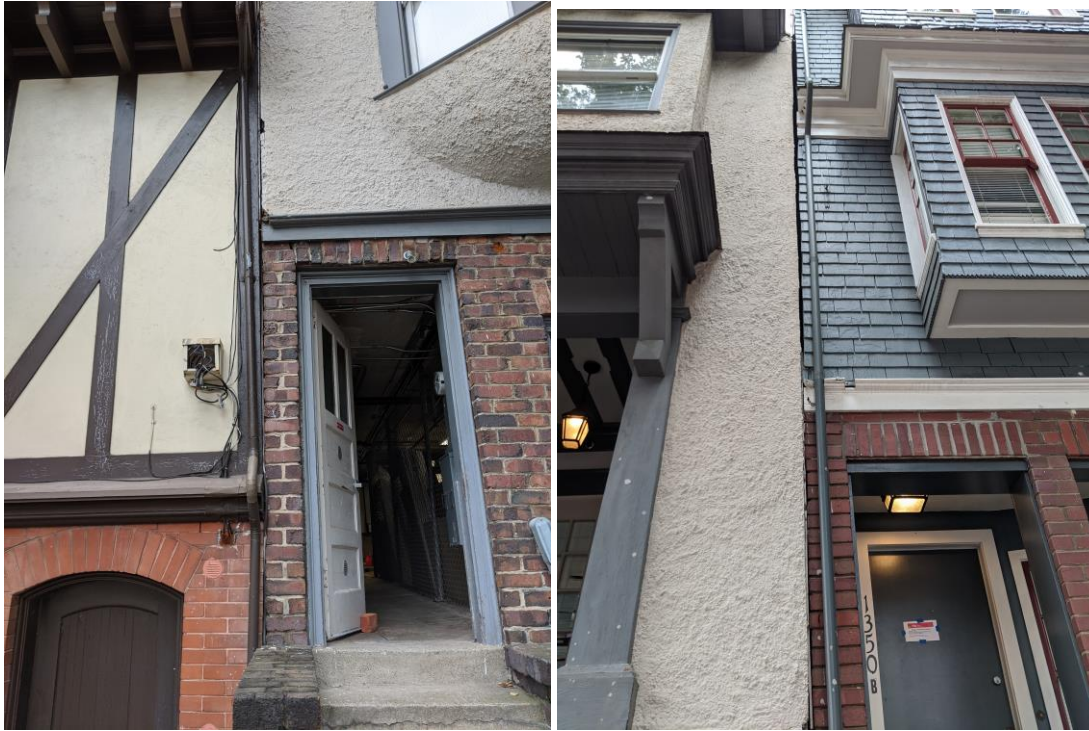
**Figure 6 - Building Separation to the North (Left) and South (Right)**

- The building is located on a sloped site. However, there is a significant length of wall on the downhill side of the building.
- The building is built to the property line with virtually no separation between the neighboring buildings to the north and south. The floor levels do not align with the adjacent buildings due to the sloped site.
- The garage cripple walls were primarily sheathed with plaster and gypsum board. Based on the age of construction it is assumed the anchor bolts for the sill plate are not adequate.

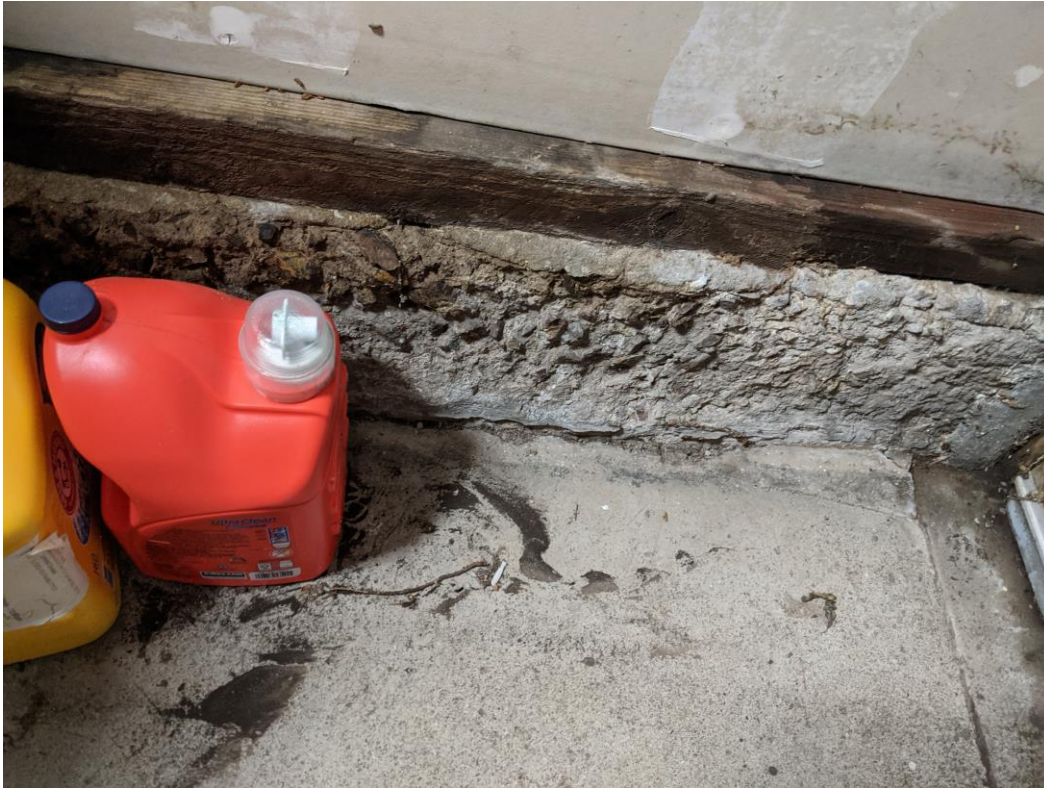
**Figure 8 – Concrete Stem Wall Spalling**

Foundation system: Existing foundation drawings are not available. It is presumed there are continuous footings below bearing walls. During the site visit on December 5, 2019 continuous concrete stem wall footings were observed around the ground floor level. The bathroom on the first floor and rear bedroom on the second floor is supported on wood posts on isolated footings at the two eastern-most corners.

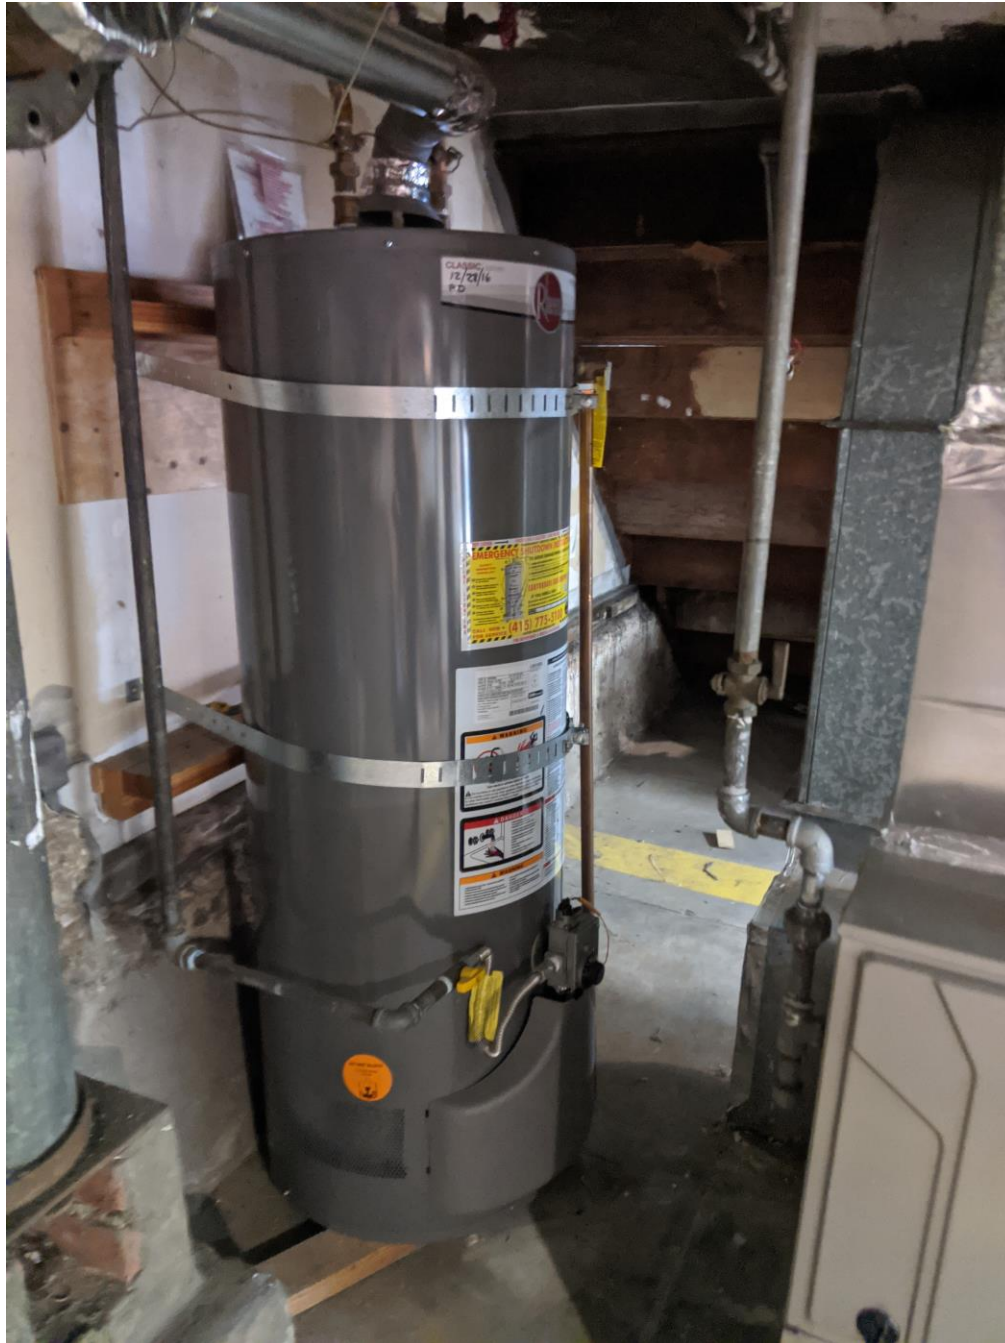
**Figure 11 - Braced Water Heater in Basement**

The water heater in the basement is strapped to the wall and had flex connections to the gas line. Bracing of the furnace was not observed, but it did have flex connections as well.

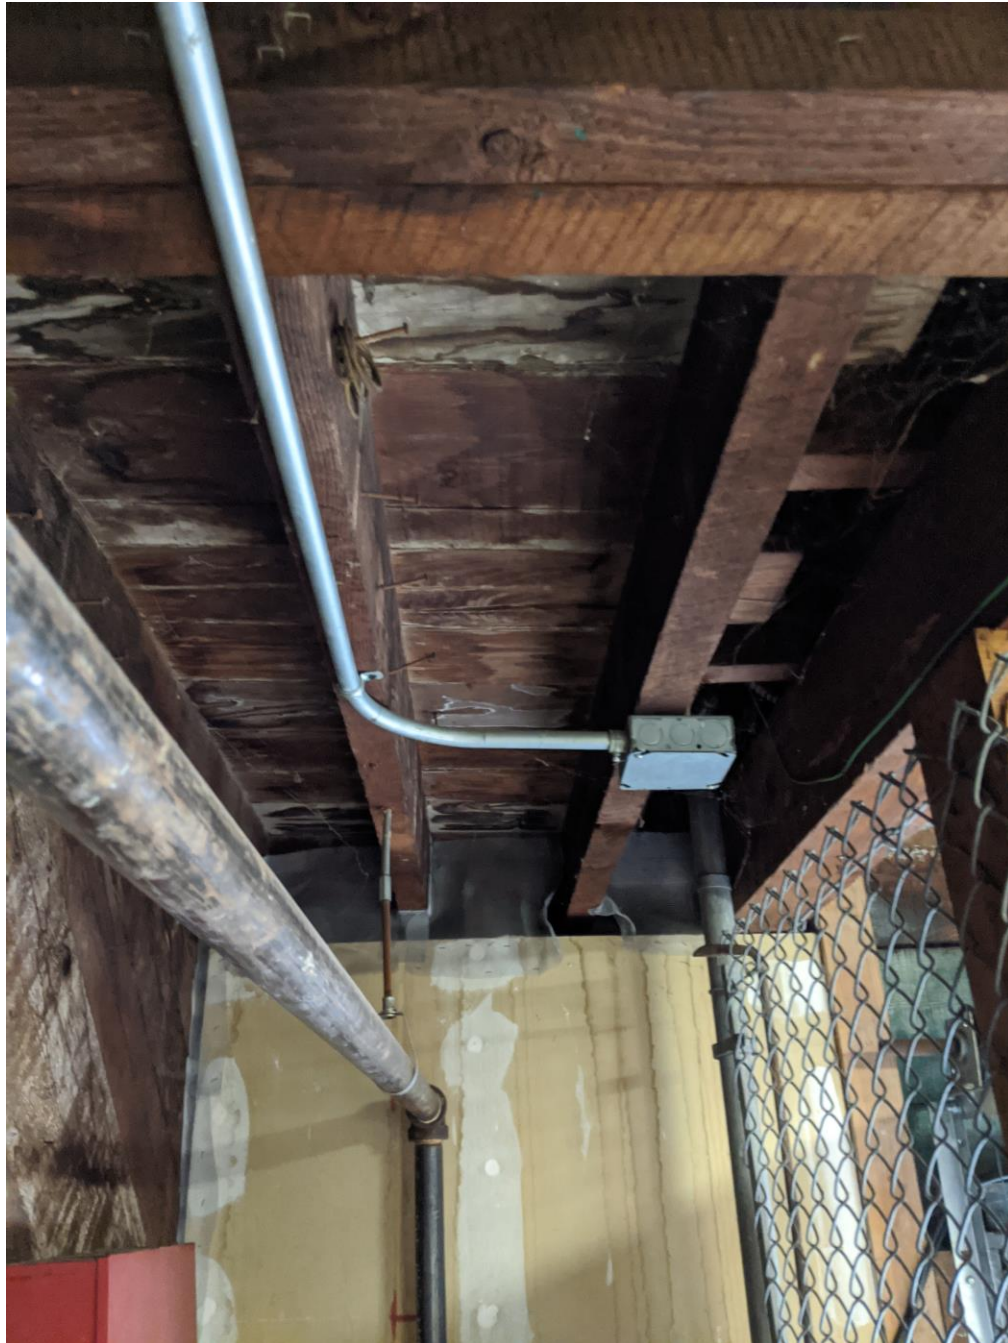
**Figure 12 – First Floor Sheathing and Framing**

Structural system for lateral forces: Drawings showing the existing framing are not available. It is presumed based on the age of the building that a sheathed diaphragm distributes load to the interior and exterior wood framed walls sheathed with gypsum board and/or plaster. Straight floor sheathing could be seen in areas where the basement ceiling was not finished.

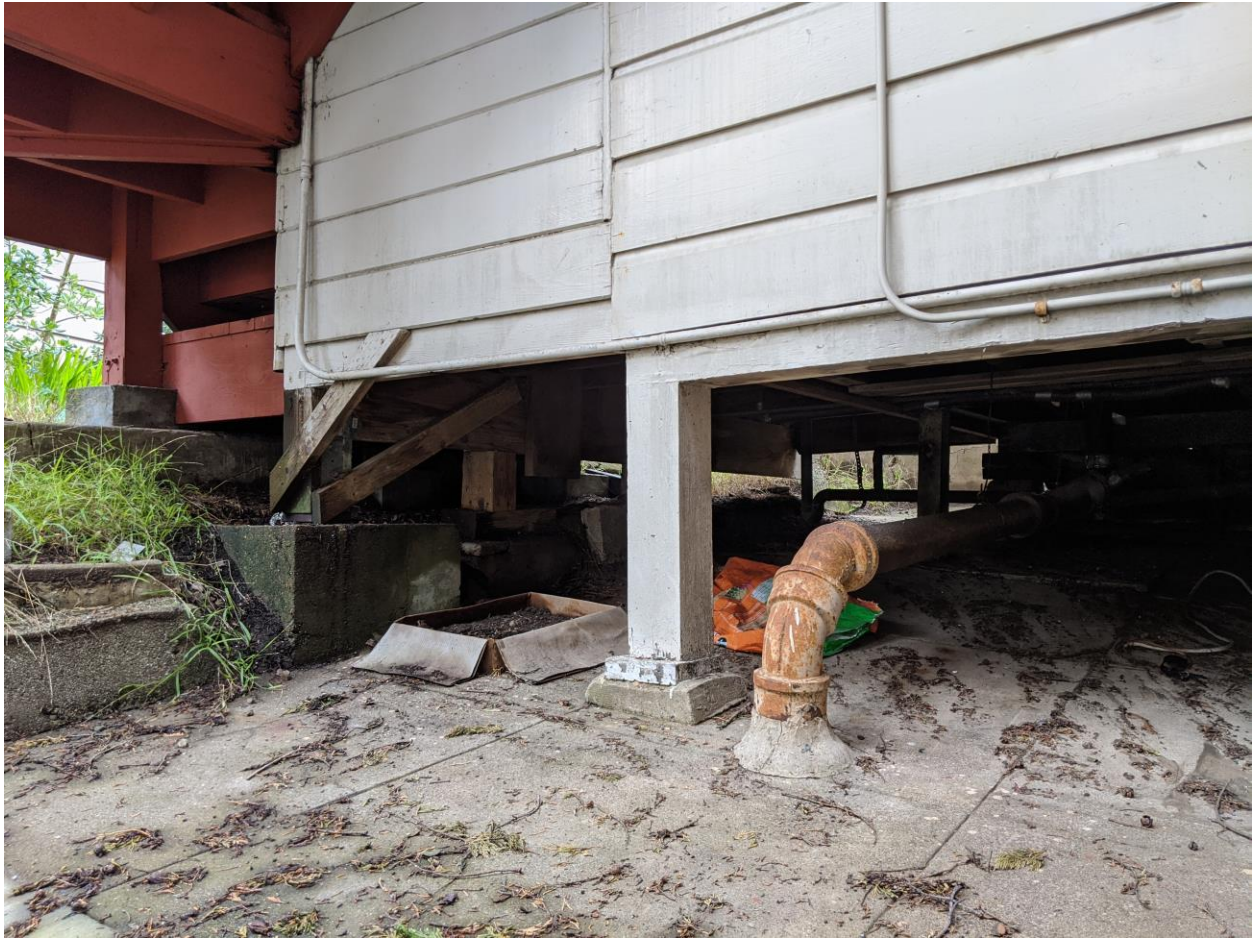
**Figure 14 – Support of Rear Bathroom and Bedroom**

Description
C	NC	N/A	U	<p>WOOD POSTS: There is a positive connection of wood posts to the foundation. (Commentary: Sec. A.5.3.3. Tier 2: Sec. 5.7.3.3)</p> <p><b>Comments:</b> Wood posts observed did not have positive connection to the foundation.</p>
<input type="radio"/>	<input checked="" type="radio"/>	<input type="radio"/>	<input type="radio"/>	
C	NC	N/A	U	<p>WOOD SILLS: All wood sills are bolted to the foundation. (Commentary: Sec. A.5.3.4. Tier 2: Sec. 5.7.3.3)</p> <p><b>Comments:</b> All wood sills in the basement space were concealed by plaster. However, based on the age of the building it is anticipated the wood sill bolting is not adequate.</p>
<input type="radio"/>	<input type="radio"/>	<input type="radio"/>	<input checked="" type="radio"/>	
C	NC	N/A	U	<p>GIRDER-COLUMN CONNECTION: There is a positive connection using plates, connection hardware, or straps between the girder and the column support. (Commentary: Sec. A.5.4.1. Tier 2: Sec. 5.7.4.1)</p> <p><b>Comments:</b> Girder-column connections were concealed, but it is assumed there is not a positive connection.</p>
