UCSF Building Seismic Ratings

1350 3RD AVENUE

CAAN #2269

1350 3RD AVENUE, SAN FRANCISCO, CA 94122

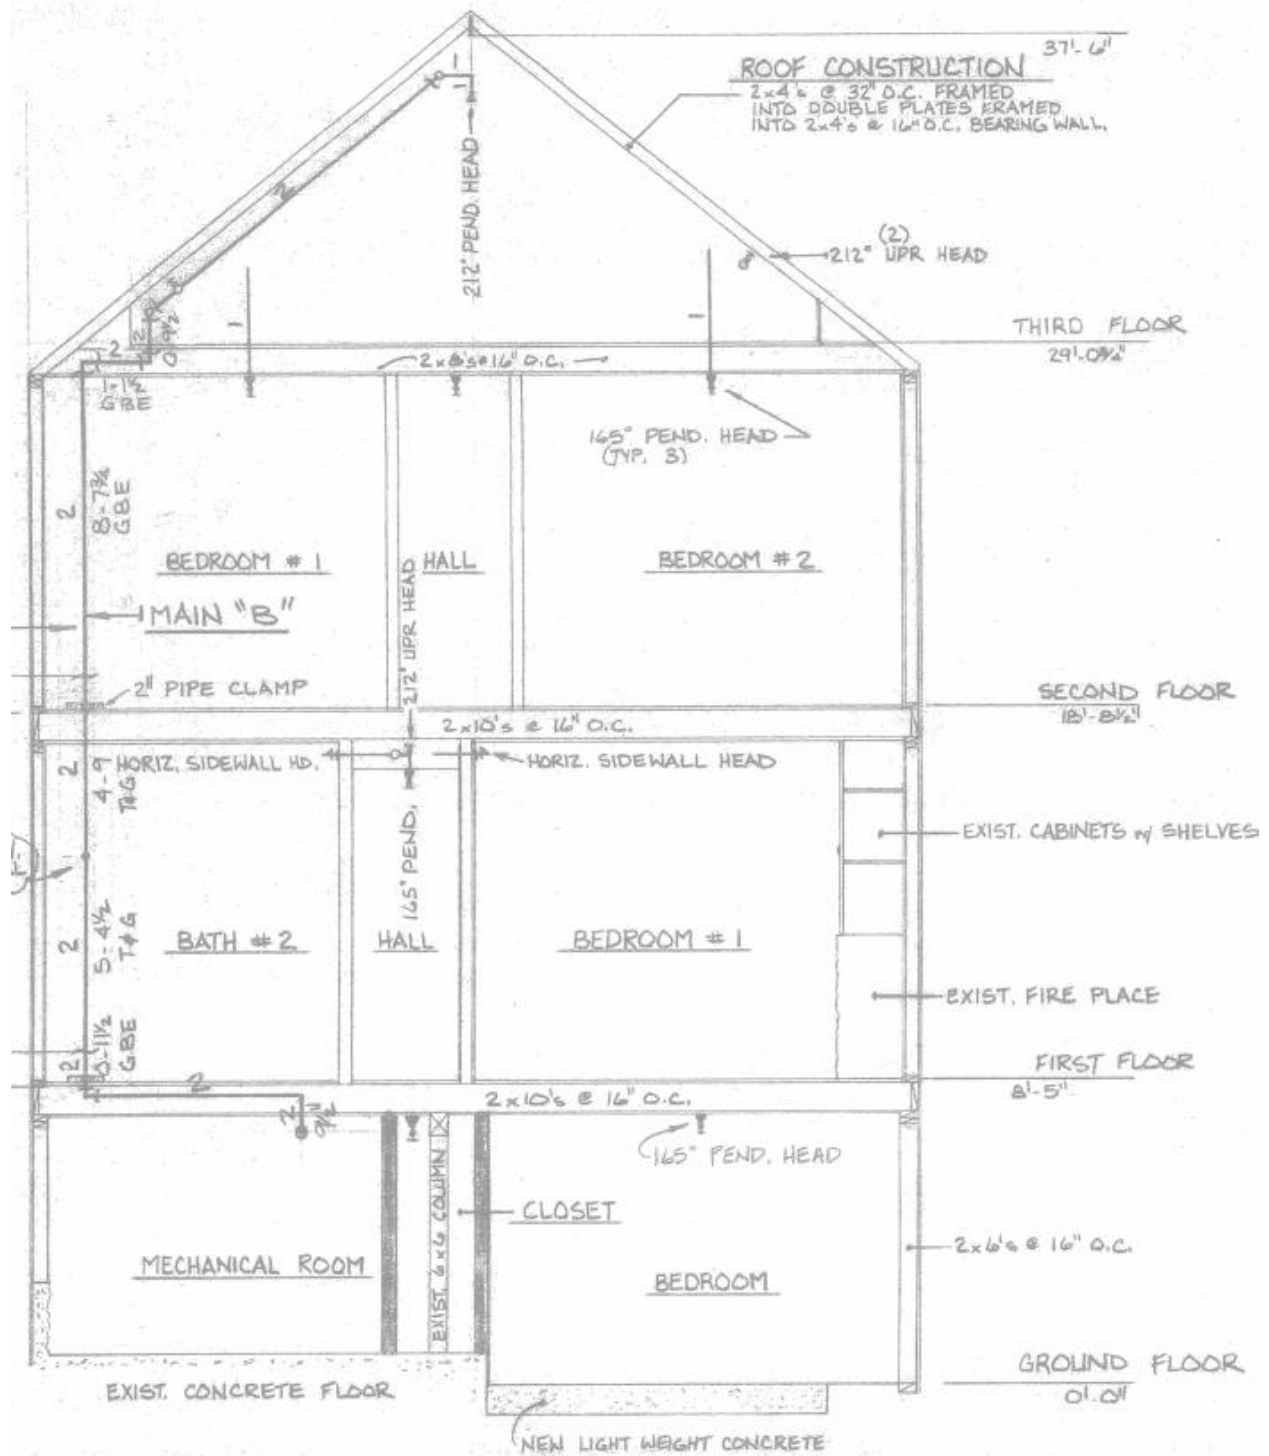
Figure 4 – Transverse Section (Looking West)

Structural system for vertical (gravity) load: The fire protection drawings include a transverse building section showing the basic gravity members (see Figure 4), which is consistent with similar buildings built around the same time. Joists span the transverse direction to exterior stud walls and an interior longitudinal line of support.

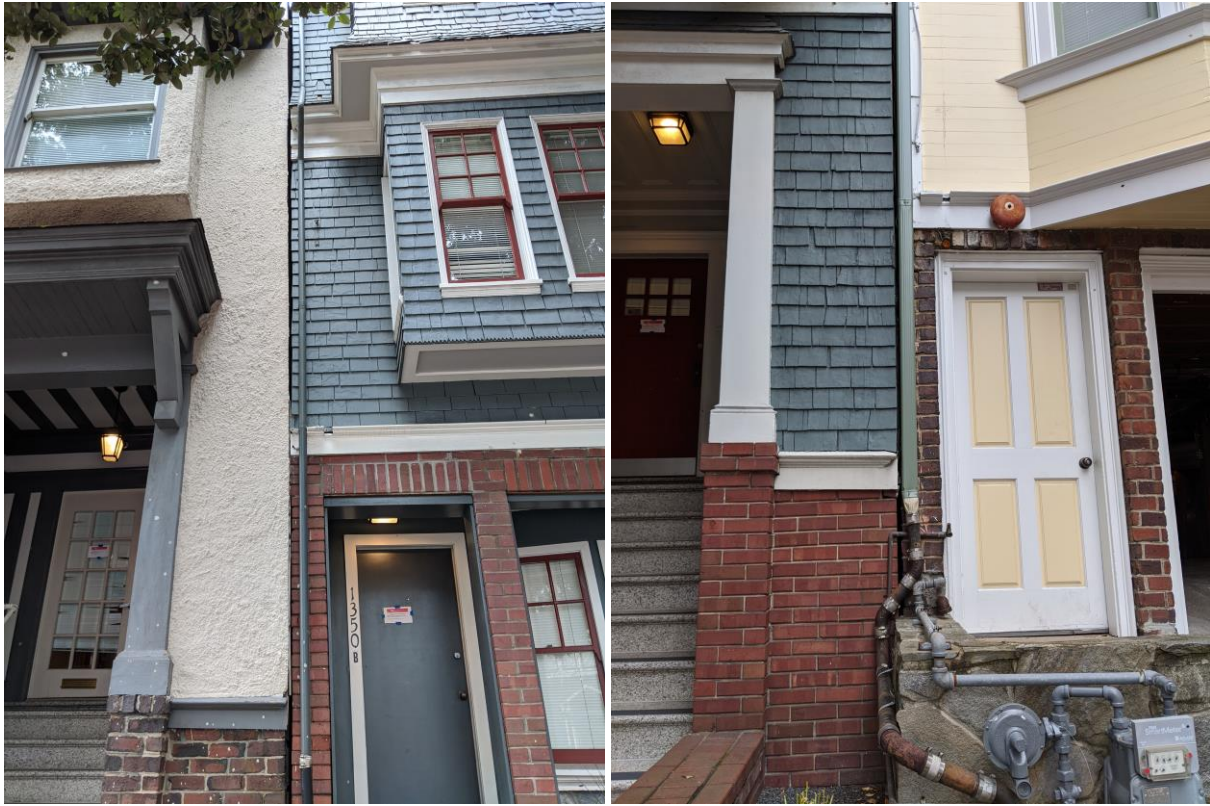
Figure 5 - Building Separation to the North (Left) and South (Right)

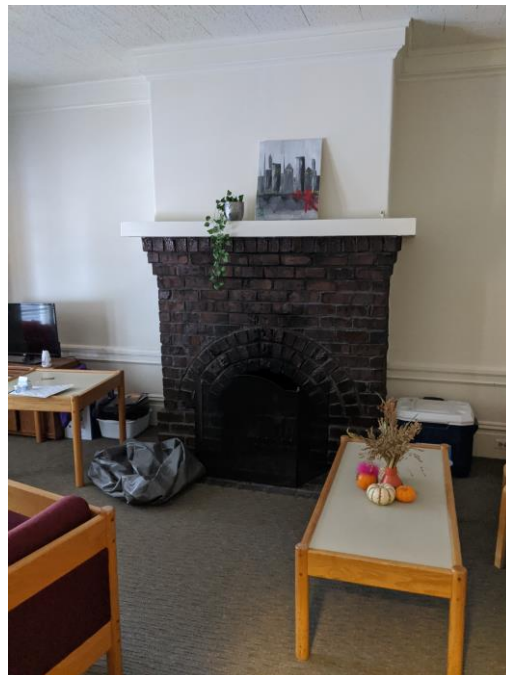
It appeared the chimney had been replaced with a sheet metal flue. The units have fireplaces, but they have been blocked off.

Figure 6 – Closed Off Existing Fireplace

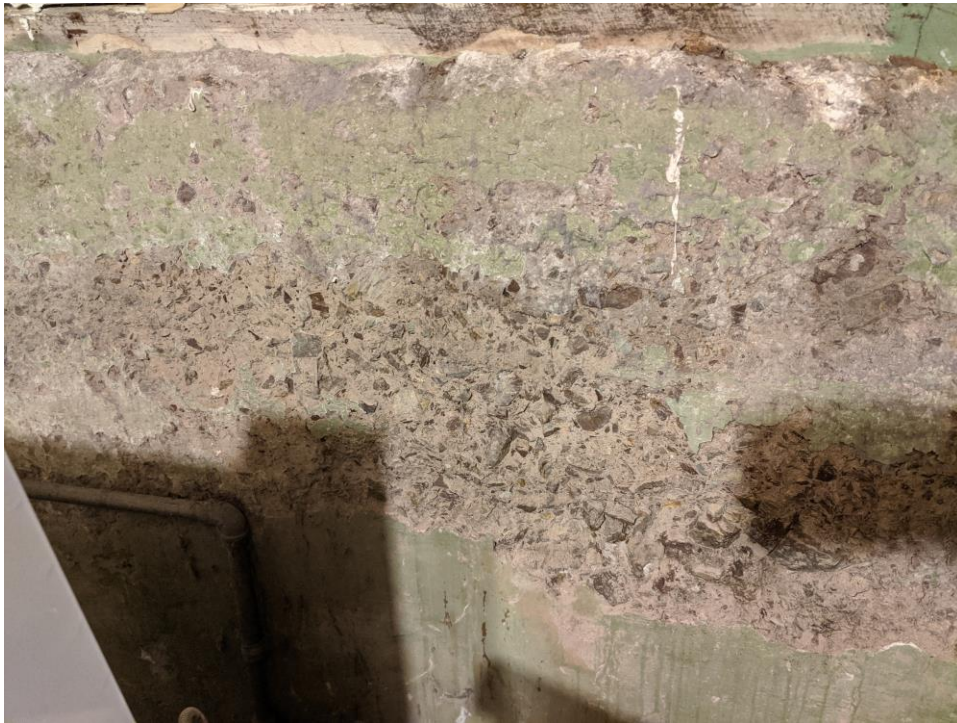
Building Condition: What could be observed of the structure of the building appeared to be in fair condition; however, most of the structure was concealed behind architectural finishes. The concrete stem walls are poorly consolidated in some areas and some spalling was observed. The rear wood exterior patio and stairs are in good condition, including connector hardware. The rear wood siding is in fair condition.

Figure 7 – Spalling of Concrete Stem Walls

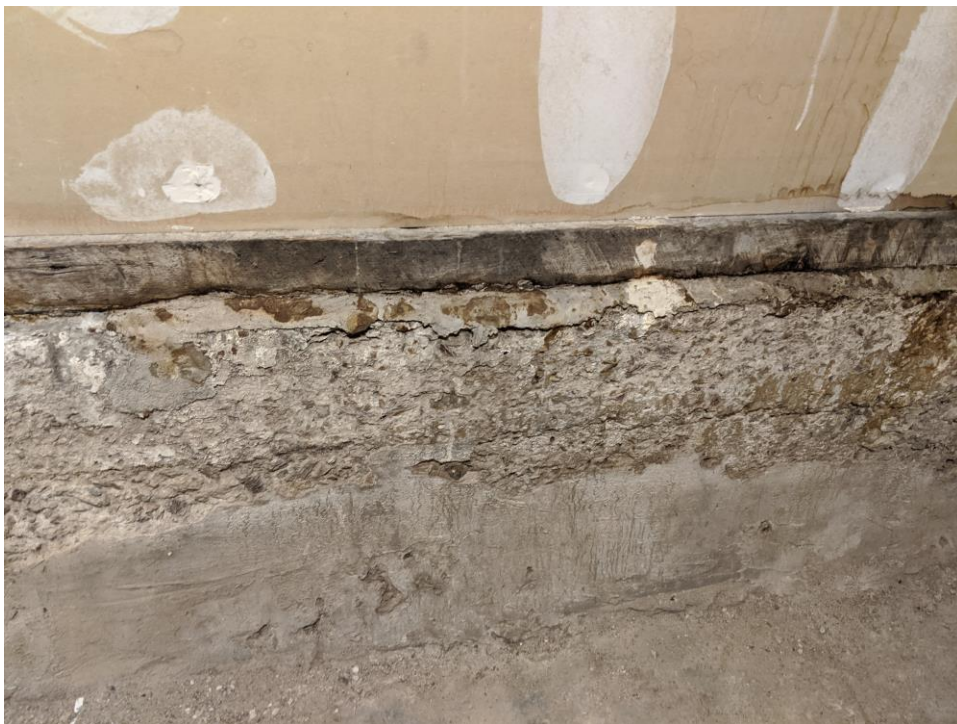
Figure 8 - Spalling of Concrete Stem Walls

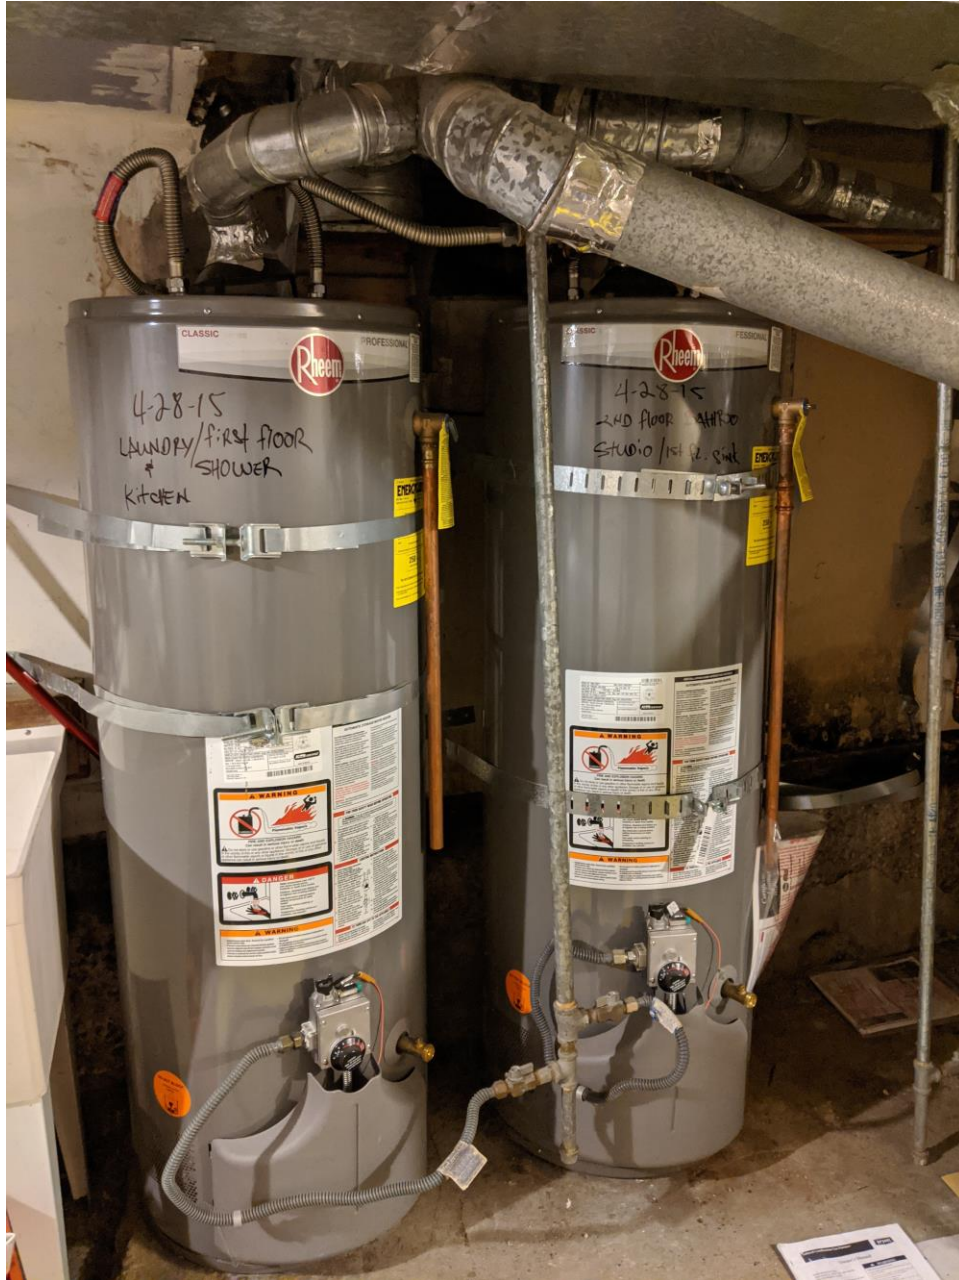
The water heater in the basement is strapped to the wall and had flex connections to the gas line. Bracing of the furnace was not observed.

Figure 9 – Braced Water Heaters at Ground Floor Utility Space
