UCSF Building Seismic Ratings

1338 3RD AVENUE

CAAN #2271

1338 3RD AVENUE, SAN FRANCISCO, CA 94122

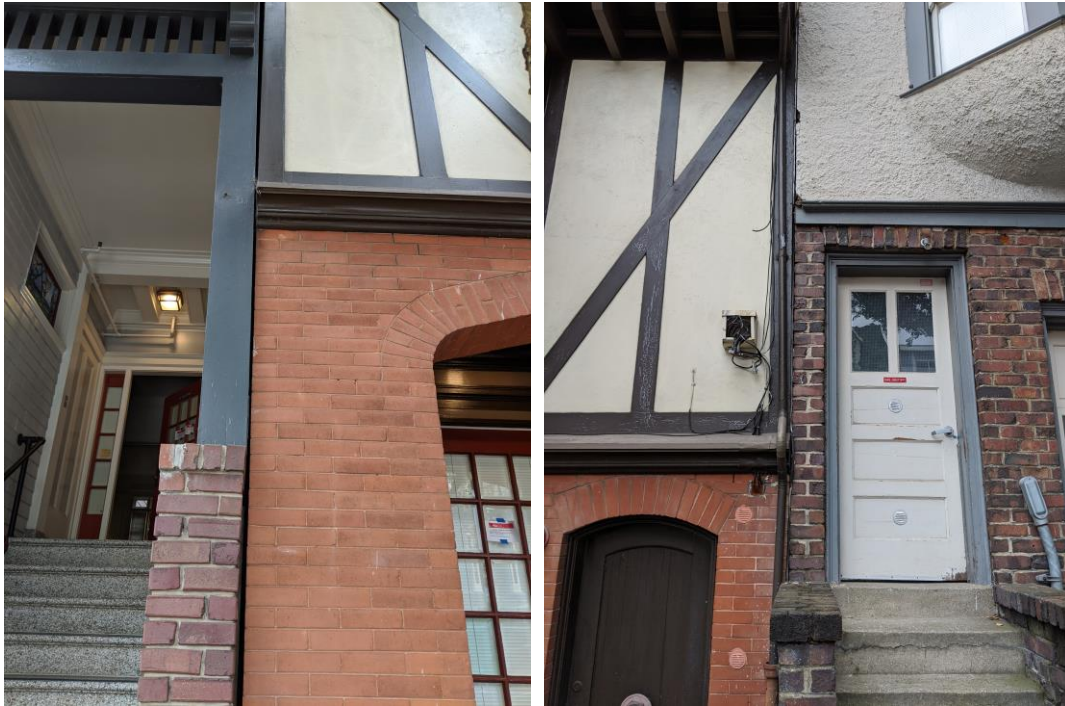
- The building is located on a sloped site. However, there is a significant length of wall on the downhill side of the building.
- The building is built to the property line with virtually no separation between the neighboring buildings to the north and south. The floor levels do not align with the adjacent buildings due to the sloped site.
- The garage cripple walls were primarily sheathed with plaster and gypsum board. Diagonal sheathing was observed along the front (west) basement wall. No mudsill bolts were observed.

Figure 5 - Building Separation to the North (Left) and South (Right)

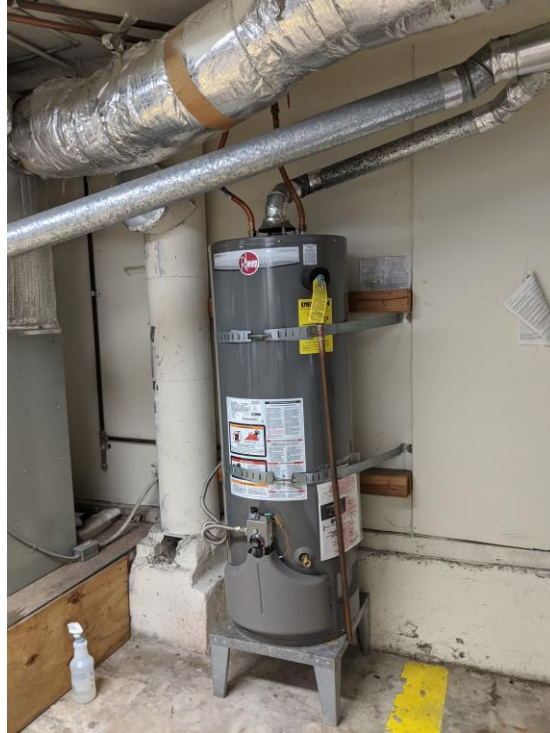
The water heater in the basement is strapped to the wall and had flex connections to the gas line. Bracing of the furnace was not observed, but it did have flex connections as well.

Figure 7 – Braced Water Heater in Basement

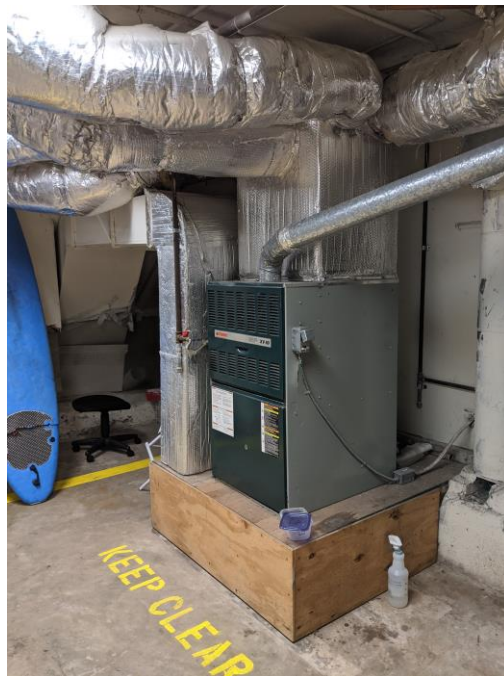
Figure 8 - Gas Furnace in Garage

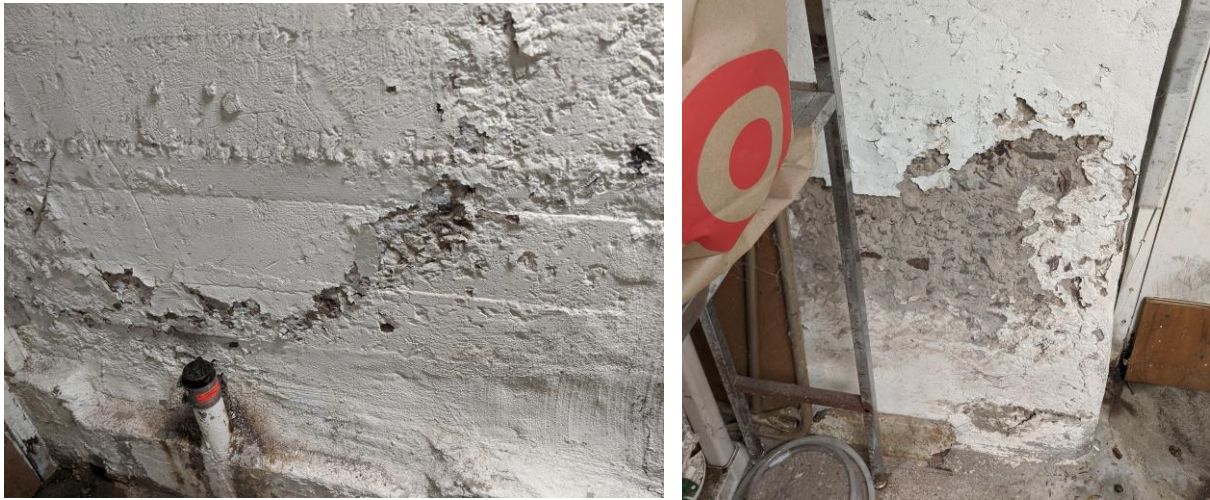
Figure 9 – Concrete Condition in Basement

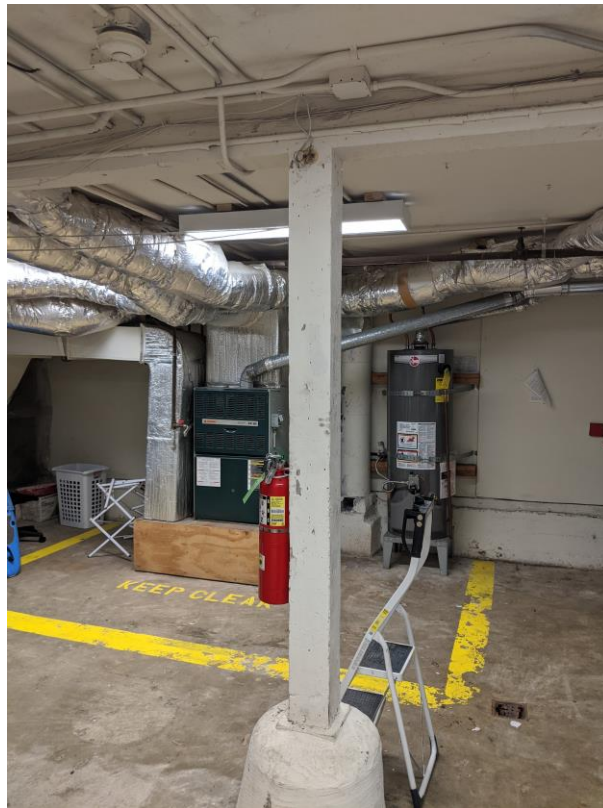
Figure 10 – Basement Post and Beam without Connector Hardware

Description
C	NC	N/A	U	<p>WOOD POSTS: There is a positive connection of wood posts to the foundation. (Commentary: Sec. A.5.3.3. Tier 2: Sec. 5.7.3.3)</p> <p>Comments: Wood post did not have positive connection to the foundation.</p>
<input type="radio"/>	<input type="radio"/>	<input type="radio"/>	<input checked="" type="radio"/>	<p>WOOD SILLS: All wood sills are bolted to the foundation. (Commentary: Sec. A.5.3.4. Tier 2: Sec. 5.7.3.3)</p> <p>Comments: All wood sills in the basement space were concealed by plaster. However, based on the age of the building it is anticipated the wood sill bolting is not adequate.</p>
<input checked="" type="radio"/>	<input type="radio"/>	<input type="radio"/>	<input type="radio"/>	<p>GIRDER-COLUMN CONNECTION: There is a positive connection using plates, connection hardware, or straps between the girder and the column support. (Commentary: Sec. A.5.4.1. Tier 2: Sec. 5.7.4.1)</p> <p>Comments: Girders observed were positively connected to columns.</p>

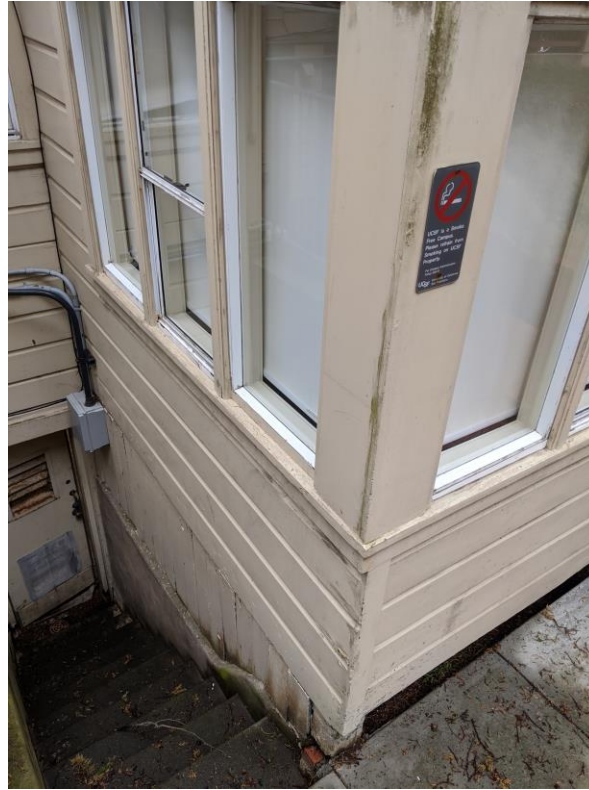
Building Condition: What could be observed of the structure of the building appeared to be in fair condition; however, most of the structure was concealed behind finishes. The rear exterior wood siding and trim showed signs of water wicking. The concrete stem walls were poorly consolidated in many areas and some spalling was observed. The rear wood exterior patio and stairs were in good condition, including connector hardware.

Figure 11 – Exterior Finish Condition at Rear of Building

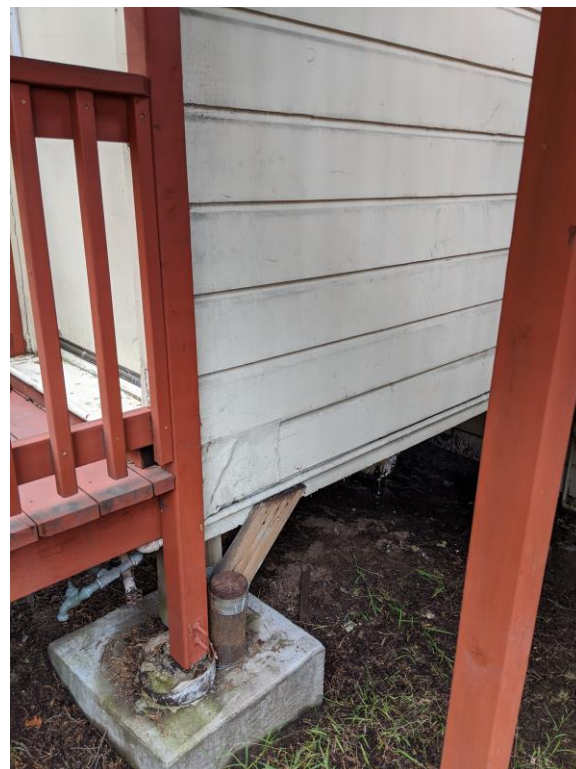
Figure 13 – Rear Stair Post Connector and Footing
