UCSF Building Seismic Ratings

1356 3RD AVENUE

CAAN #2272

1356 3RD AVENUE, SAN FRANCISCO, CA 94122

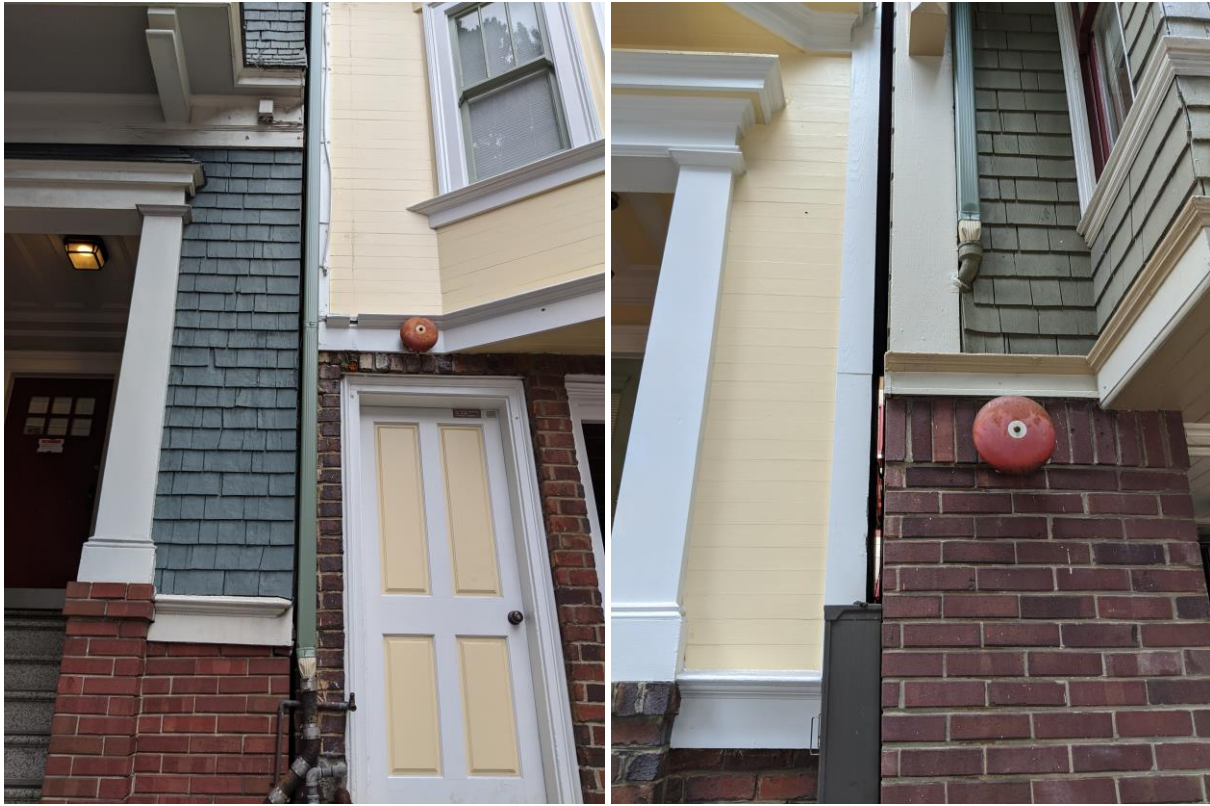
- The building is located on a sloped site. However, there is a significant length of wall on the downhill side of the building.
- The building is built to the property line with virtually no separation between the neighboring building to the north. To the south, there is approximately a 2-1/2 inch gap, or about 0.75% of the total height. The floor levels do not align with the adjacent buildings due to the sloped site.
- The garage cripple walls were primarily sheathed with plaster and gypsum board. Based on the age of construction it is assumed the anchor bolts for the sill plate are not adequate.

Figure 5 - Building Separation to the North (Left) and South (Right)

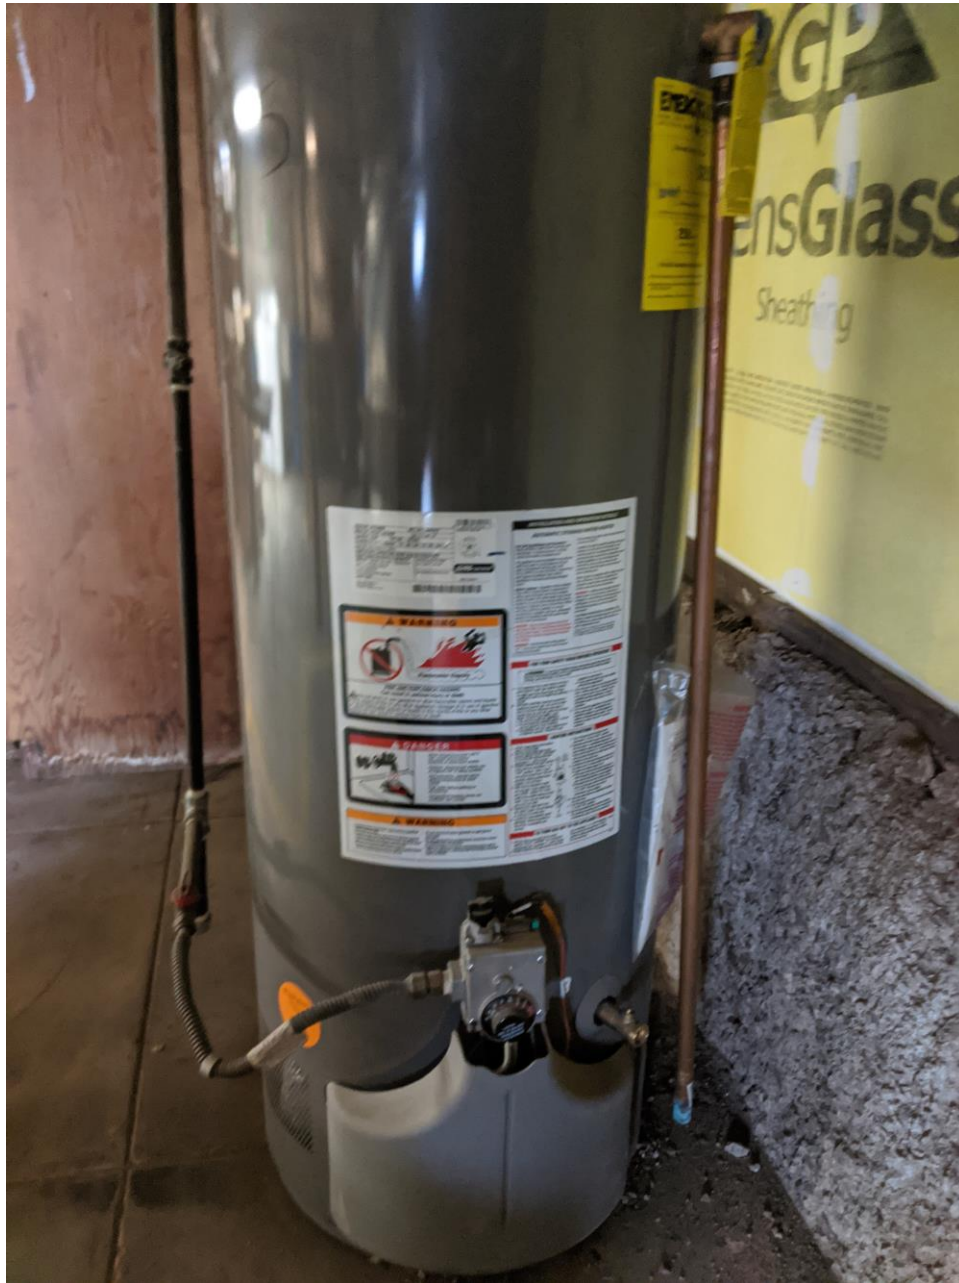
The water heater in the basement was unanchored but did have flex connections to the gas line. Bracing of the furnace was not observed, but it did have flex connections as well.

Figure 6 – Unanchored Water Heater in Basement

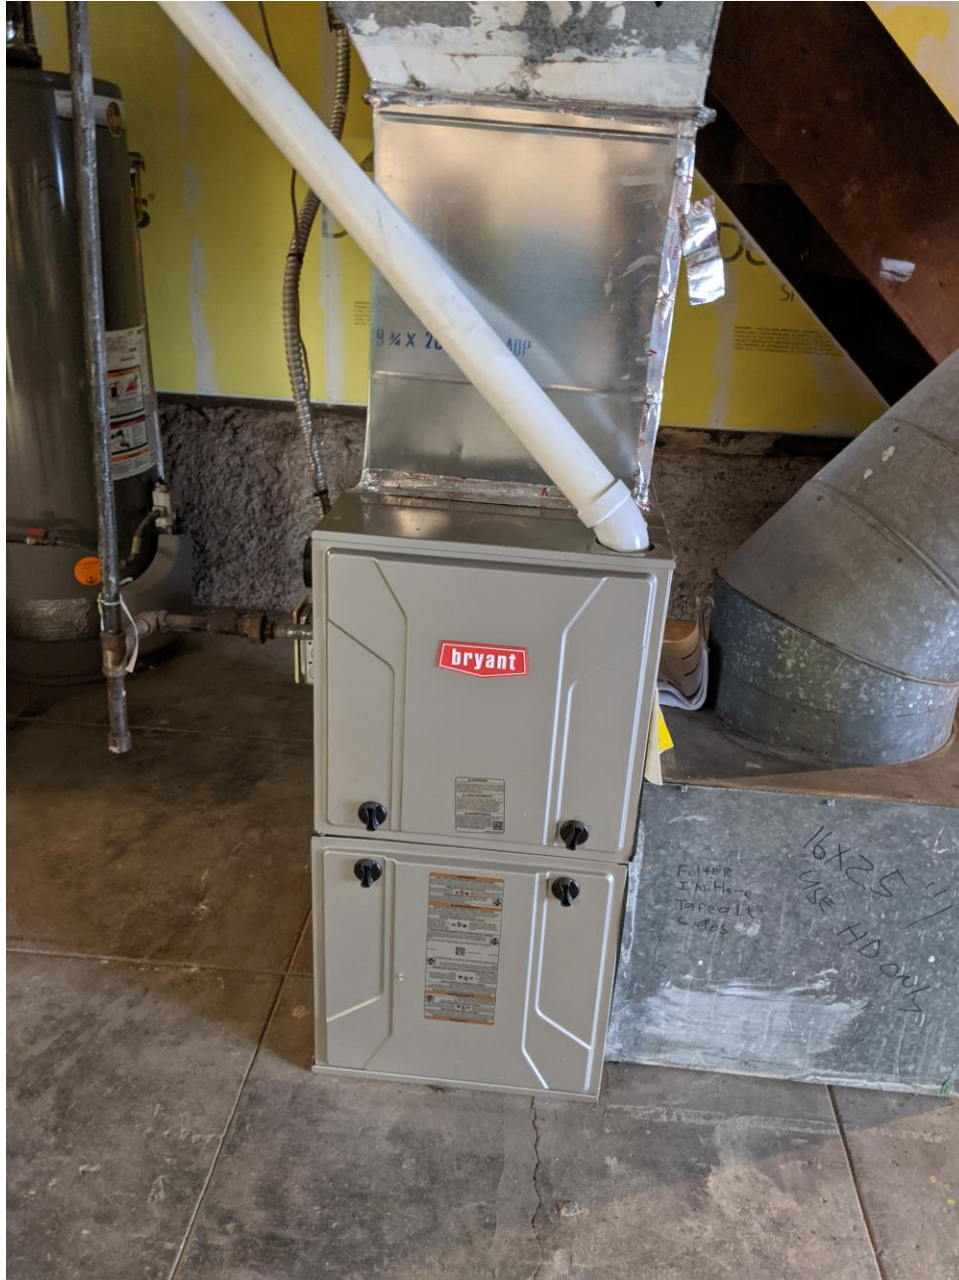
Figure 7 – Furnace in Basement

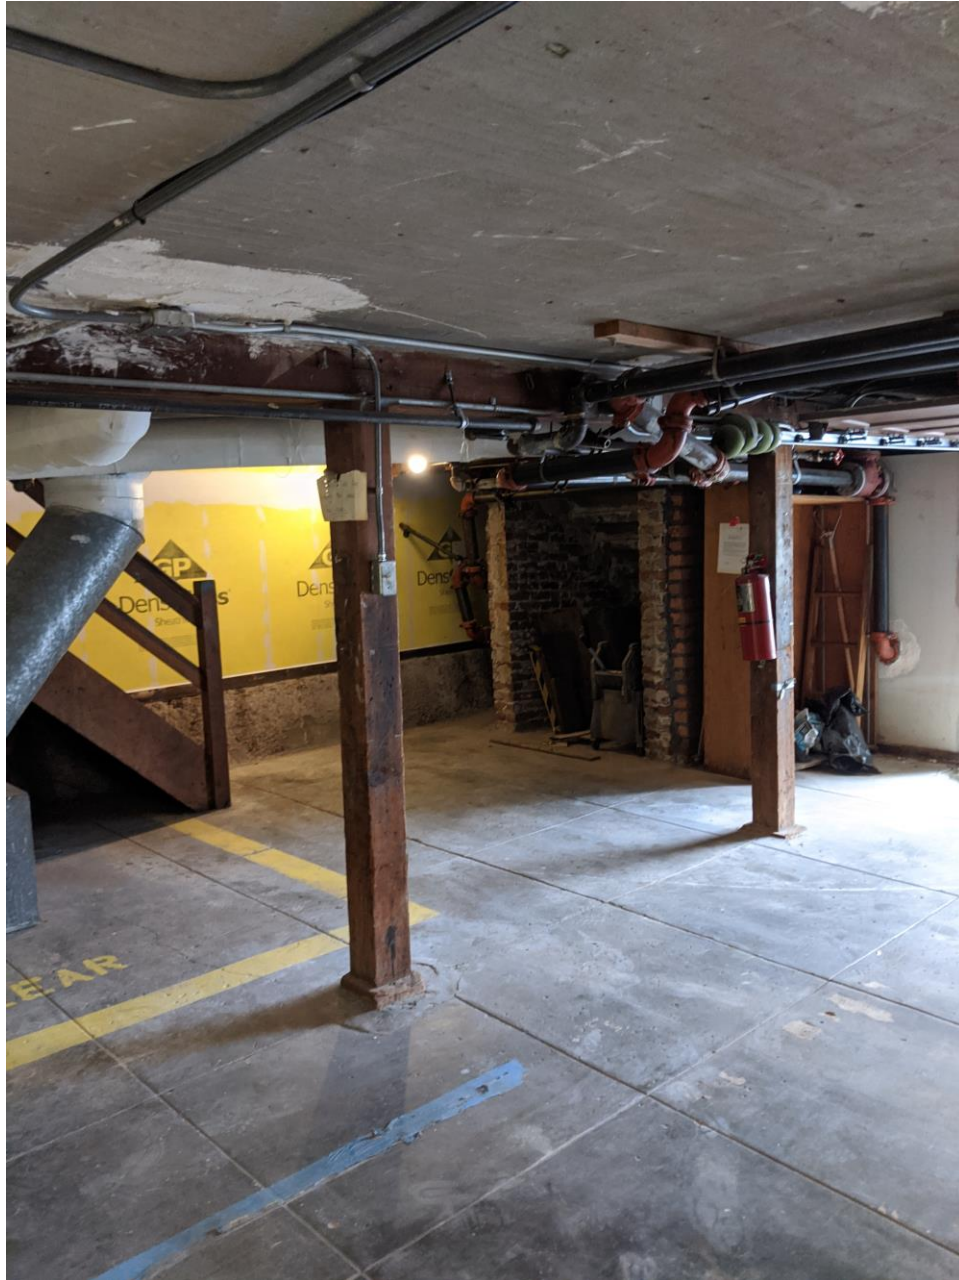
Figure 8 – Post and Beams in Basement

Comments: Girders did not have positive connections to columns.

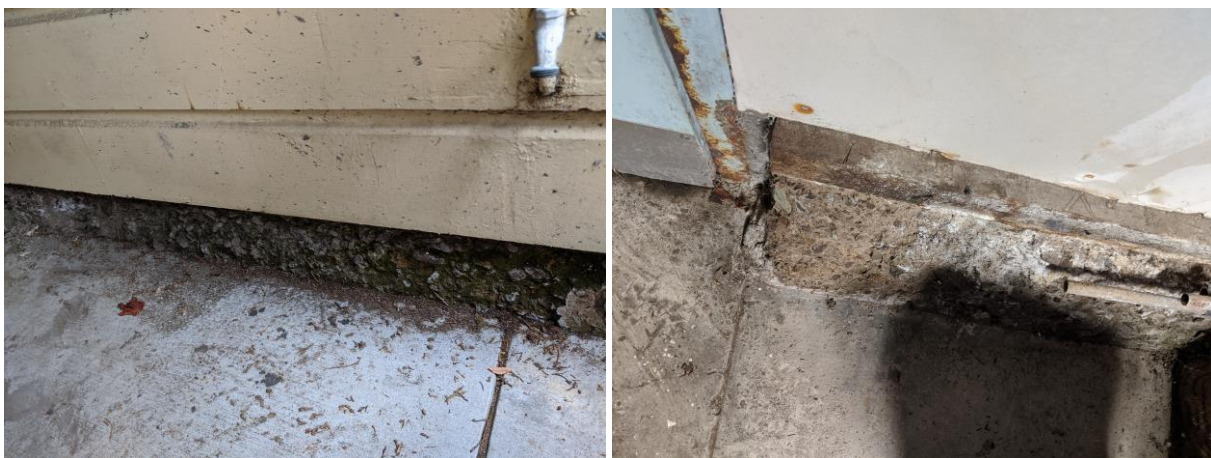
Building Condition: What could be observed of the structure of the building appeared to be in fair condition; however, most of the structure was concealed behind finishes. The concrete stem walls were poorly consolidated in many areas and some spalling was observed. The rear exterior wood siding and trim looked to be in fair condition. The rear wood exterior patio and stairs were in good condition. The front exterior siding appeared to be in good condition. The building underwent architectural renovations in 1988 and 2001, which included new paint and finishes. There was no structural work as a part of either project.

Figure 11 – Spalling of Concrete Stem Wall
