UCSF Building Seismic Ratings

1362 3RD AVENUE

CAAN #2273

Rating summary	Entry	Notes
UC Seismic Performance Level (rating)	V	Findings based on drawing review and ASCE 41-17 Tier 1 evaluation ¹
Rating basis	Tier 1	ASCE 41-17
Date of rating	2020	
Recommended UCSF priority category for retrofit	Priority B	Priority A = Retrofit ASAP Priority B=Retrofit at next permit application for modification
Ballpark total project cost to retrofit to IV rating	High	See recommendations on further evaluation and retrofit.
Is 2018-2019 rating required by UCOP?	Yes	
Further evaluation recommended?	No

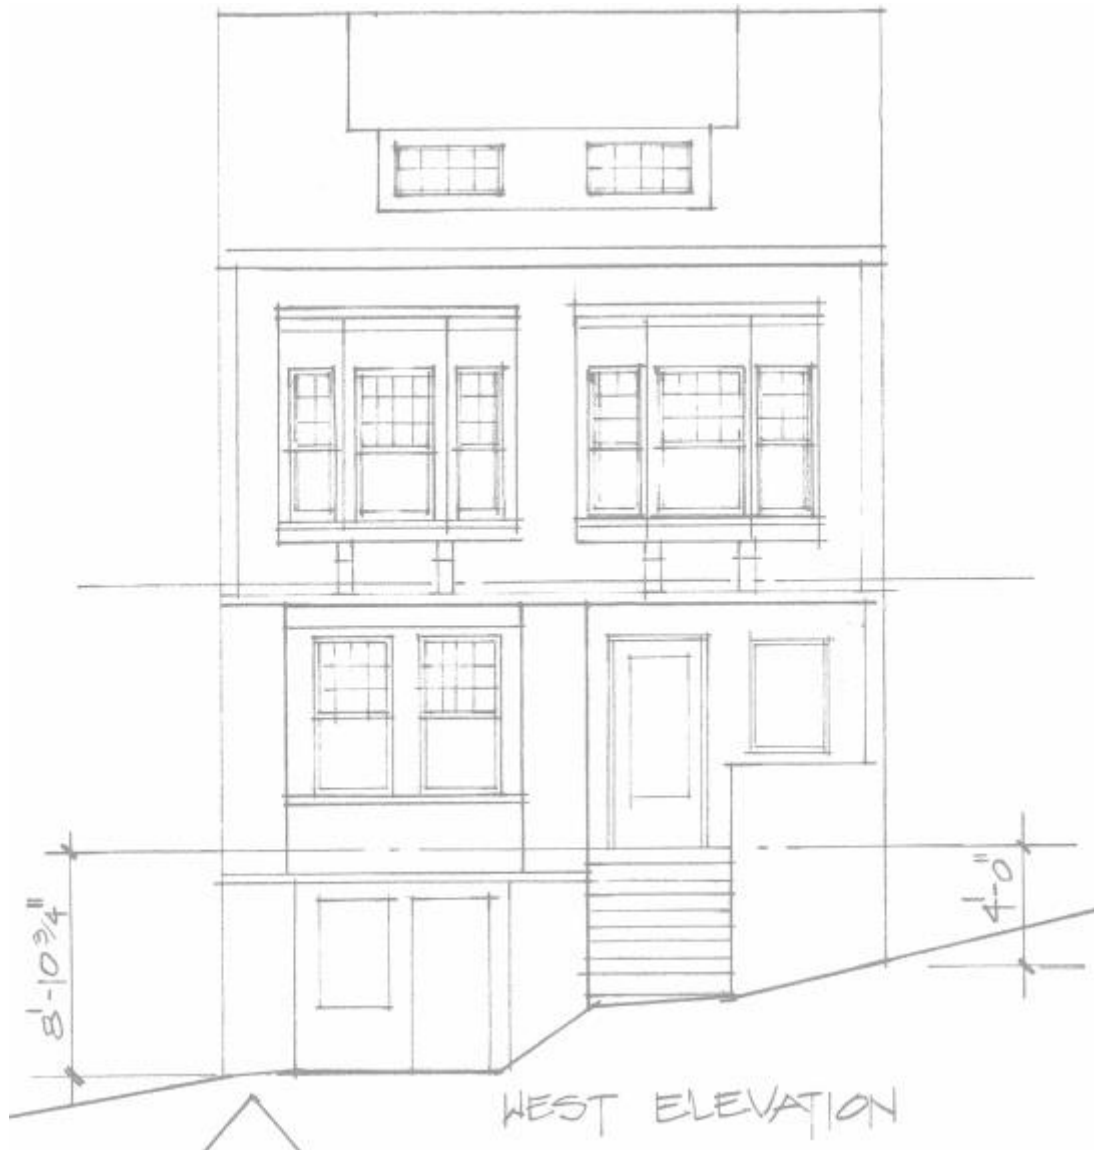
Figure 4 - Exterior Elevation (West Elevation)

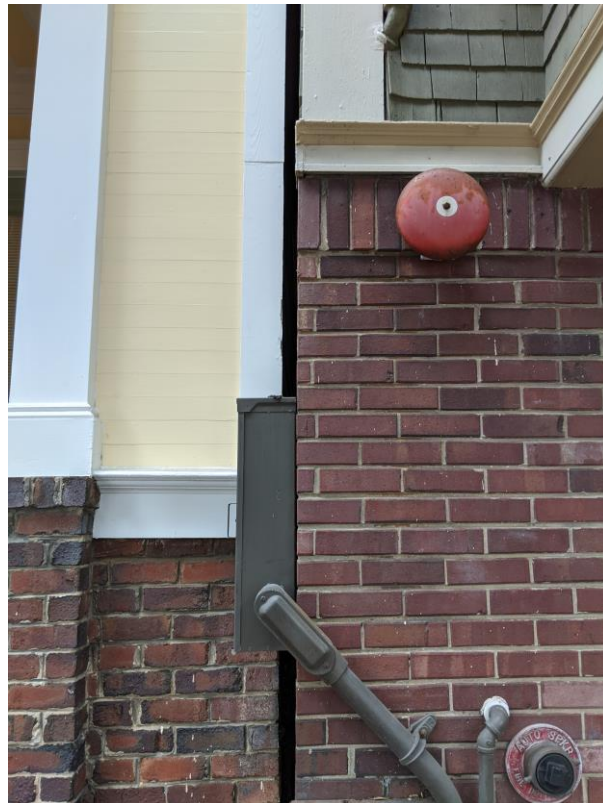
Figure 5 - Building Separation to the North (Left)

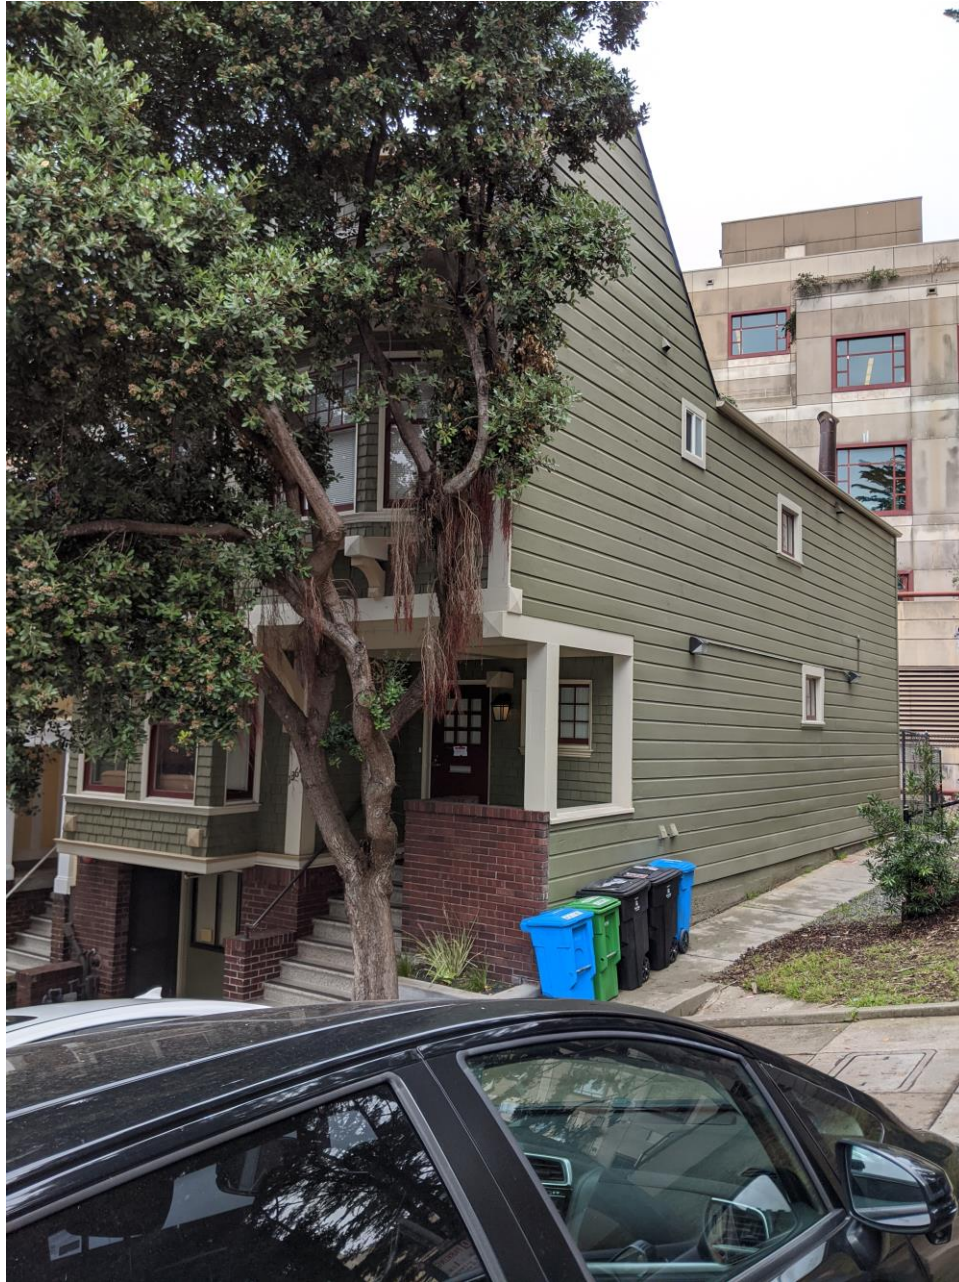
Figure 6 – South Exterior Wall

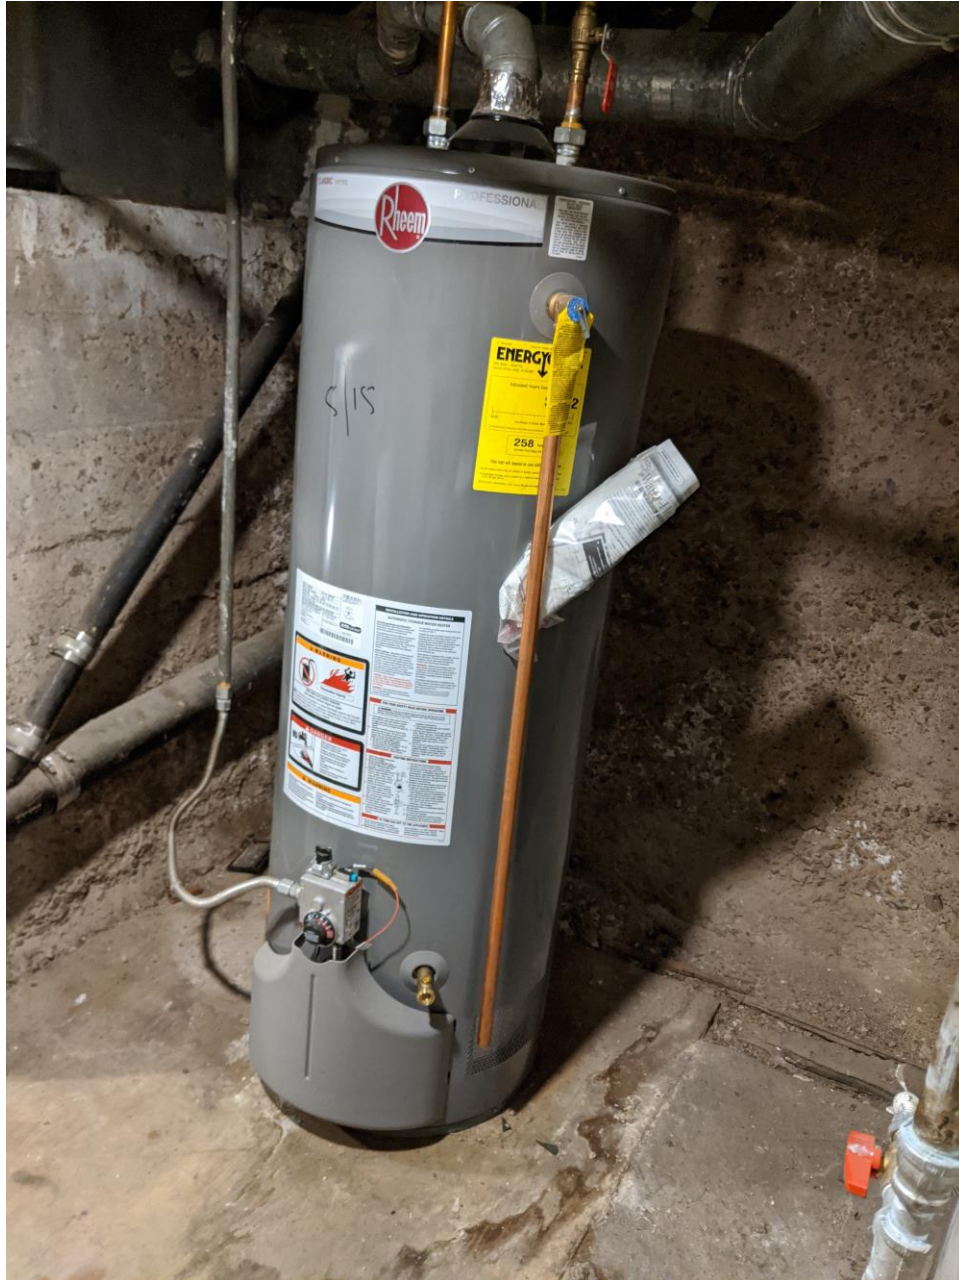
The water heater in the basement was unanchored but did have flex connections to the gas line. Bracing of the furnace was not observed, but it did have flex connections as well.

Figure 7 - Unanchored Water Heater in Basement

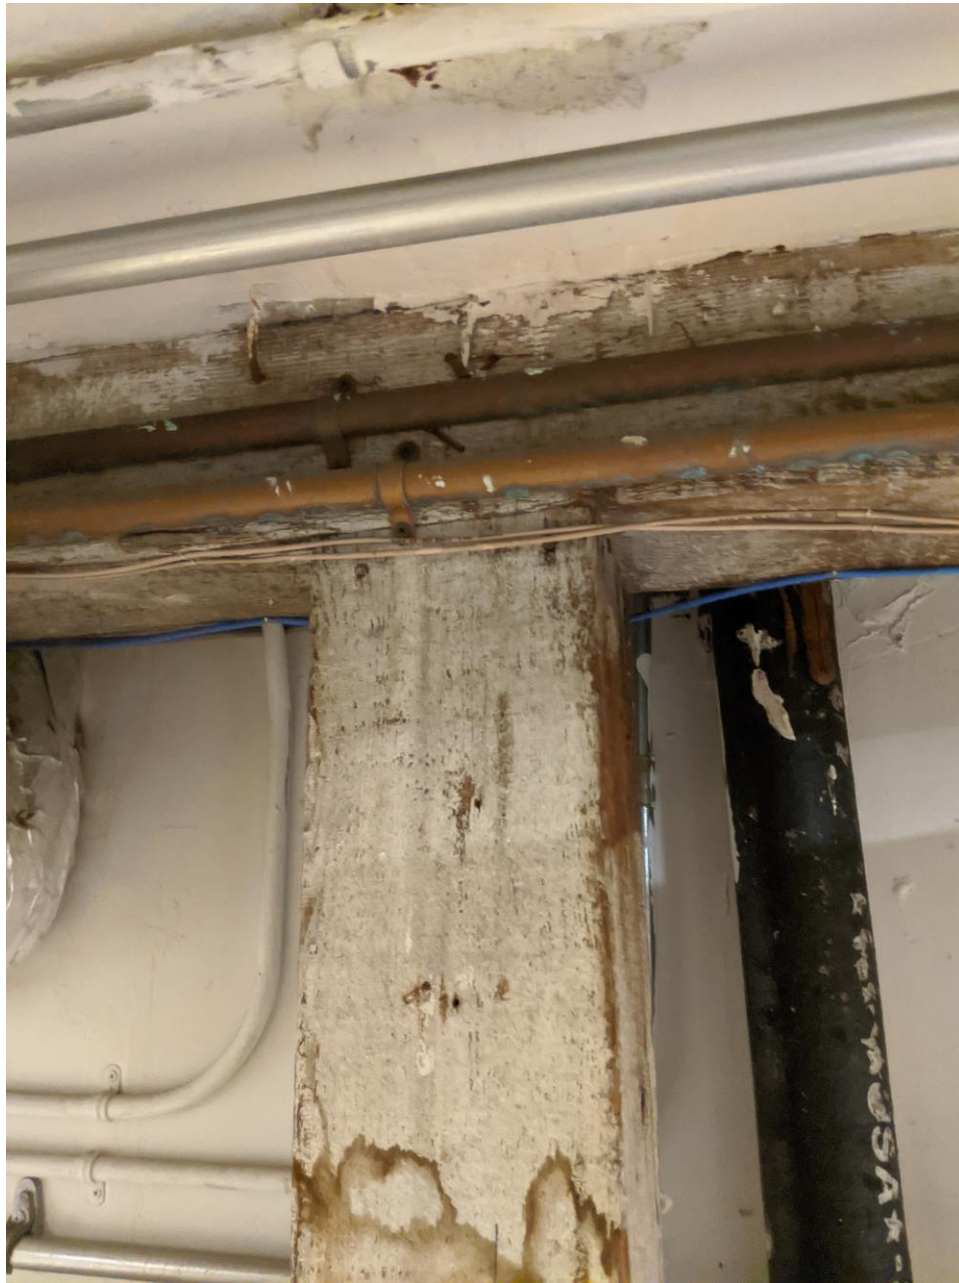
Figure 8 – Interior Basement Post and Beam without Positive Connections

Description				
C	NC	N/A	U	<input type="radio"/>	<input checked="" type="radio"/>	<input type="radio"/>	<input type="radio"/>	<p>WOOD POSTS: There is a positive connection of wood posts to the foundation. (Commentary: Sec. A.5.3.3. Tier 2: Sec. 5.7.3.3)</p> <p>Comments: Interior wood posts did not have positive connections to the foundation.</p>
C	NC	N/A	U	<input type="radio"/>	<input type="radio"/>	<input type="radio"/>	<input checked="" type="radio"/>	<p>WOOD SILLS: All wood sills are bolted to the foundation. (Commentary: Sec. A.5.3.4. Tier 2: Sec. 5.7.3.3)</p> <p>Comments: All wood sills in the basement space were concealed by plaster. However, based on the age of the building it is anticipated the wood sill bolting is not adequate.</p>
C	NC	N/A	U	<input type="radio"/>	<input checked="" type="radio"/>	<input type="radio"/>	<input type="radio"/>	<p>GIRDER-COLUMN CONNECTION: There is a positive connection using plates, connection hardware, or straps between the girder and the column support. (Commentary: Sec. A.5.4.1. Tier 2: Sec. 5.7.4.1)</p> <p>Comments: Girders did not have positive connections to columns.</p>

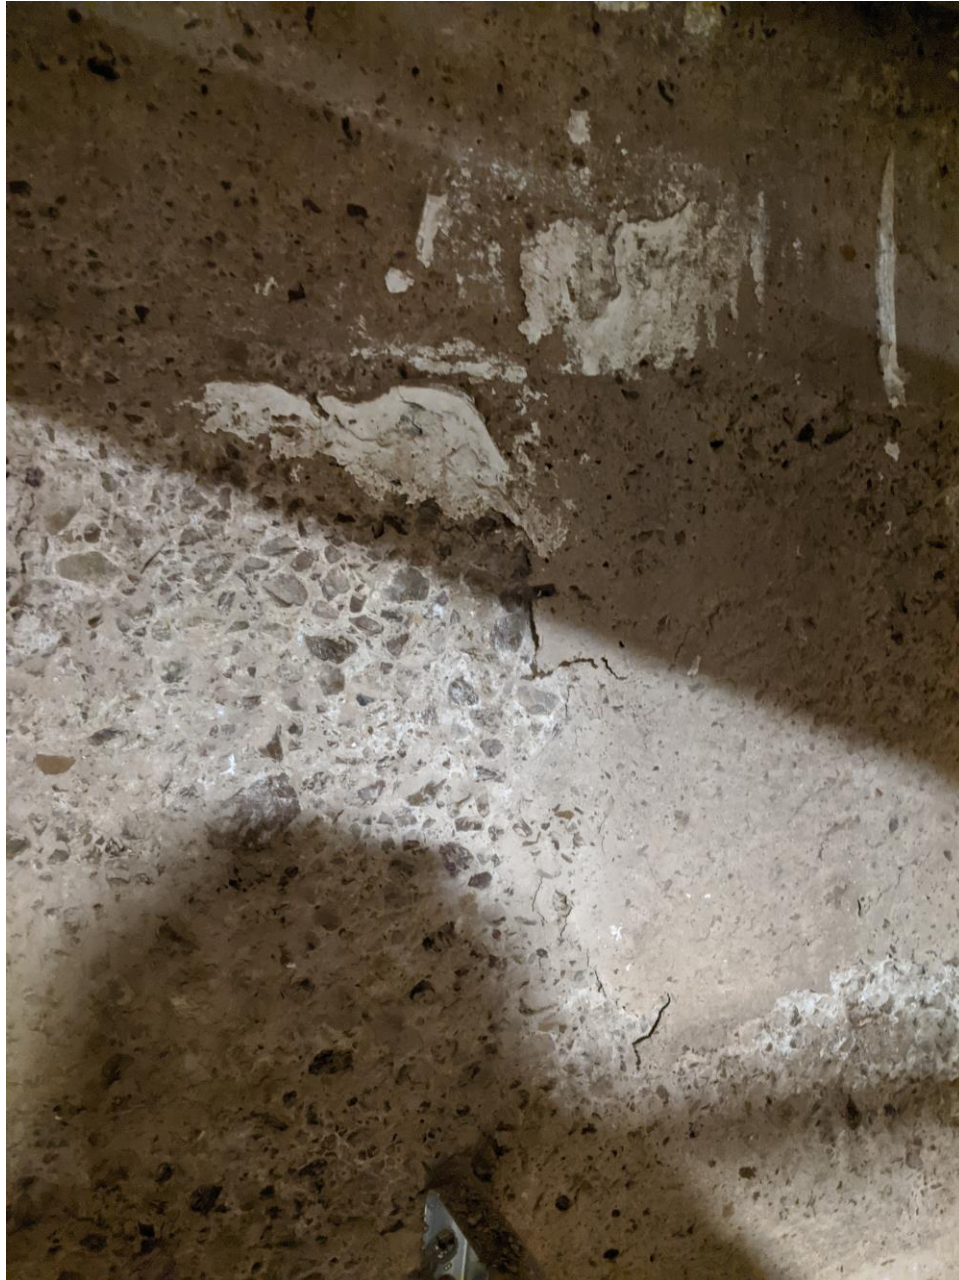
Building Condition: What could be observed of the structure of the building appeared to be in fair condition; however, most of the structure was concealed behind finishes. The concrete stem walls in the utility space were

poorly consolidated in many areas and some spalling was observed. The wood siding, trim, and rear wood exterior patio and stairs looked to be in good condition.

Figure 9 - Spalling of Concrete Stem Wall

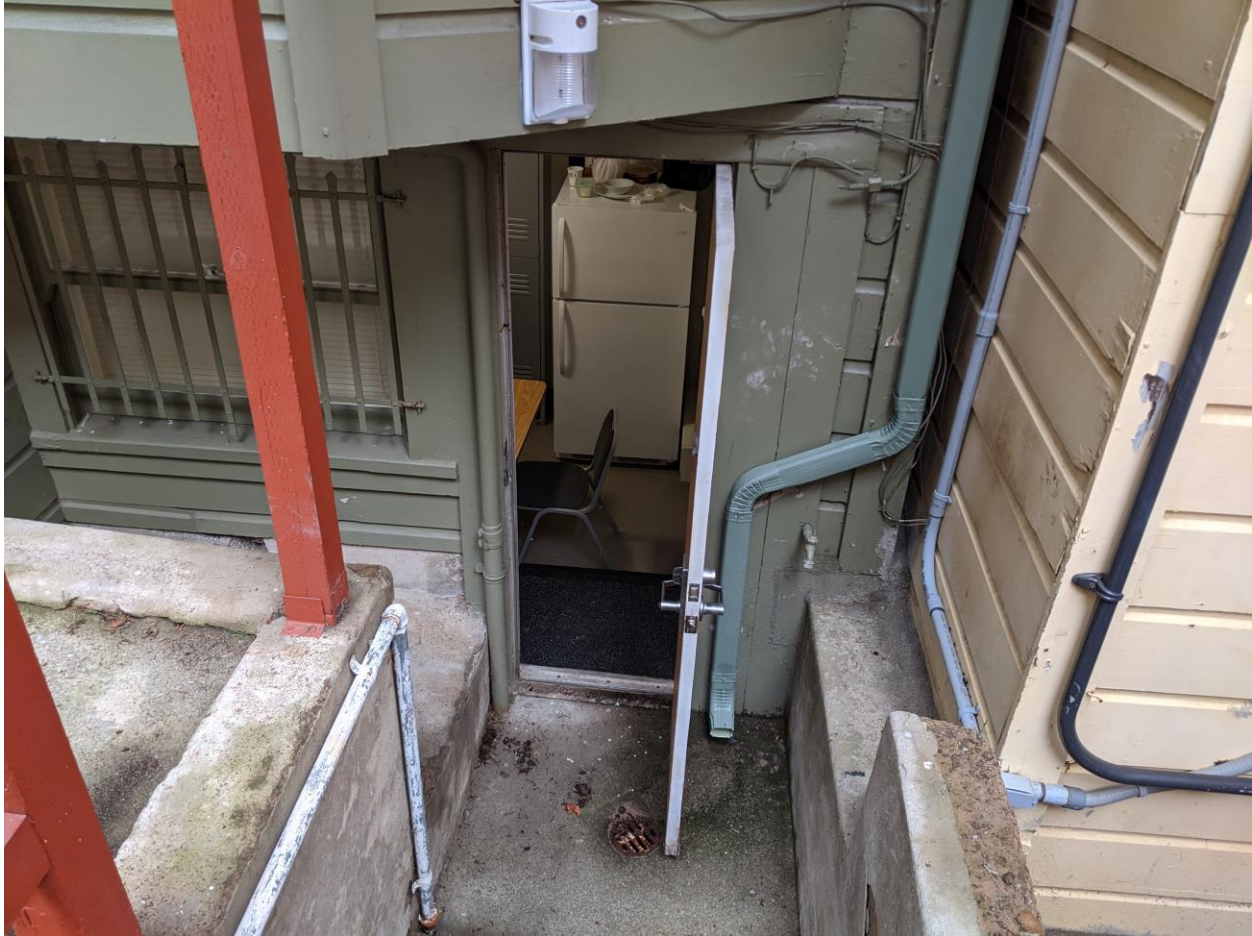
Figure 10 – Basement Rear Egress and Retaining Walls

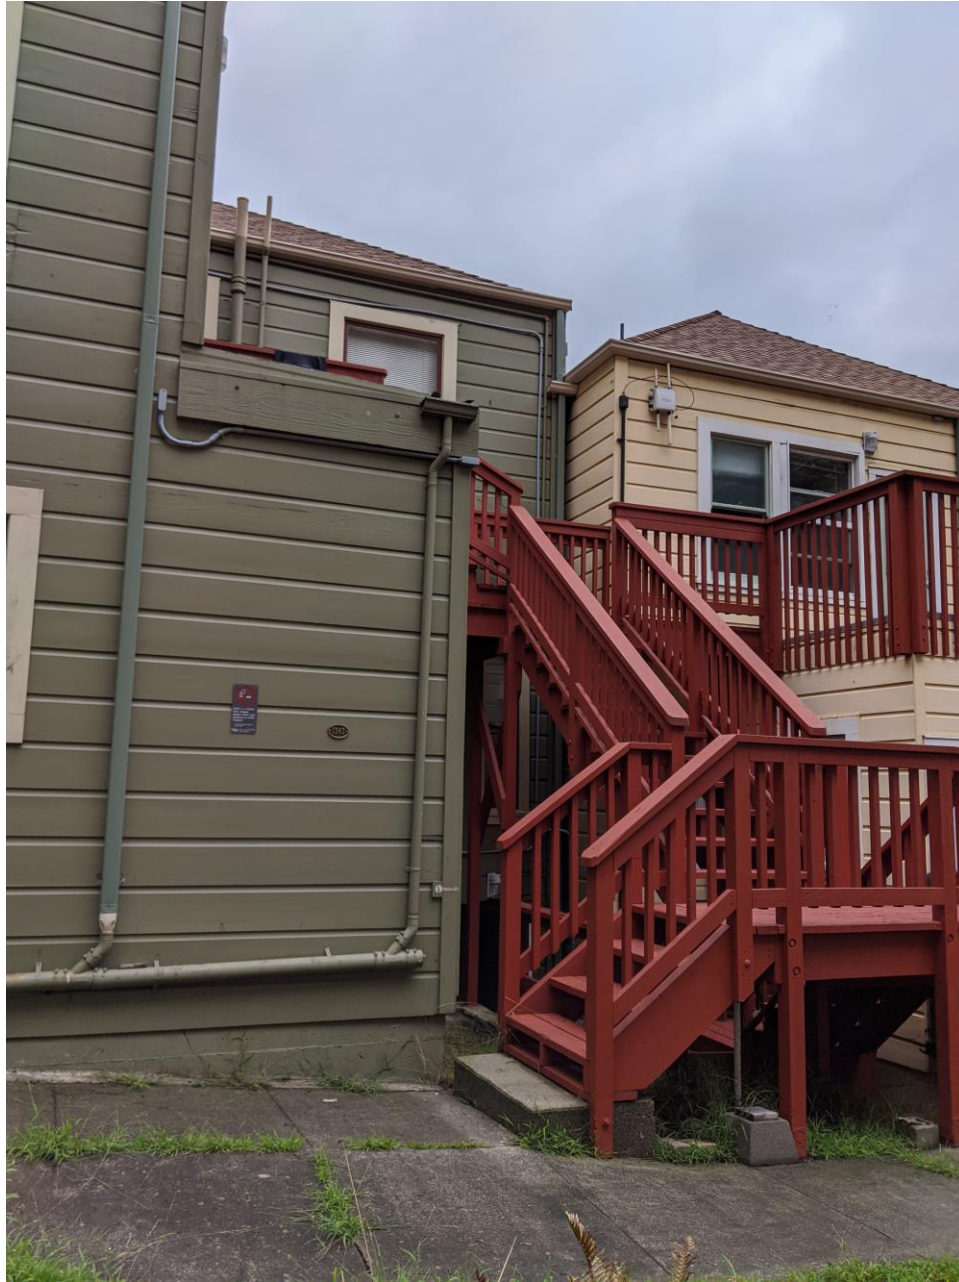
Figure 11- Rear of Building and Exterior Stair
