UCSF Building Seismic Ratings

1326 3RD AVENUE

CAAN #2276

1326 3rd AVENUE, SAN FRANCISCO, CA 94122

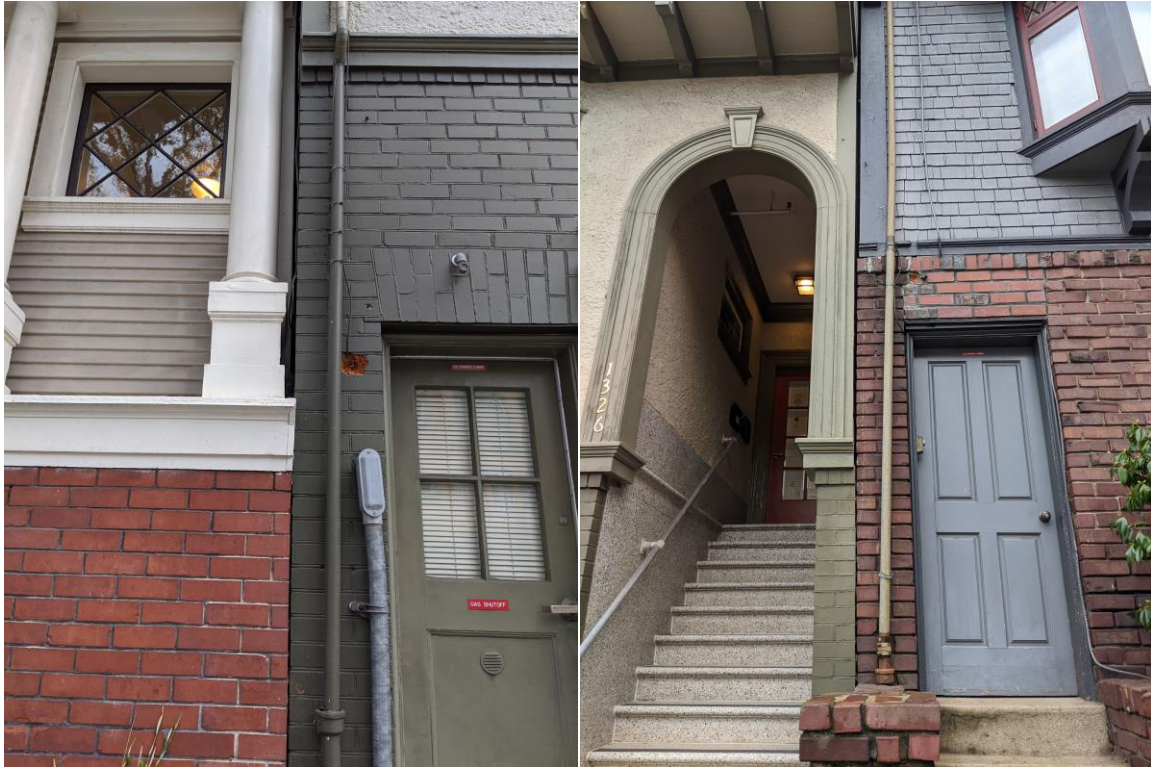
- The building is built to the property line with virtually no separation between the neighboring buildings to the north and south. The floor levels do not align with the adjacent buildings due to the sloped site.

Figure 6 - Building Separation to the North (Left) and South (Right)

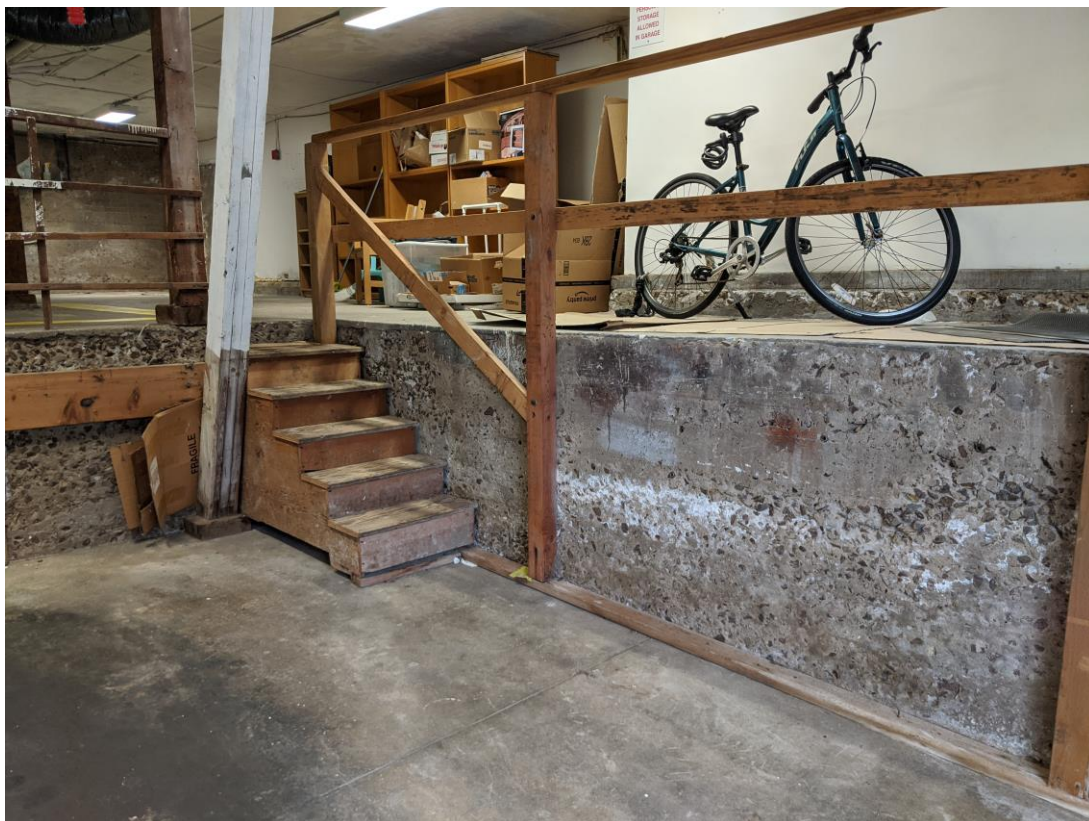
Building Condition: What could be observed of the building structure appeared to be in fair condition; however, most of the structure was concealed behind finishes. The wood around some windows had degraded. The stem wall concrete was poorly consolidated and there is extensive efflorescence and some spalling, especially at the rear of the basement. The exterior patio and stair on the south side of the house were in good condition, including the connector hardware.

Figure 7 – Concrete Condition at Garage Area

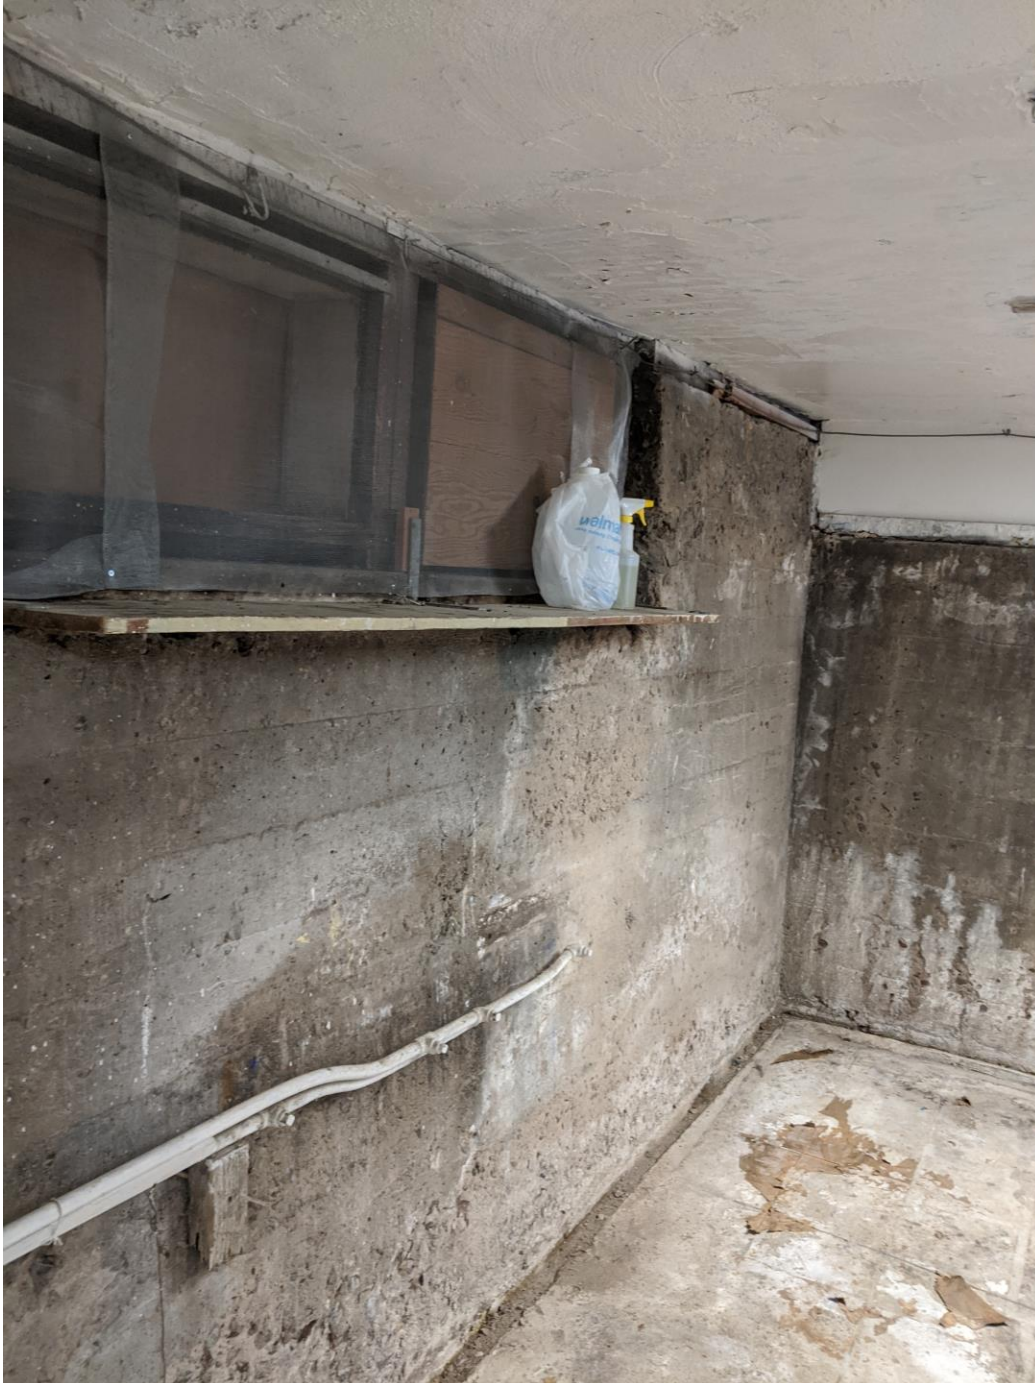
Figure 8 – Concrete Condition at Rear (East) Wall

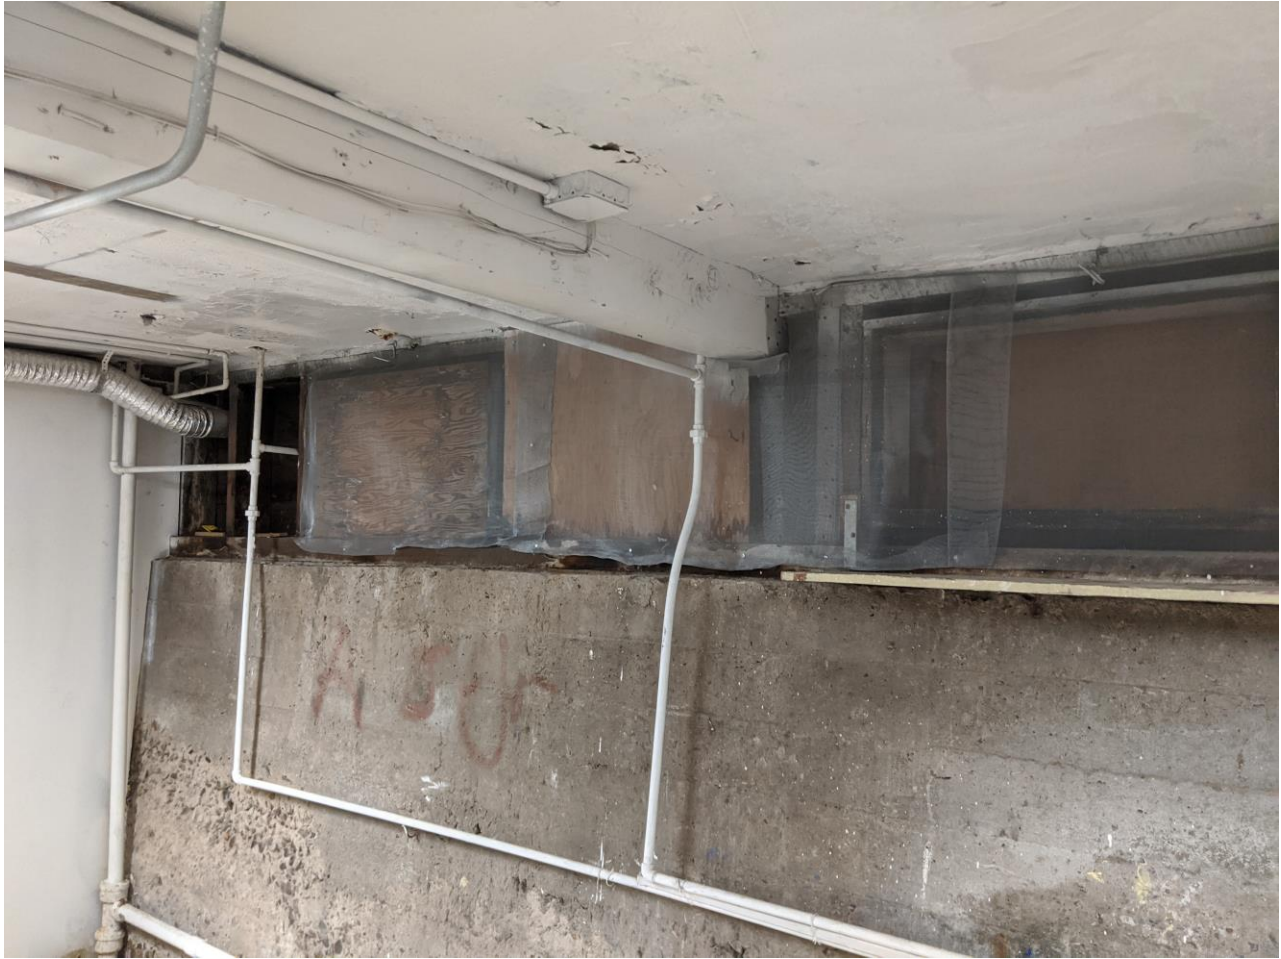
- The garage cripple walls were primarily sheathed with plaster and gypsum board. Where sheathing could be observed, it was straight on the side walls and diagonal on the street-side wall. No mudsill bolts were observed.

Figure 9 – Sheathing at Rear (East) Cripple Wall

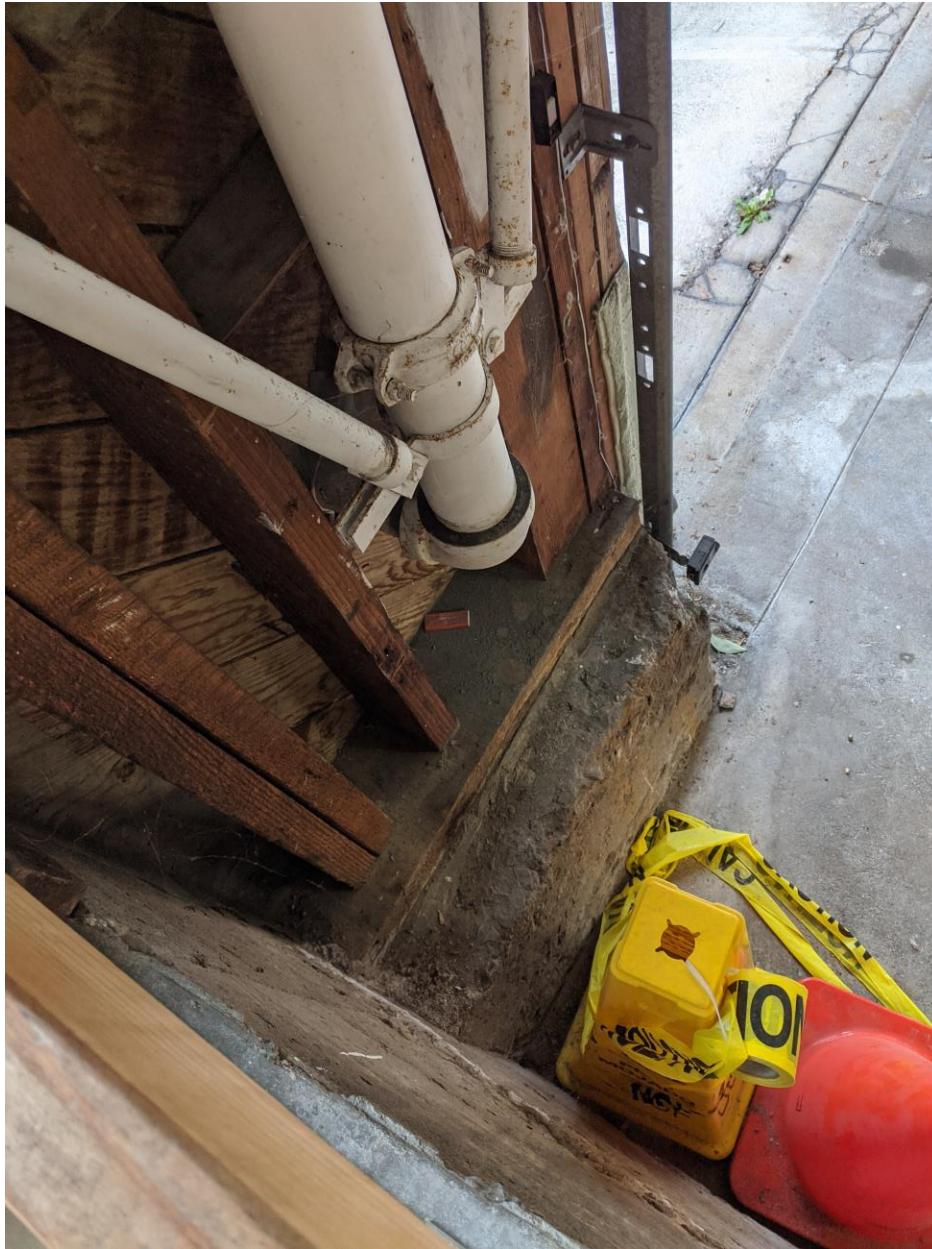
Figure 10 – Diagonal Sheathing at Front (West) Wall without Sill Bolts

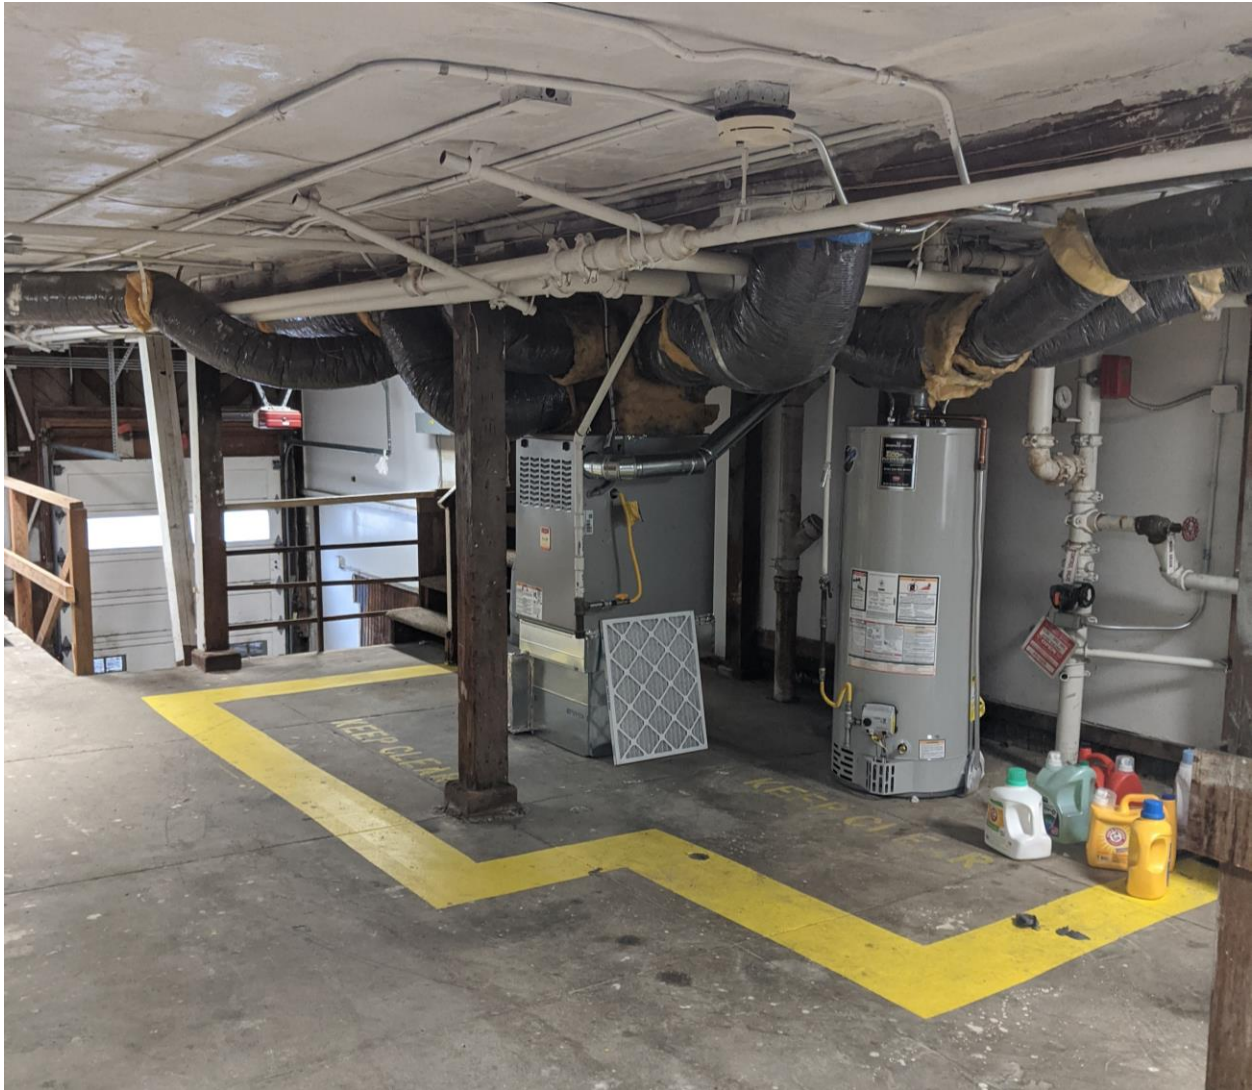
Anchorage or bracing of the basement water heater and furnace was not observed. The furnace did have a flexible connection to the gas line.

Figure 11 – Unanchored Furnace and Water Heater, both with Flexible Gas Lines
