07-24-2019

UCSF Building Seismic Ratings
Aldea San Miguel 8

CAAN #2308
105 Behr Avenue, San Francisco, CA 94131
UCSF Campus: Parnassus

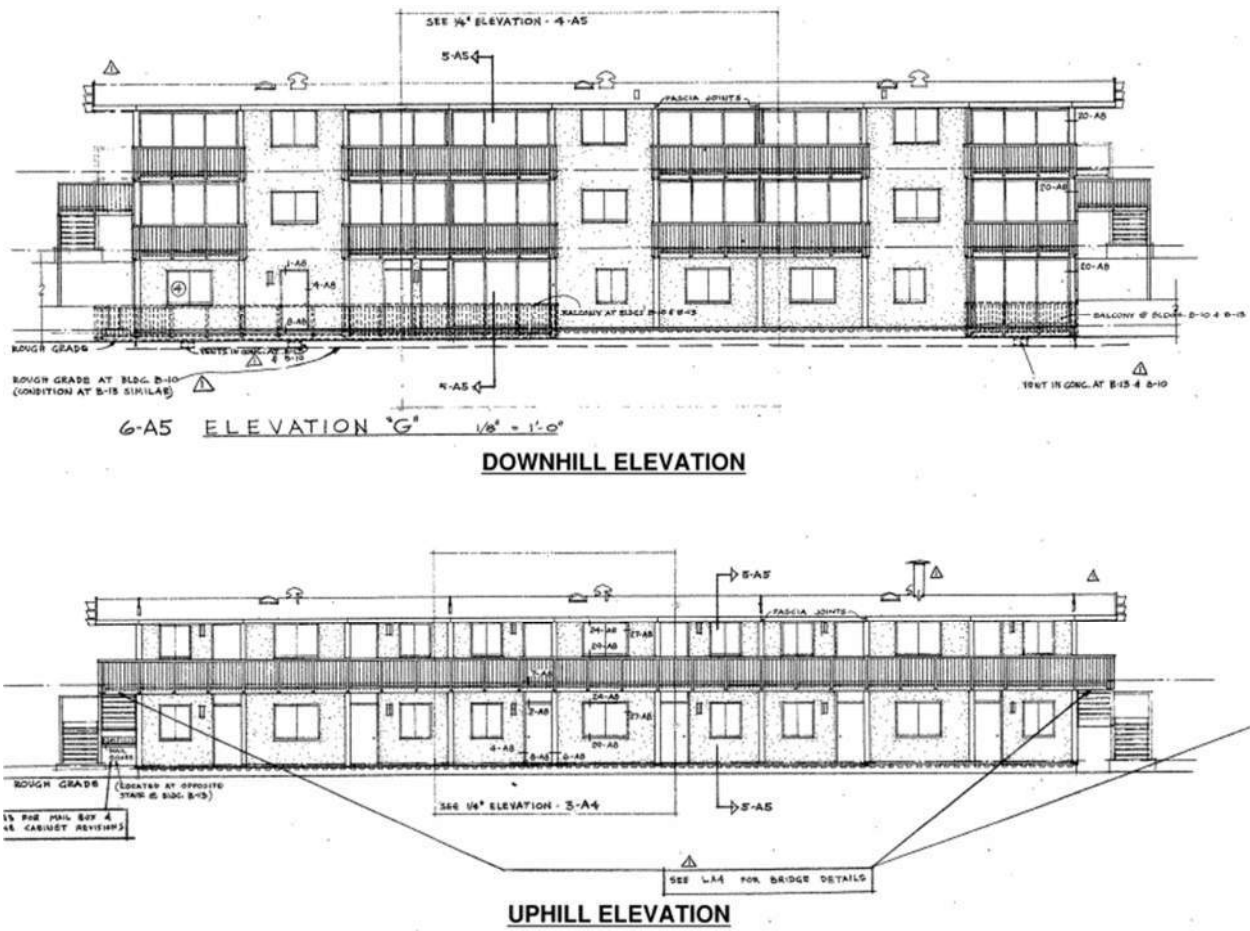
Figure 1. – Exterior Longitudinal Elevations

- The interior plywood shear walls in the longitudinal direction are discontinuous at the first floor.
- In a quick check of the lateral-force-resisting system, the shear walls do not have adequate shear capacity. See further evaluation of the lateral system below.
- Due to window openings, the exterior longitudinal walls have aspect ratios greater than 2:1.
- On the downhill slope of the building, the exterior longitudinal walls have aspect ratios greater than 1:1 due to window openings.

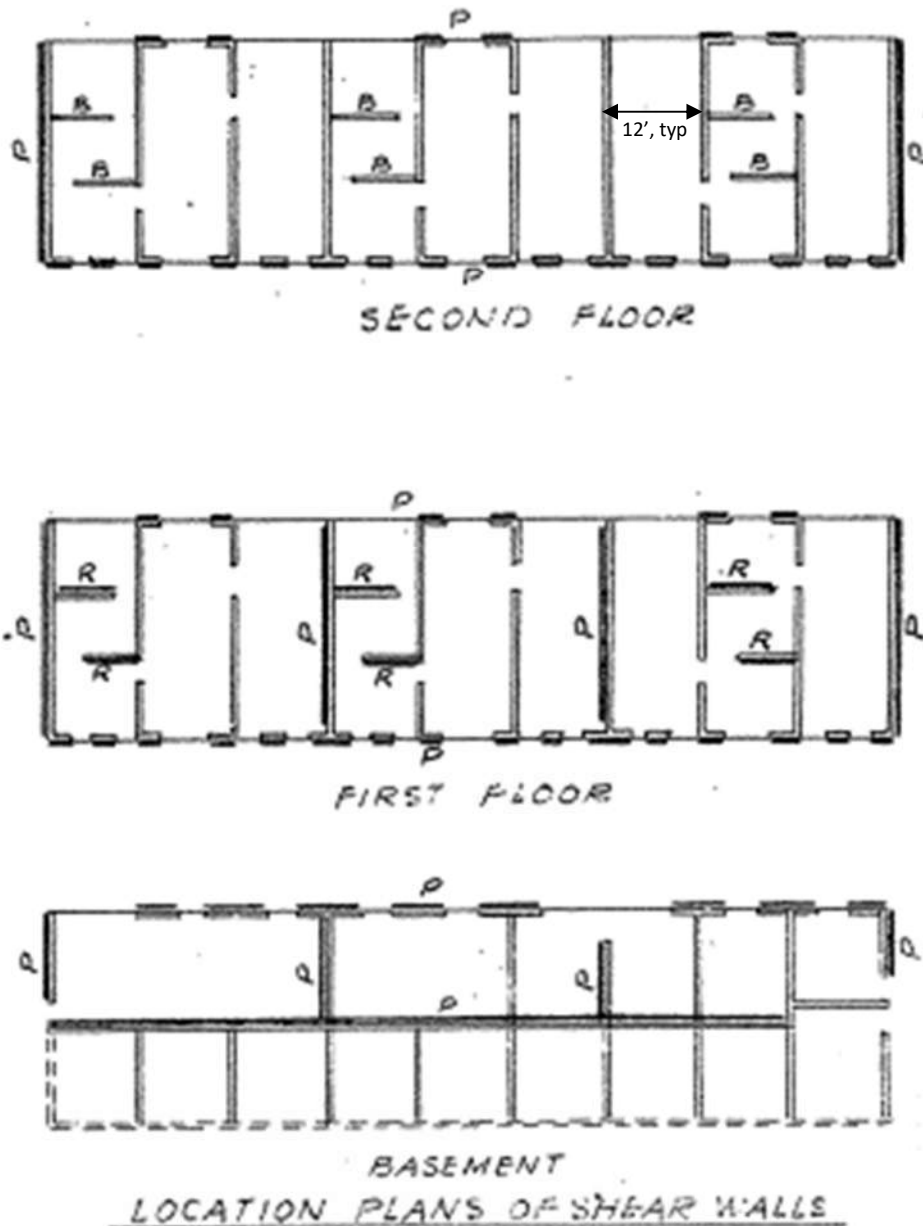
Figure 3. – Location of Vertical Lateral-Force-Resisting Elements

In the longitudinal direction, at the top story, the let-in braces were ignored and it was assumed that the force is resisted by the exterior plywood shear walls. At the ground floor, it was assumed one-quarter of the lateral force was distributed to the foundation directly due to the hillside slope, one-half was distributed to the middle shear wall, and one-quarter was distributed to the downhill slope exterior wall.

In the transverse direction, at the top story, it was assumed that the interior gypsum wallboard walls participated to cut down the span and aspect ratio of the straight-sheathed diaphragms. At the ground level, it was assumed that half the force was distributed to the foundation directly due to the hillside slope, while the other half is resisted by the plywood shear walls.

Walls marked "B" to have 1" x 8" let-in brace. Nail 3-10^d per stud & 5-10^d @ ends
 Walls marked "P" & "R" to be sheathed sill to plate with $\frac{3}{8}$ " plywood. Nail 8^d @ 4" c.c.
 along all plywood sheaf edges & 8^d @ 12" c.c. intermediate nailing See

for hold-down &
 each end of shear walls marked "R".
