07-24-2019

UCSF Building Seismic Ratings
Aldea San Miguel 10

CAAN #2310
175 Johnstone Drive, San Francisco, CA 94131
UCSF Campus: Parnassus

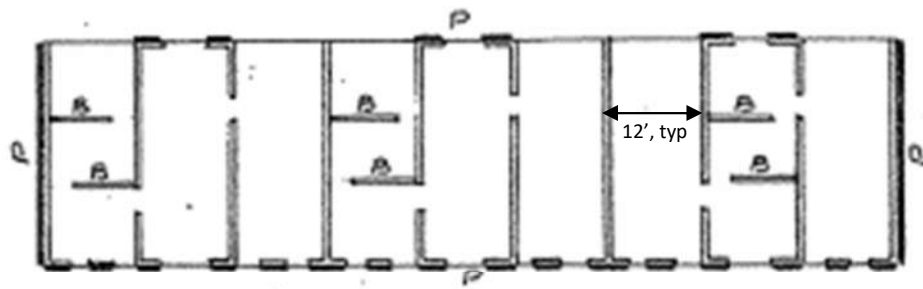
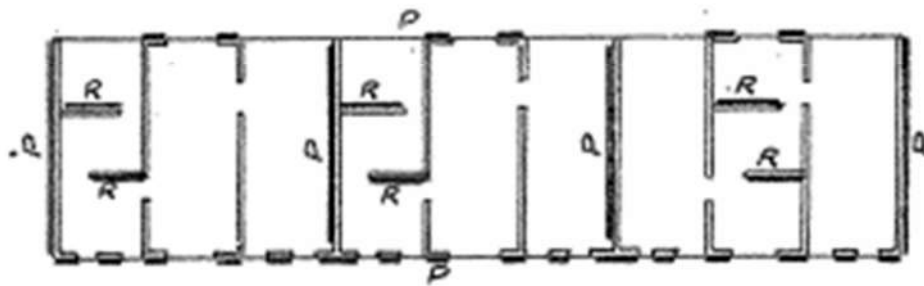
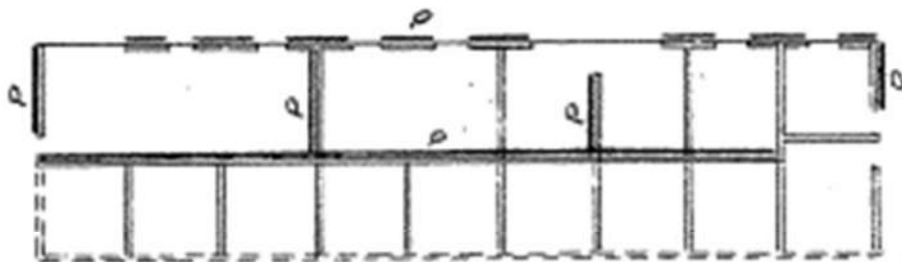
Figure 3. – Location of Vertical Lateral-Force-Resisting Elements

- The interior plywood shear walls in the longitudinal direction are discontinuous at the first floor.
- In a quick check of the lateral-force-resisting system, the shear walls do not have adequate shear capacity. See further evaluation of the lateral system below.
- Due to window openings, the exterior longitudinal walls have aspect ratios greater than 2:1.
- On the downhill slope of the building, the exterior longitudinal walls have aspect ratios greater than 1:1 due to window openings.

Comments:
Interior longitudinal walls are discontinuities at the first floor.
