07-24-2019

UCSF Building Seismic Ratings
Aldea San Miguel 12

CAAN #2312
165 Johnstone Drive, San Francisco, CA 94131
UCSF Campus: Parnassus

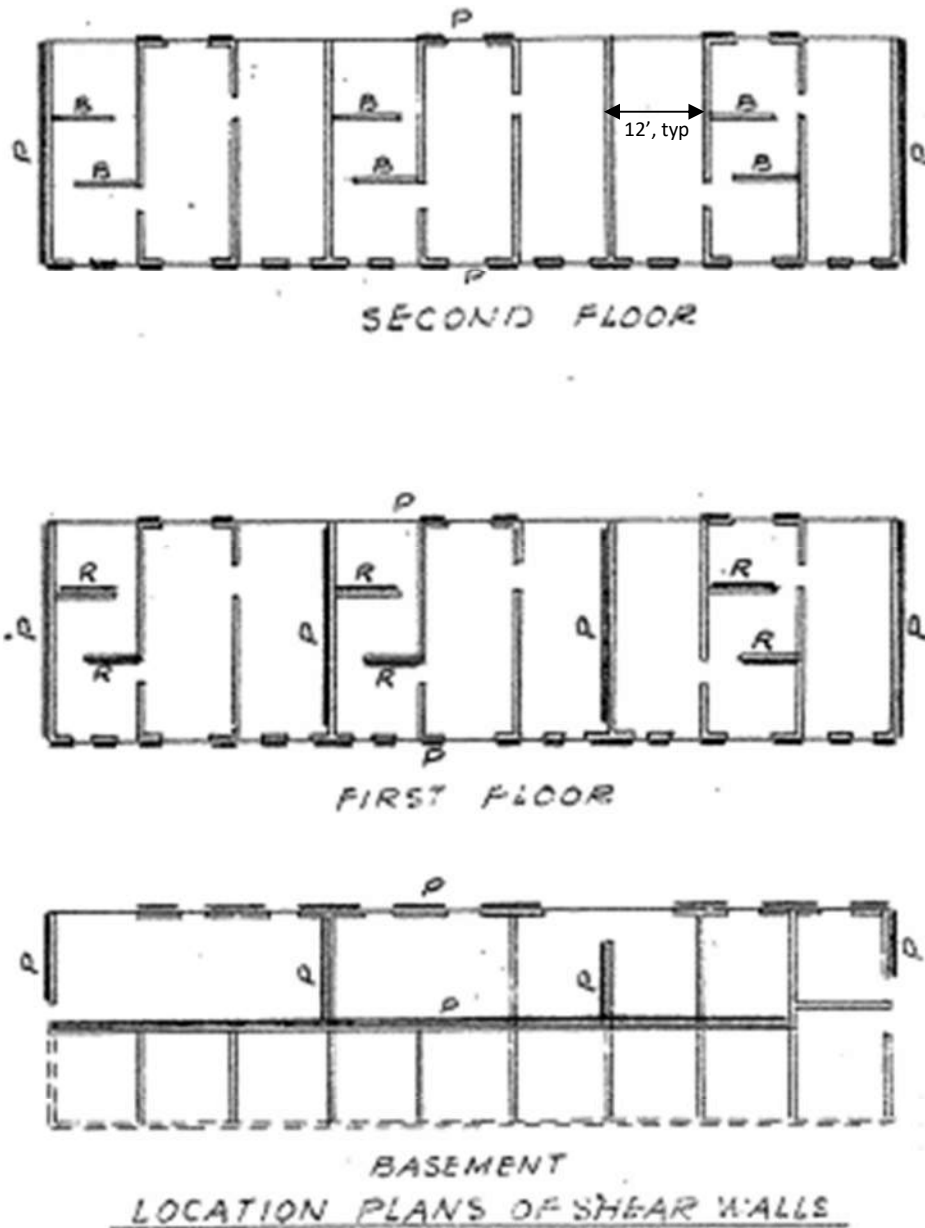
Figure 3. – Location of Vertical Lateral-Force-Resisting Elements

- The interior plywood shear walls in the longitudinal direction are discontinuous at the first floor.
- In a quick check of the lateral-force-resisting system, the shear walls do not have adequate shear capacity. See further evaluation of the lateral system below.
- Due to window openings, the exterior longitudinal walls have aspect ratios greater than 2:1.
- On the downhill slope of the building, the exterior longitudinal walls have aspect ratios greater than 1:1 due to window openings.

Walls marked "B" to have 1" x 8" let-in brace. Nail 3-10^d per stud & 5-10^d @ ends
 Walls marked "P" & "R" to be sheathed sill to plate with $\frac{3}{8}$ " plywood. Nail 6^d @ 4" c.c. along all plywood sheaf edges & 8^d @ 12" c.c. intermediate nailing See

for hold-down @ each end of shear walls marked "R".
