UCSF Building Seismic Ratings

Koret Vision Research

CAAN #2325

10 Koret Way, San Francisco UCSF

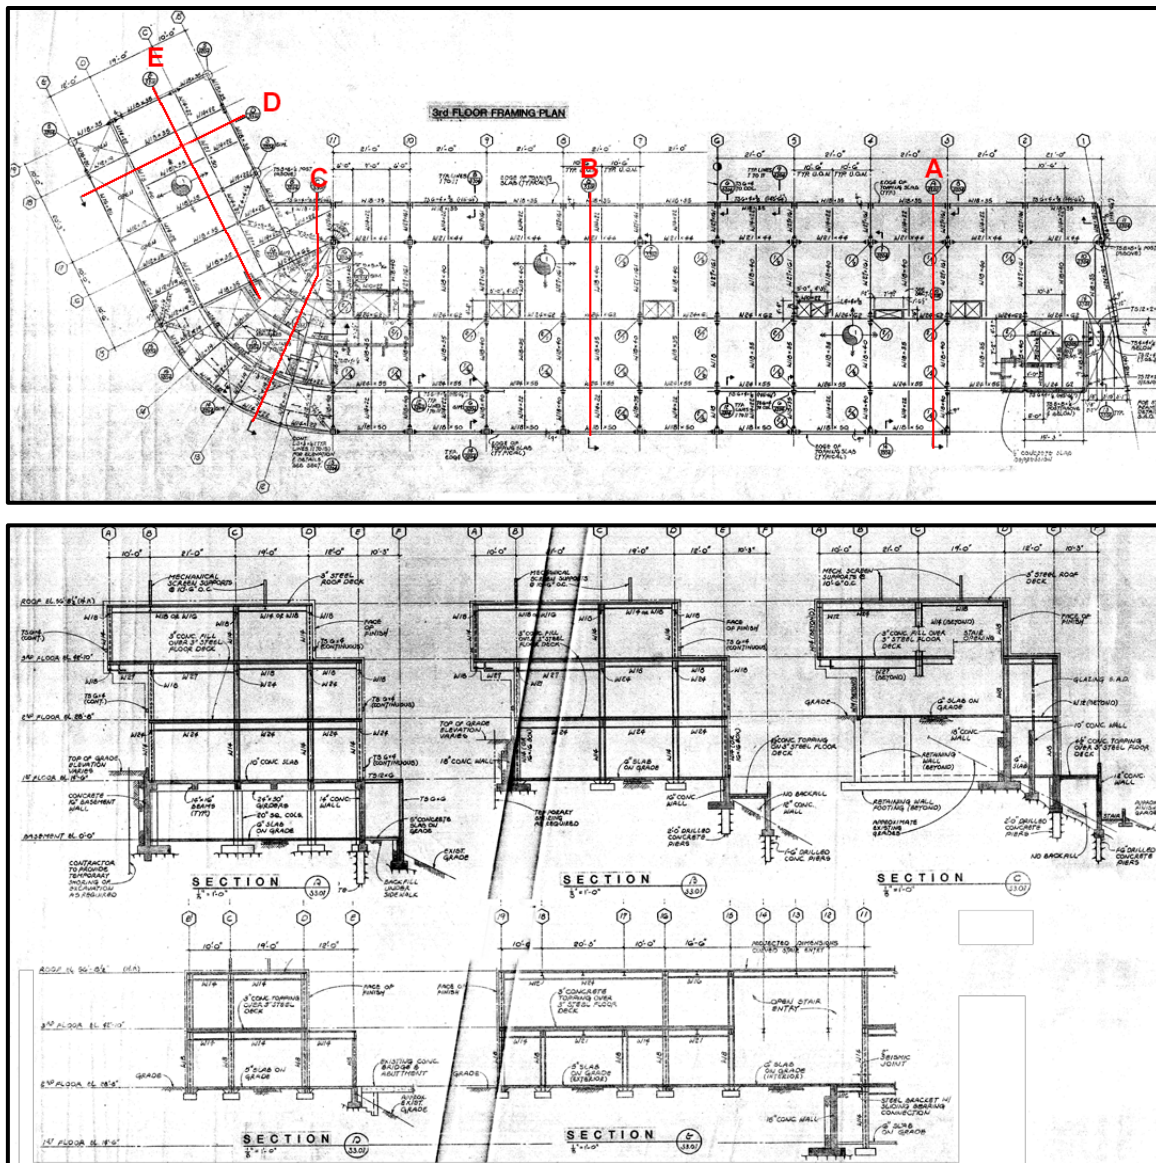
resisting frames. The welded steel moment frame (WSMF) portion of structure is partially constructed over a reinforced concrete basement with perimeter reinforced concrete walls. The upper three-story longitudinal section is a fully-distributed frame, with 3 bays by 11 bays on the long arm, See Figure 2. The frames are detailed in a pre-Northridge manner typical of the time, see Figure 3. The basement is of massive reinforced construction. The building is sufficiently separated from adjacent buildings that they are not expected to be subjected to pounding and possible damage from their interaction.

Figure 2. The upper image shows the third floor framing plan showing the steel framing. The red lines and letters indicate the cross-sections of the lower image.

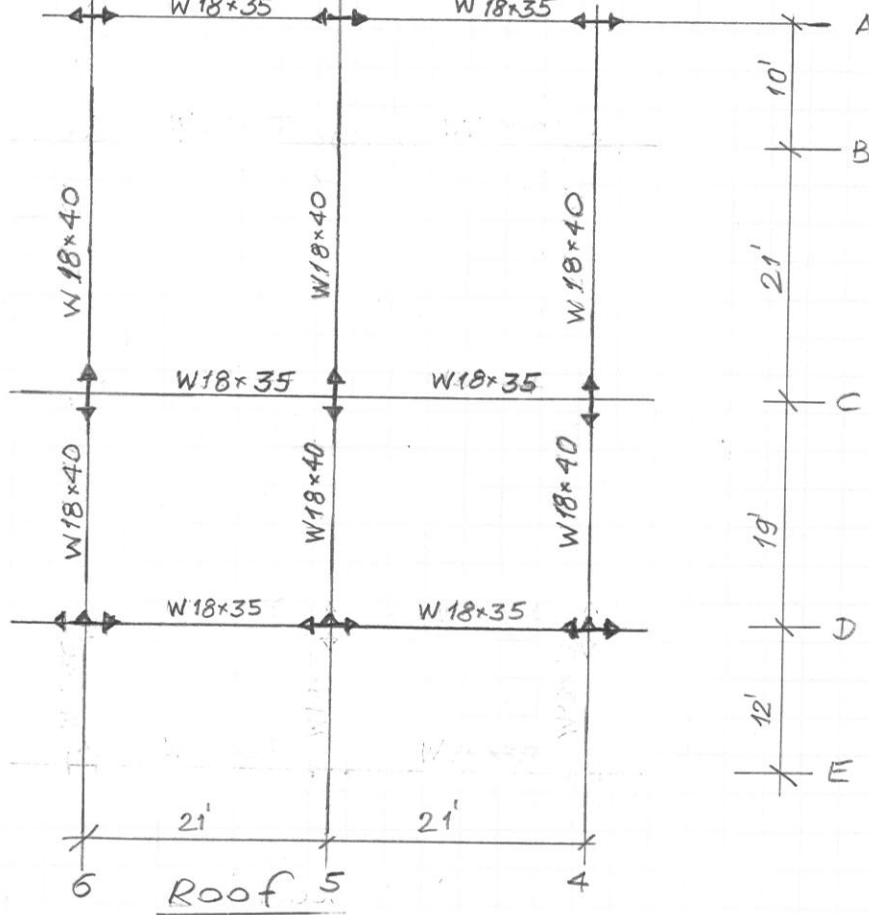
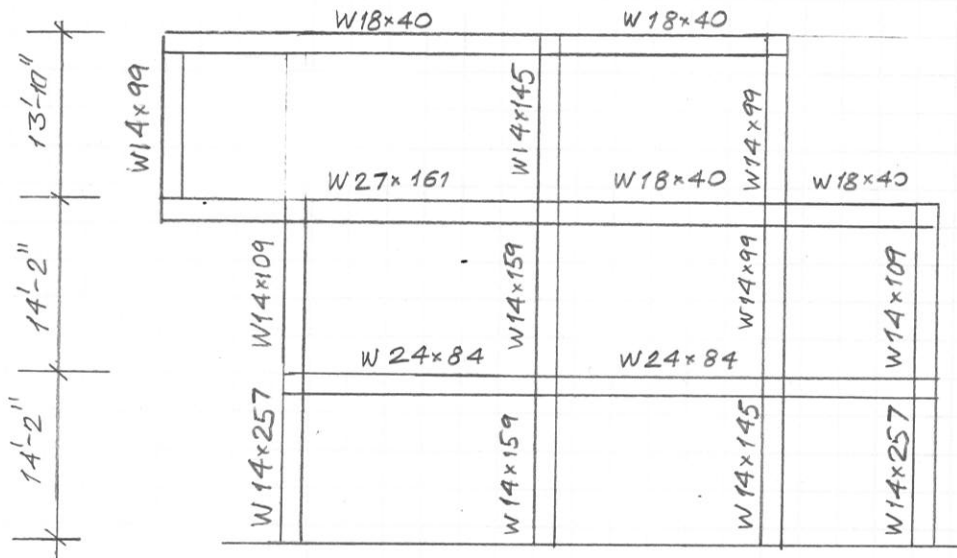
Figure 3. Typical details for the WSMF connections. They are typical of pre-Northridge practice. They were not observed but typical experience at this time indicates that the run-off tabs and backing bars used in welding the joint are still in place.

The building's principal steel lateral load-resisting system is a pre-Northridge WSMF, see Figure 3. The PGA at the site in 1989 Loma Prieta earthquake was measured as 0.09g horizontal peak acceleration by instruments in the adjacent UCSF Nursing Building. The SAC WSMF inspection for WSMF buildings experiencing earthquakes includes three criteria: a magnitude threshold, a specified measured or estimated PGA at the building site, and physical observations of building's impacts as the means of determining whether a building frame's steel joints should be inspected for possible damage, [FEMA, 1996]. The magnitude threshold by the site PGA was more than 50% lower than the trigger point. We examined the condition of the concrete, and gypsum board and found no indications in protected areas (from use and maintenance) of any signs of cracking, whether present or repaired, that would indicate interstory displacements sufficient to suggest that inspection of welded joints is warranted. Telesis has discovered a number of previously unidentified damaged WSMF buildings in the Bay Area by such observations, but they were all at this distance from the epicenter located on soft soil sites. The site here is stiff. The McGinnis Chen 1993 report concentrated on water proofing issues in the building's exterior, which were resolved, and apparently not related to the 1989 seismic response of the building. The building is not subject to inspection for WSMF connection integrity by the SAC criteria.
