11-05-2019

UCSF Building Seismic Ratings
University House

CAAN #2407
66 Johnstone Drive, San Francisco, CA 94131
UCSF Campus: Parnassus

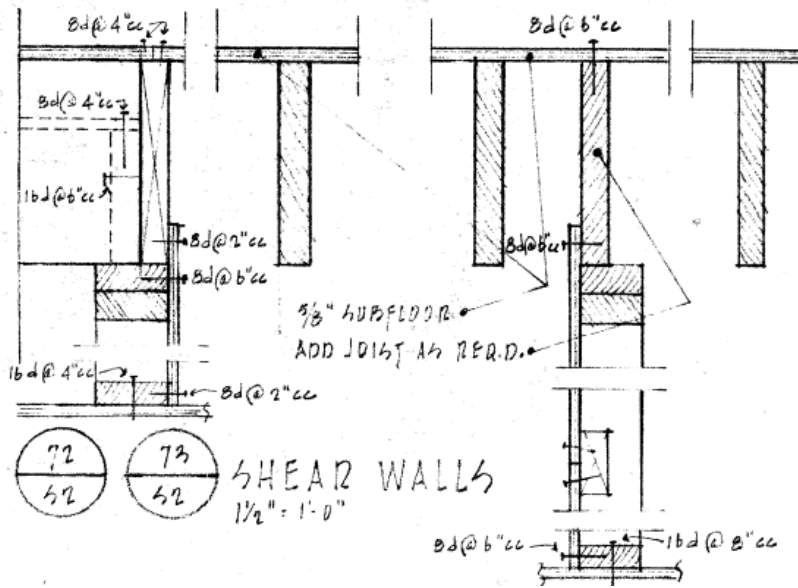
Figure 4 - Typical Shear Wall Details

Structural system for lateral forces: There is a blocked plywood diaphragm at the roof, upper floor, and lower floor with 8d @ 6" on center edge nailing and 8d @ 12" on center field nailing. The vertical component of the lateral force-resisting system is the plywood shear walls. The existing drawings call for 6" edge nailing and connections through to the structure below. The drawings do not show holdowns between floors, and no holdowns were observed in the site visit.

- There are no holdowns at the shear walls. The distribution of walls and total length of wall will help to reduce the overturning forces. However, local shear wall damage is expected at the ends of some shear walls. Such damage is not expected to pose a significant safety concern.
- The building is located on a hillside. There is a substantial amount of wall in the longitudinal direction at the crawl space level. There are some wall piers at the lower level with aspect ratios greater than 1:1 with a maximum width-to-height ratio of 1.3:1. The amount of wall on this level and relatively low stresses will limit the potential for adverse effects from the sloping site.

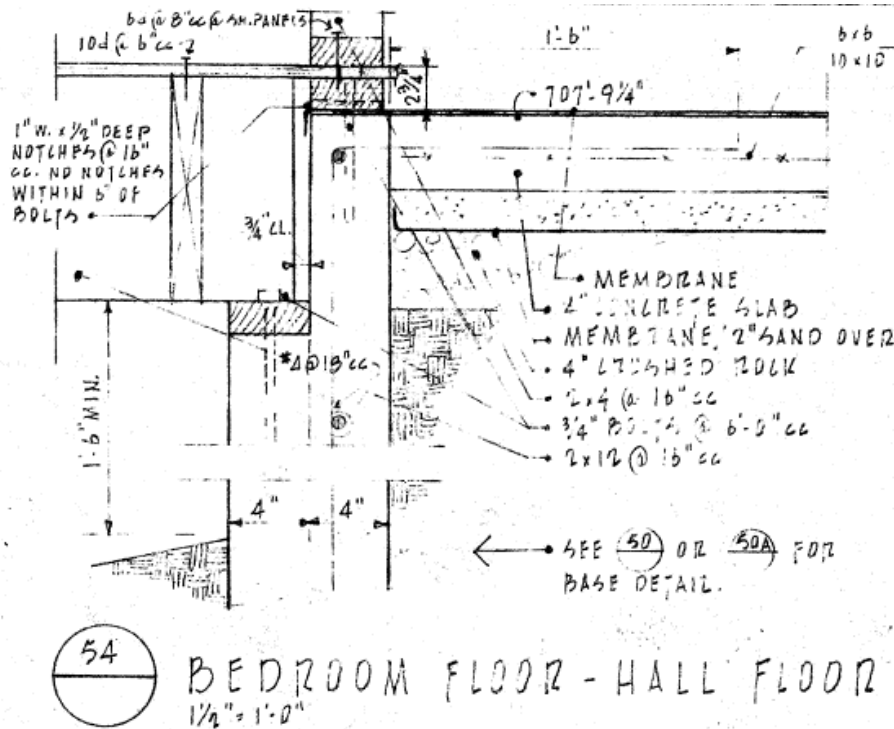
Figure 5 - Lower Floor Anchorage to Foundation at South Wall

C <input checked="" type="radio"/>	NC <input type="radio"/>	N/A <input type="radio"/>	U <input type="radio"/>	<p>WOOD SILLS: All wood sills are bolted to the foundation. (Commentary: Sec. A.5.3.4. Tier 2: Sec. 5.7.3.3)</p> <p>Comments:</p> <p style="padding-left: 40px;">Wood sills are anchored at 4' on center. This is shown on the drawings and was verified in the field.</p>
C <input checked="" type="radio"/>	NC <input type="radio"/>	N/A <input type="radio"/>	U <input type="radio"/>	<p>GIRDER-COLUMN CONNECTION: There is a positive connection using plates, connection hardware, or straps between the girder and the column support. (Commentary: Sec. A.5.4.1. Tier 2: Sec. 5.7.4.1)</p> <p>Comments:</p>

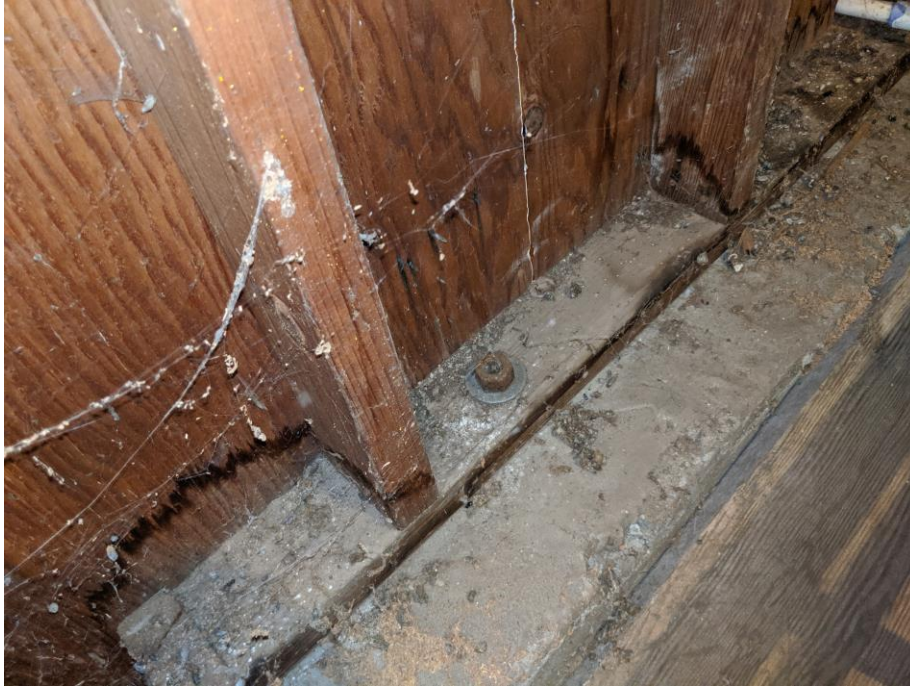
Figure 10 - Crawl Space Anchor Bolts, Plywood Sheathing

Building Condition: Good. The building appears to be well maintained. There was some minor rusting on the nuts of shear wall anchor bolts, and water staining of wood in the crawl space was observed. Repairs to decks, stairs, and retaining walls were made in 2016.
