## UCSF building seismic ratings

### School of Dentistry, University of California San Francisco

CAAN #2412

DATE: 2020-06-26

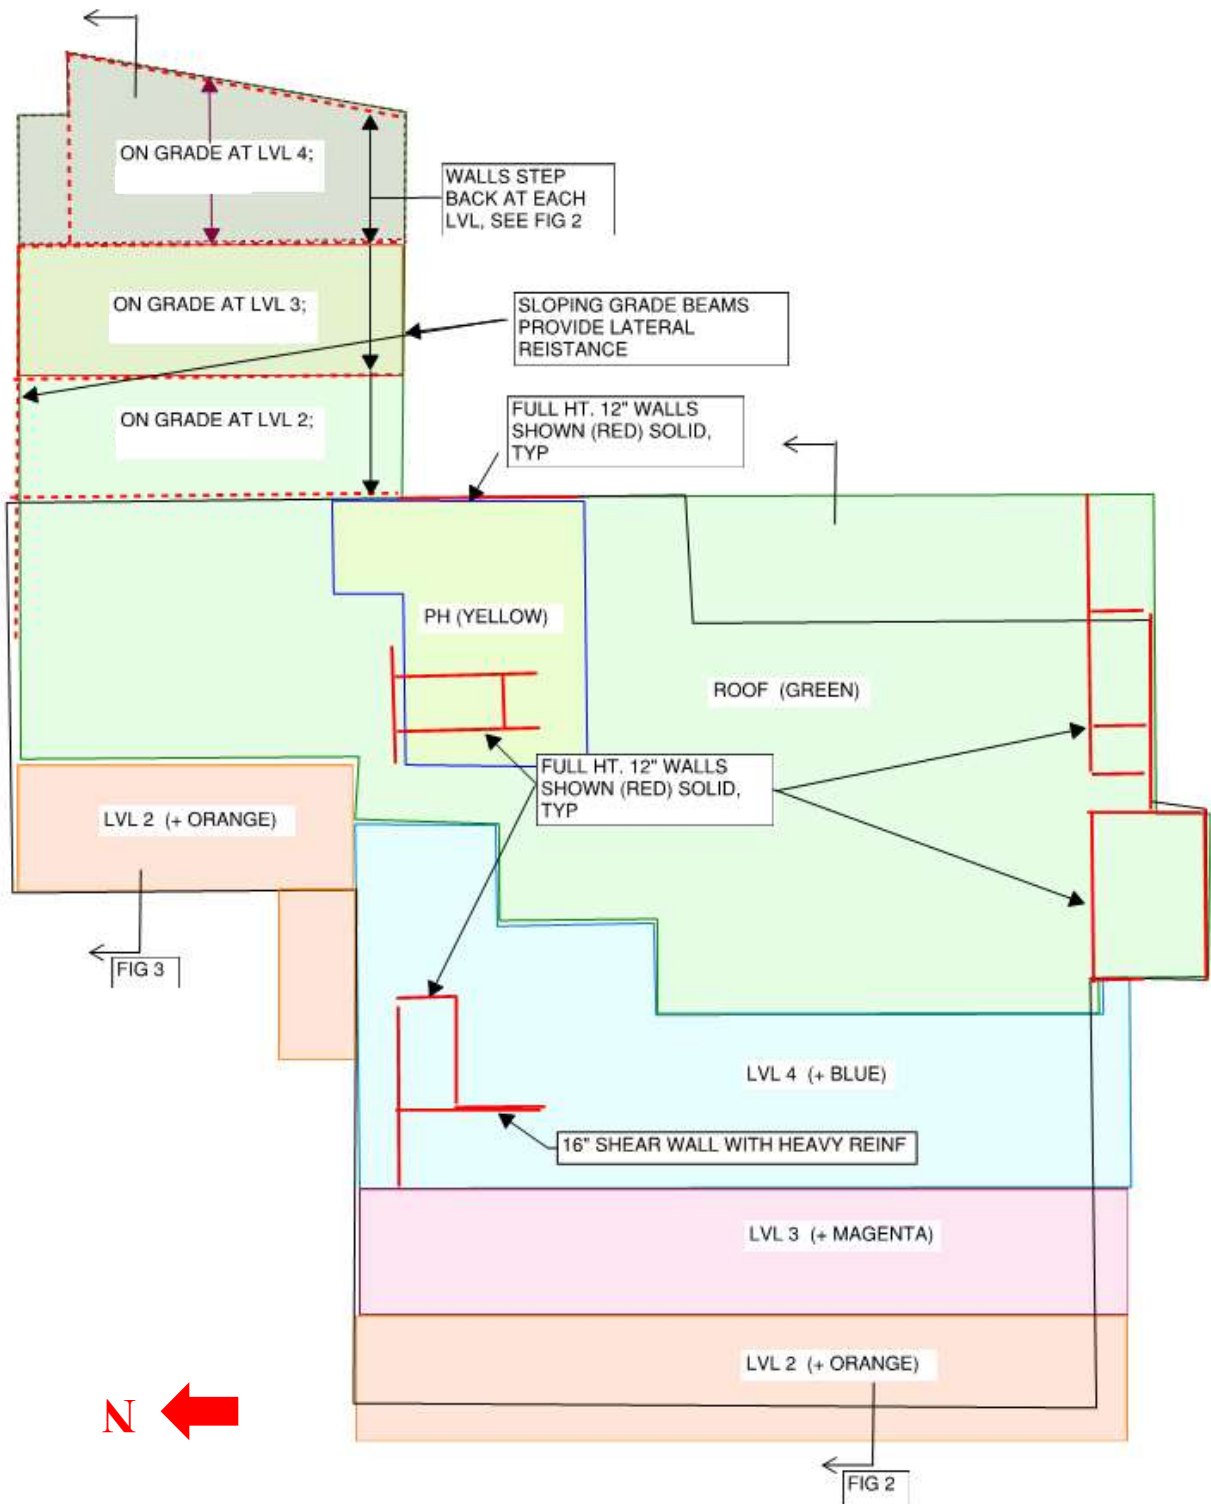
Figure 1: Diagrammatic Plan

Structural system for lateral forces: Lateral seismic forces are typically resisted by reinforced concrete walls. Referring to Figure 1, walls shown solid extend full height from the roof to foundations. Walls shown dotted typically extend 1 level and typically serve to retain 1 story of lateral earth pressure. At the North Wing, lateral forces in the east-west direction are resisted by sloped concrete grade beams that extend from the base to Level 4 and act much like braced frames.

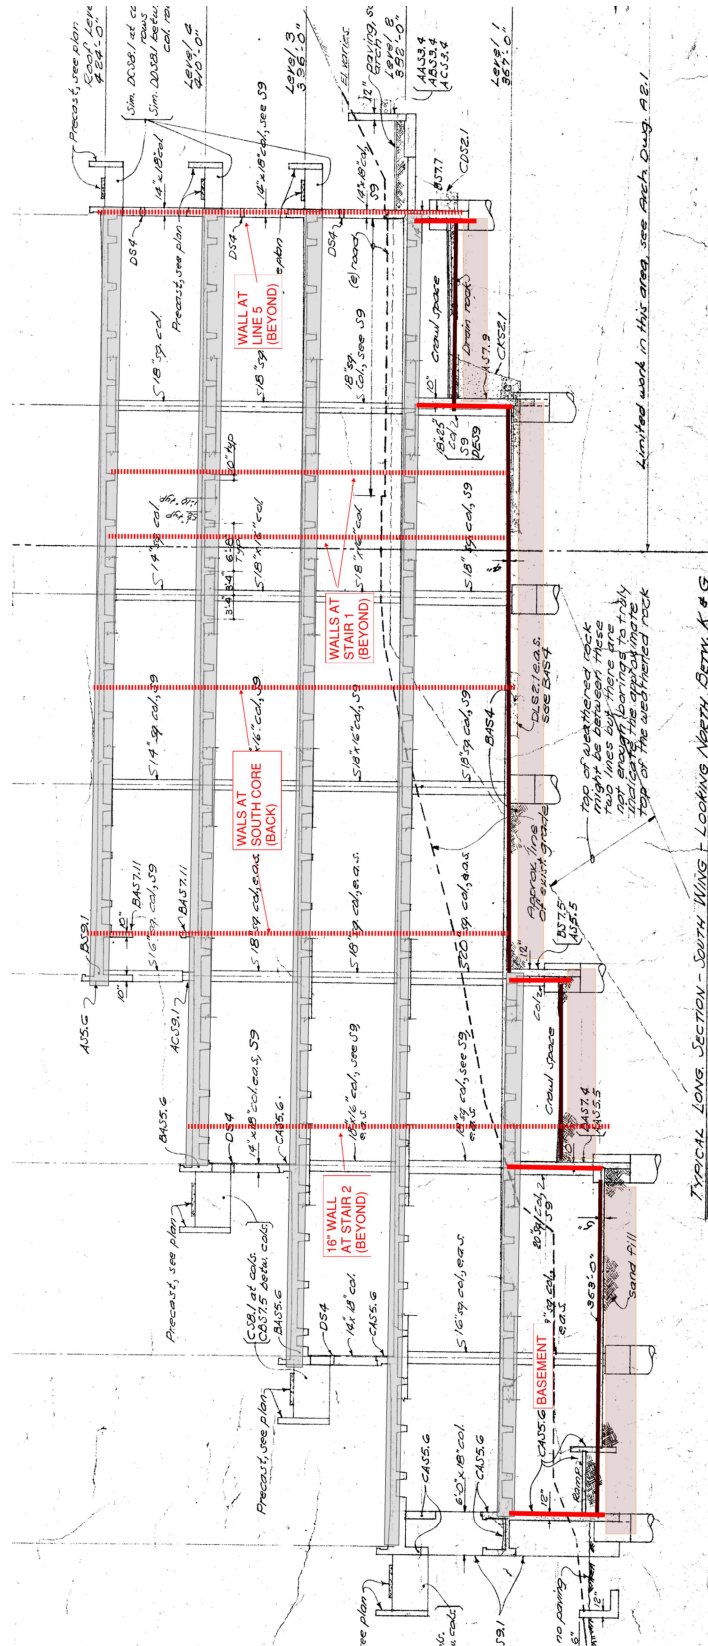
Figure 2: Section at South Wing

The building has four stories above grade plus a relatively small penthouse. A basement mechanical level underlies a portion of ground level, and a crawl space underlies a portion of the remainder. The building is terraced into the hillside, in particular at the North Wing, as can be seen in Figure 3. Upper floor levels step back to follow the hillside as can be seen in Figures 1, 2 and 3 and the aerial photos.
