UCSF Building Seismic Ratings

Mission Center Building

CAAN# 2415

1855 Folsom Street, San Francisco, CA 94103

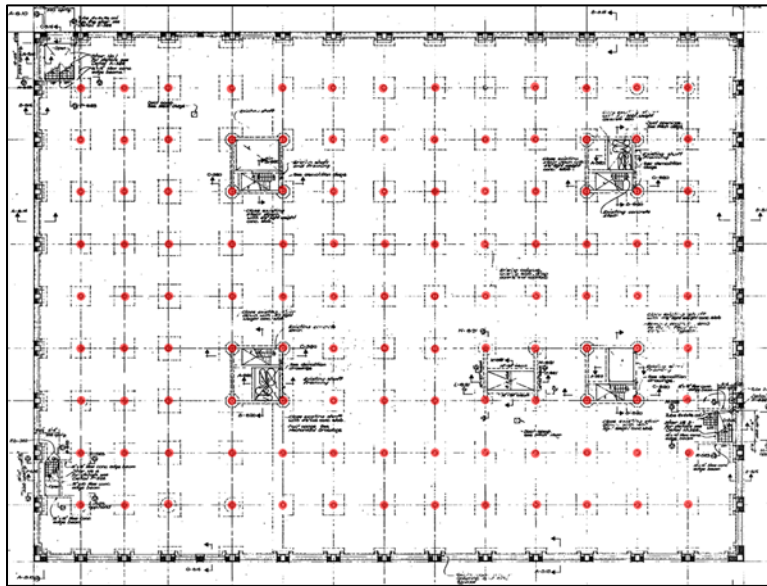
Figure 1. The original plan of one of the floors showing the interior concrete columns (red), and the exterior concrete columns (black dots) within the exterior concrete frame, and exterior brick walls. See Figure 7 for an elevation of the typical exterior wall with annotations of the added concrete framing on the interior surface of the brick infill. As constructed, the fourth bay from the left had a drive aisle the full width of the building. At the perimeter there are rectangular columns integrated into the concrete spandrels in the original construction, and the black dots represent the 1971 retrofit piers, see Figure 4.

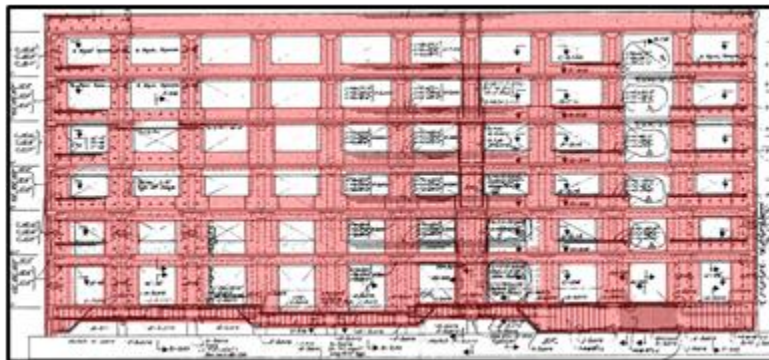
Figure 2. The reinforced concrete pier and spandrel system (red highlight) installed in the 1971 retrofit. See Figure 5 for the detailing of the added pier elements around the existing columns and attachment to the exterior brick masonry by the small + marks. At the bottom, the piers terminate into a heavily reinforced concrete grade beam.

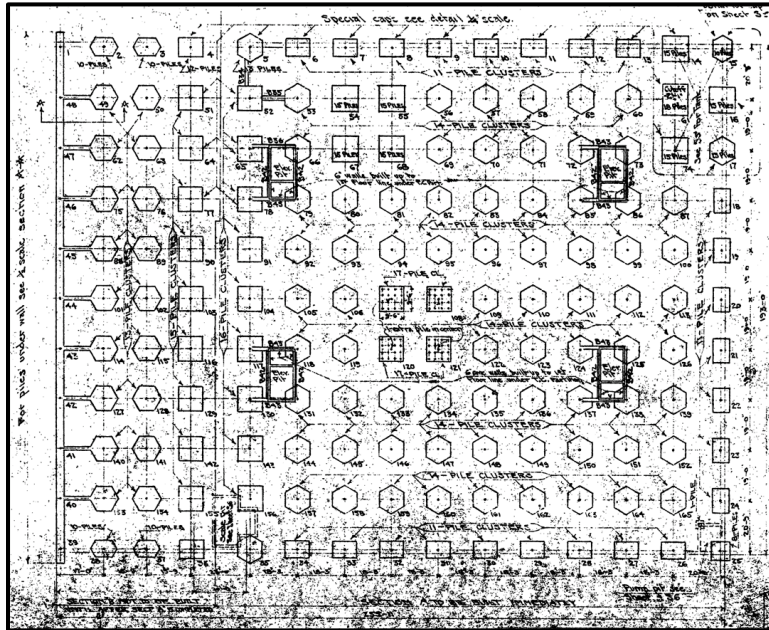
Figure 3. The pile plan from the original design. There are a number of different pile cap arrangements. The square caps of the fourth and fifth vertical grid lines indicate the location of a driveway the full width of the building, since enclosed. A typical pile cap is shown in Figure 4. Note that the pile caps support all interior columns and walls.

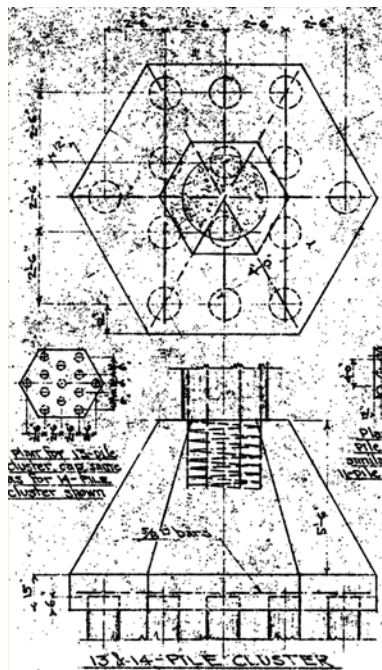
Figure 4. A typical pile cap for a 13- or 14-pile cluster. The driven timber piles extend 6 inches into the concrete pile cap. The concrete column reinforcing cage extends into the pile cap. At the bottom of the cap, above the piles is a dense two-directional reinforcing mat.

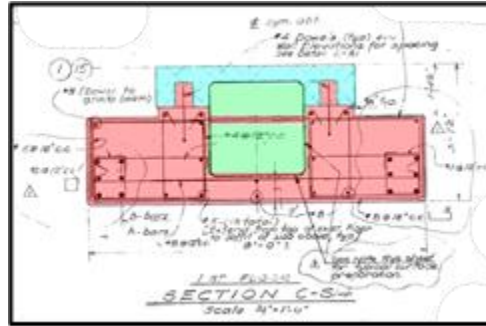
Figure 5. The 1971 retrofit resulted in the conversion of the reinforced concrete perimeter columns (green highlight) into heavily reinforced piers (red highlight) of the perimeter shear walls. These piers along with the original reinforced concrete perimeter beams form a very robust perimeter shear walls. The exterior brick masonry (blue highlight) is reliably anchored to the pier.

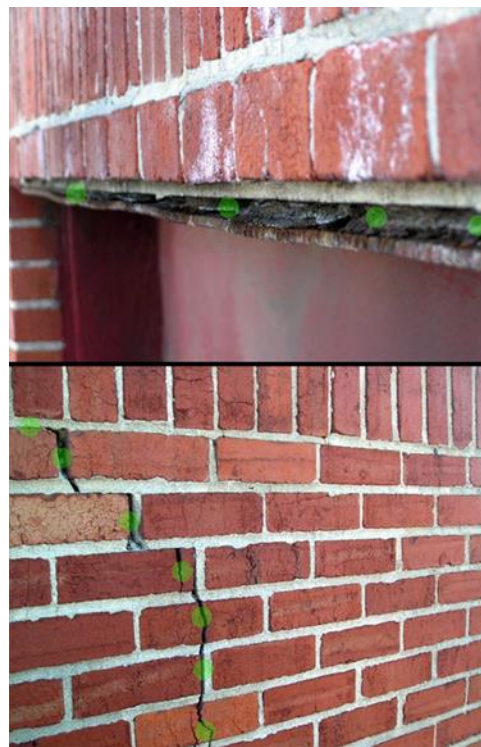
Condition Observations: The exterior of the building shows signs that some embedded steel that was used in the masonry exterior is degrading and the exterior cracks attributed to water infiltration were observed, see Figure 6. Wiss Janney Elstner found that, in general, the brick masonry components of the building facade were in reasonably good condition, and aside from veneer anchorage issues, the noted deterioration was caused by the normal aging process of the building components. The deteriorated mortar joints and leaking windows have permitted water to infiltrate the masonry and cause corrosion and efflorescence. Implementing the window repairs was recommended and repointing the mortar joints should alleviate many of the noted problems. The window lintel corrosion and corrosion of the veneer ties were not considered hazardous in 2006 but the deterioration has since progressed to the point that prompt attention is required to prevent these accelerating forms of deterioration from progressing further, to the point of becoming falling hazards. We understand that at the present time, a brick remediation project is underway.

- The exterior of the building shows evidence of corrosion of embedded steel that supports and restrains the brick masonry walls. A project is currently underway to mitigate the falling hazard associated with the exterior brick. There is no evidence that the exterior concrete elements beneath the brick is deteriorated.

Figure 6. Sections of steel lintel rusting (upper marked by green), and cracking (lower image to the left marked with green) in the brick masonry exterior from Wiss Janney Elstner report on the façade in 2013 showing conditions probably caused by water infiltration at windows.

* Remediation under way to mitigate hazard associated with brick cladding; Permit drawings by Estructure, April, 2019

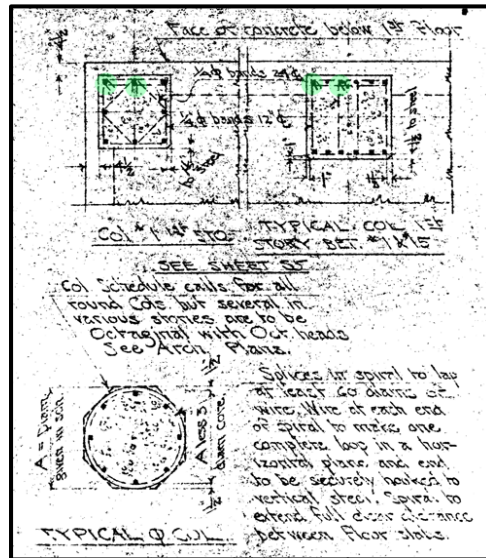
Figure 7. The 1926 columns reinforcing included spiral reinforcing for round and octagonal column, and well reinforced square and rectangular columns that include 135° hooks (green). The ties are #2 at 12 in. o.c., and the spiral reinforcing is #0-#3 wire at pitches of ±2.25 in. .

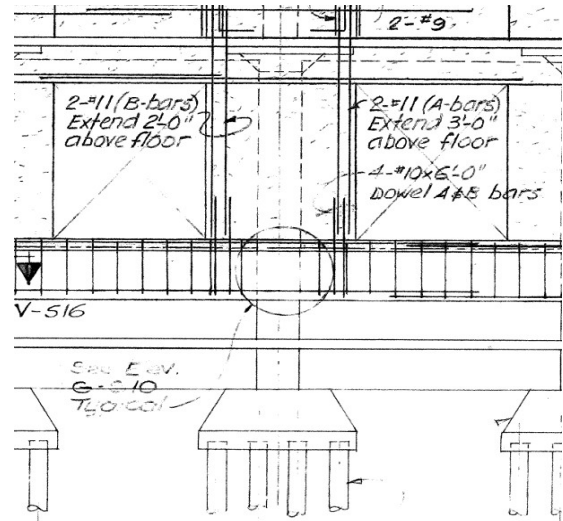
Wall to foundation connection:

A typical detail on right shows that the (2) #11 bars in the wall are followed by (4) #10 dowels

Area of (2)#11 bars = 3.12 in²
 Area of (4)#10 bars = 5.08 in²

Hence OK
