DATE: 2019-06-25

**UCSF building seismic ratings**  
**Marilyn Reed Lucia Child Care Study Center**

CAAN #2416

610 Parnassus Ave, San Francisco, CA 94122

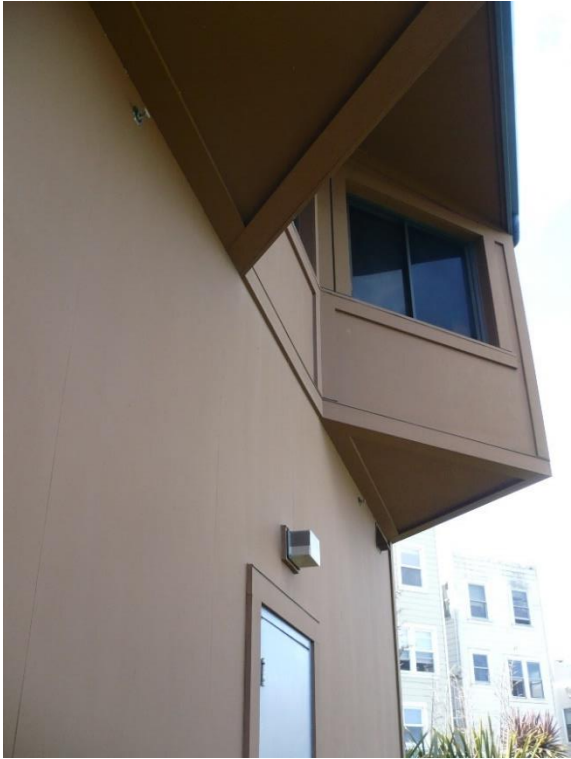
Building condition: Good. Possible dry rot was observed in the exterior wall sill on the west elevation. UCSF facilities staff indicate that, once a year, the structure is closed for maintenance such as painting and replacement of the carpet.

West elevation (looking southwest)

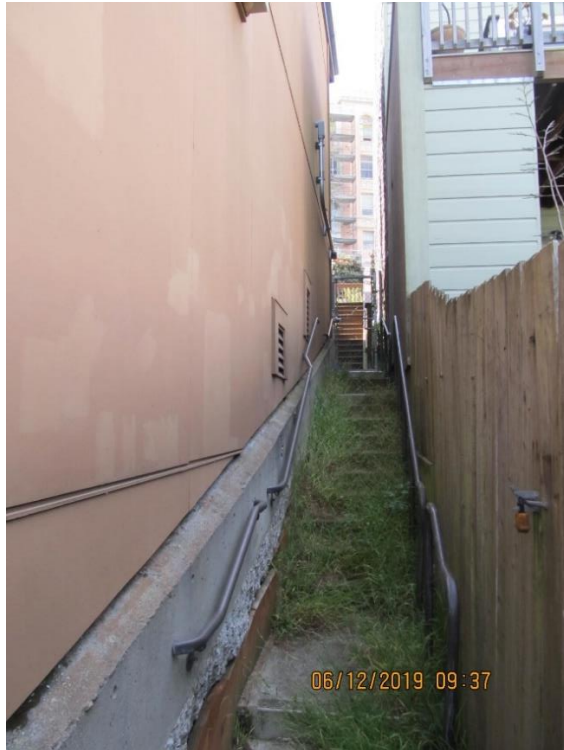
West elevation (looking south)

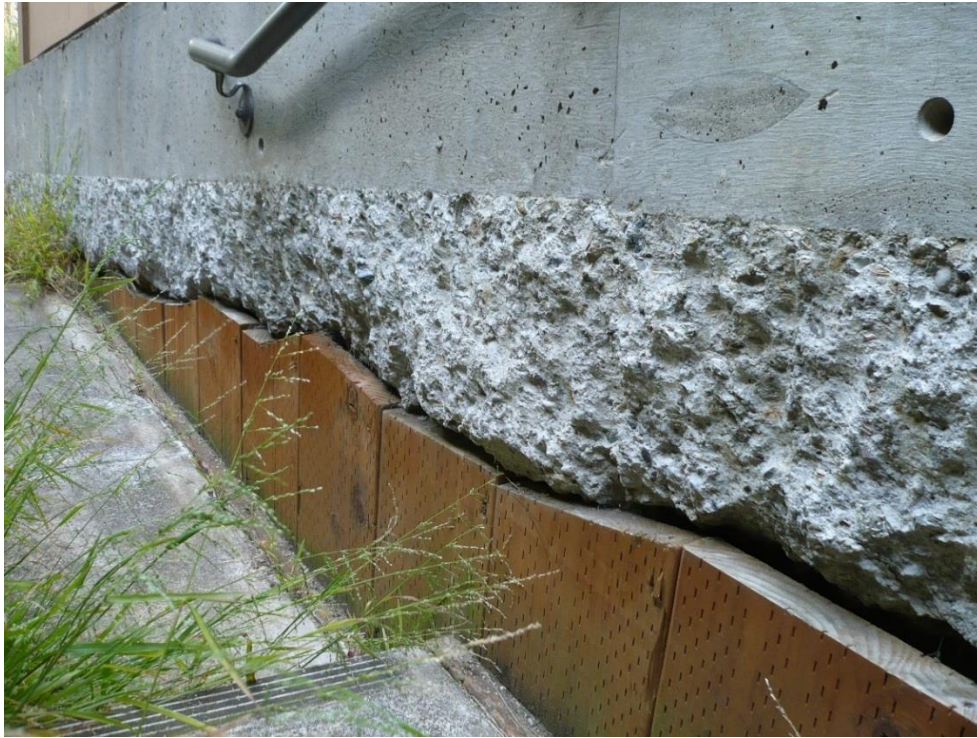
bars at the top and bottom and #4 ties spaced at 18" o.c. The vertical pier reinforcing extends 1'-8" into the grade beams. The site observation revealed that the existing grade beams on the northwest elevation were partially chipped and exposed to view. It is presumed that this was completed when the building addition was constructed in 2011; however, this is unconfirmed as no documentation showing this structural modification is available.

Existing chipped and sloped grade beams on west elevation (possibly to install the stairs in the narrow space available). Beams span to piers.
