**UCSF building seismic ratings**

**Oyster Point**

CAAN #2418

612 Forbes Boulevard, South San Francisco

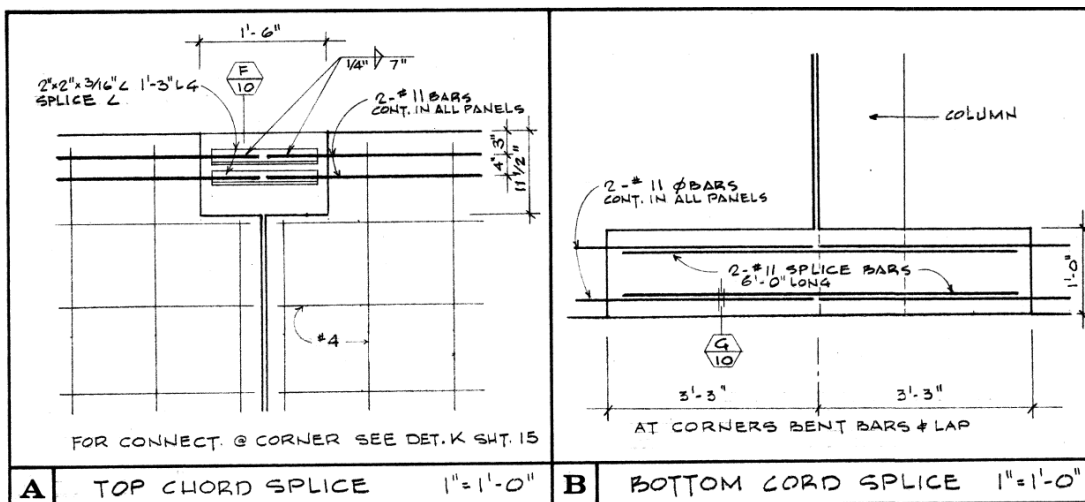
Figure 6 - Chord Splice Details

- Continuous chord elements are provided at the top of the panel (rather than at the roof level) by a 7” double sided fillet weld between a #11 bar and angle. The location of the chord above the roof framing may result more damage at the roof level.

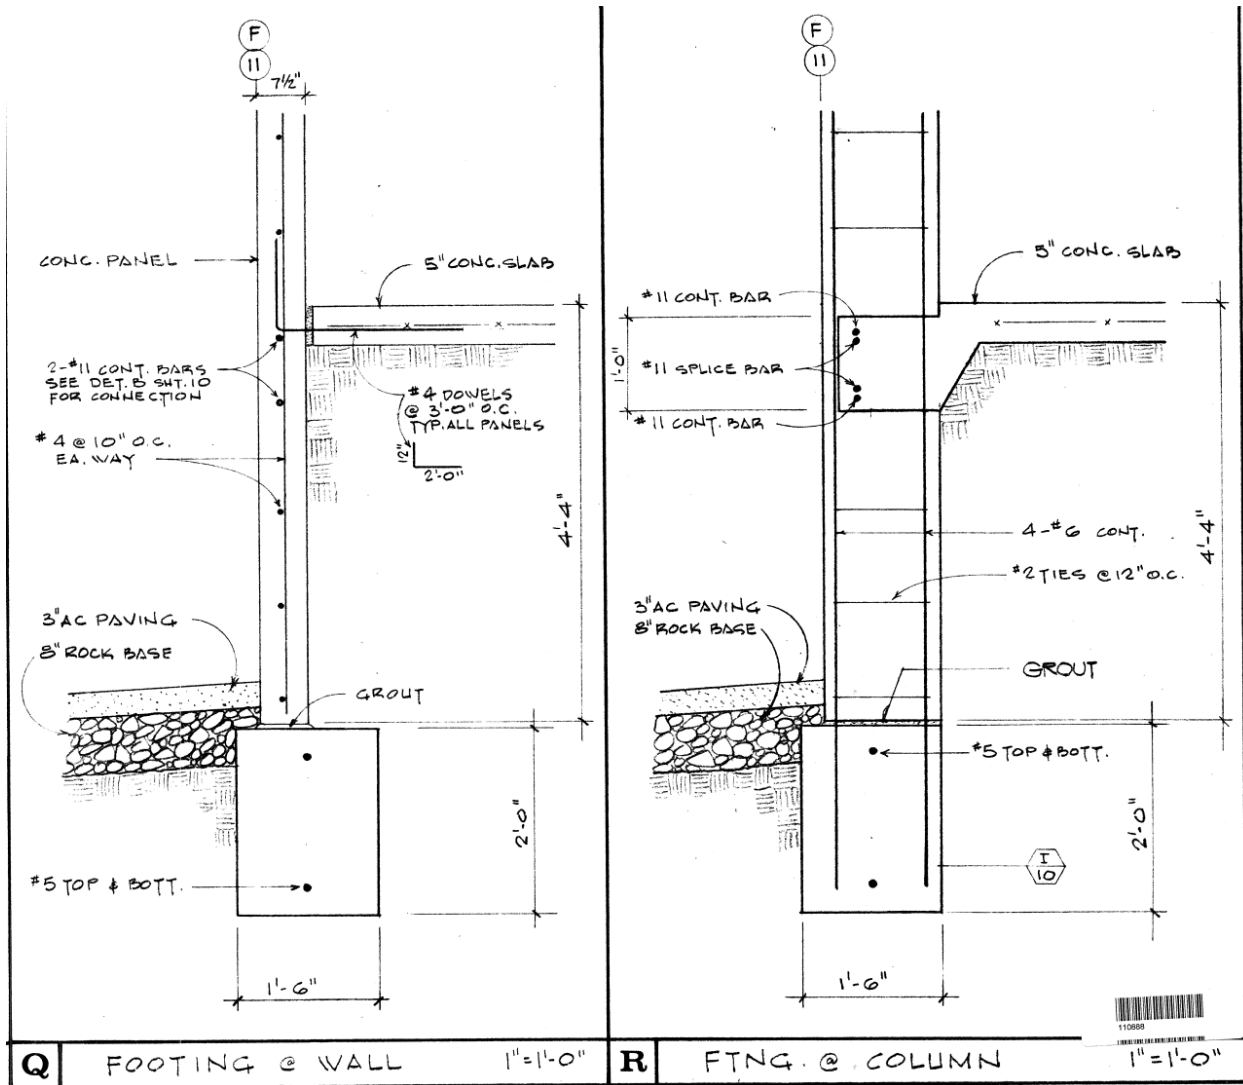
Figure 7 - Foundation / Wall Connection Details

- A positive connection is not provided between the panel and the footings. The panels are tied in with short dowels at the slab on grade level and pilasters are positively attached to the footing.

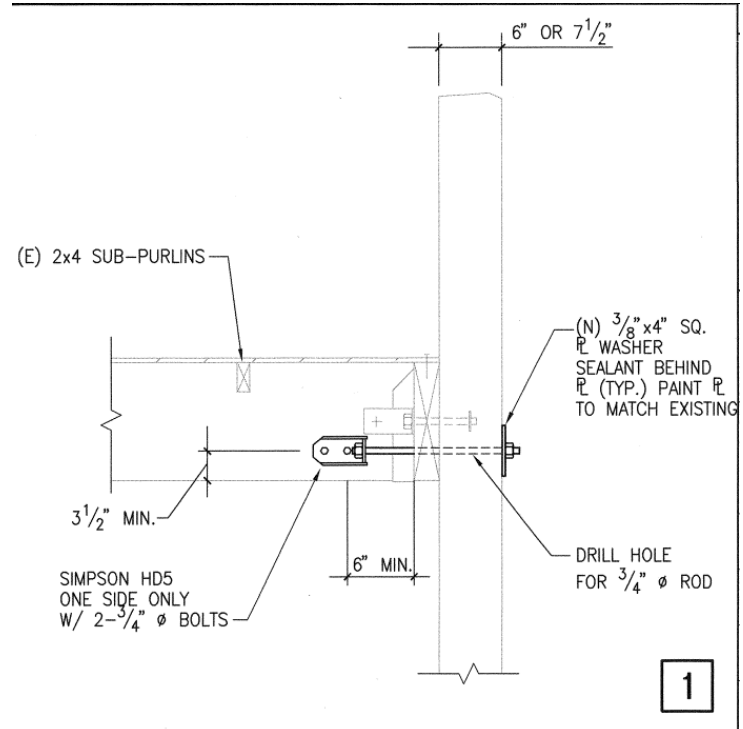
Figure 8 – Out-of-Plane Wall Anchorage at Purlin (1985 and 1998 Seismic Retrofit)

- Out-of-plane wall anchorage does not satisfy ASCE 41-17 requirements. In particular, a single out-of-plane wall anchor is provided at each purlin (spaced at 8’ on center) and these anchors are overstressed by 100%.

Retrofits in 1985 and 1998 addressed the most serious seismic deficiencies. However, out-of-plane wall anchorage at the roof purlin framing is inadequate for demands associated with ASCE 41-17. Additionally, the CMU structure may have inadequate anchorage from the roof framing to the top of wall, and/or insufficient horizontal reinforcement to span to perpendicular walls under seismic loading.

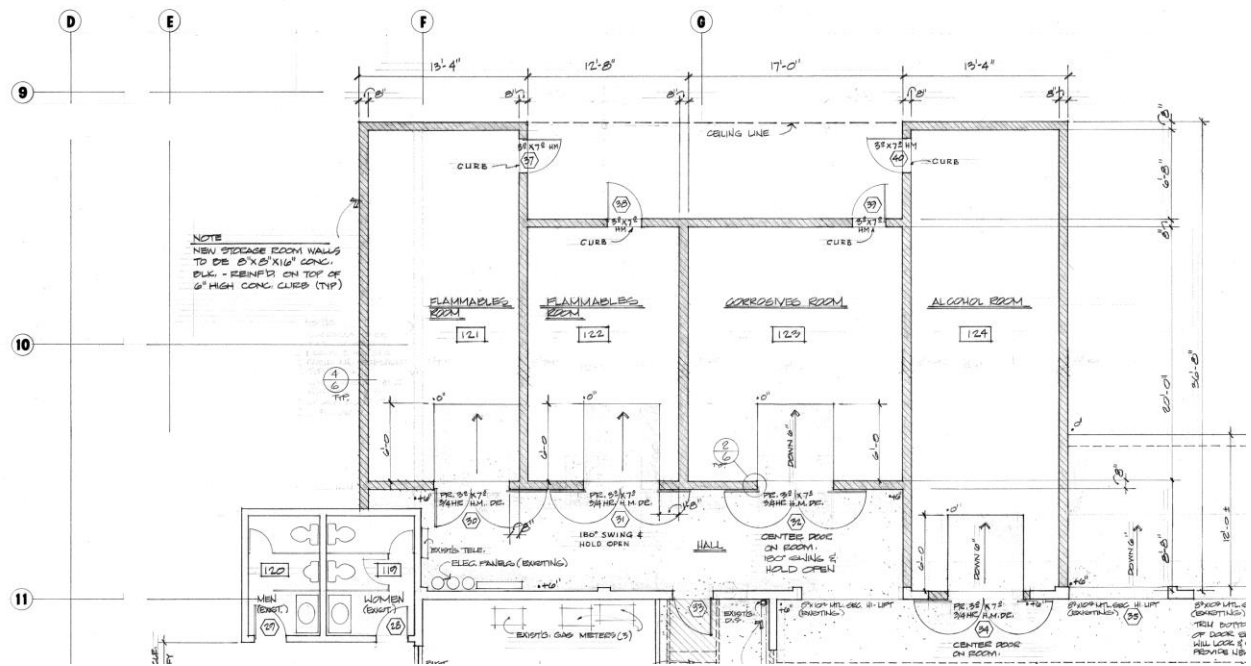
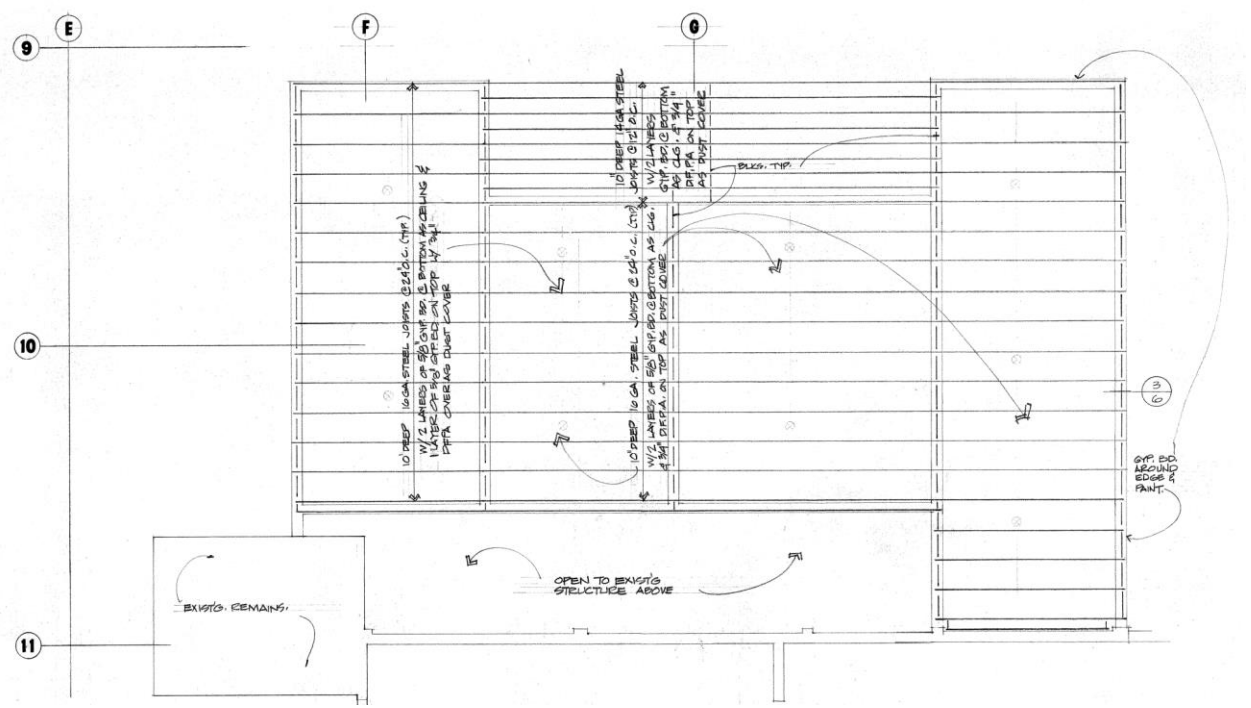
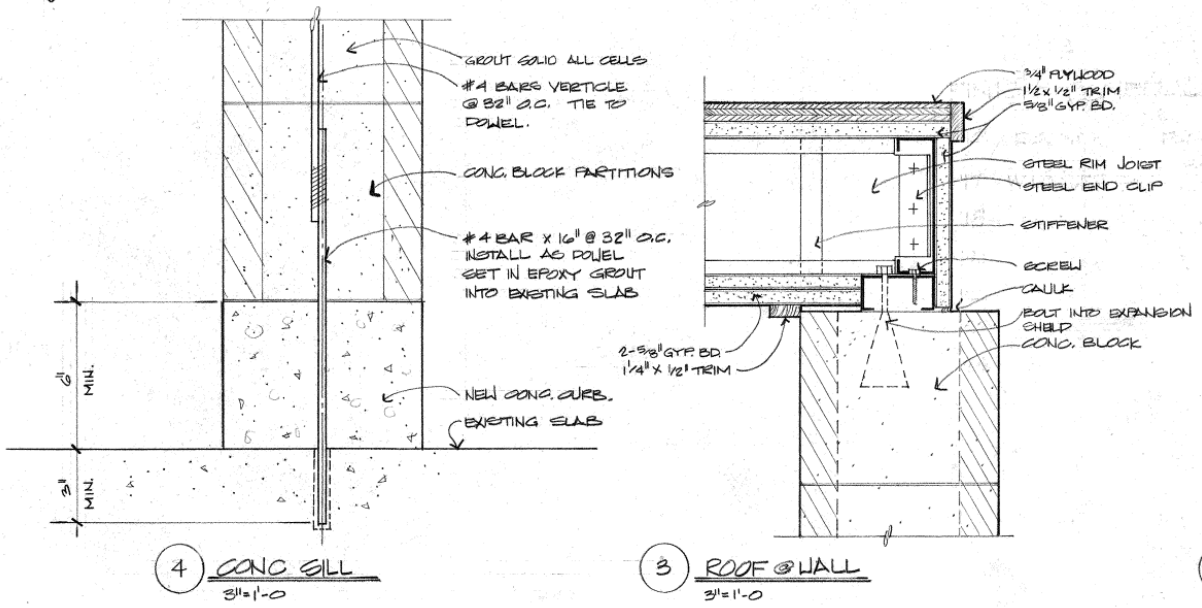
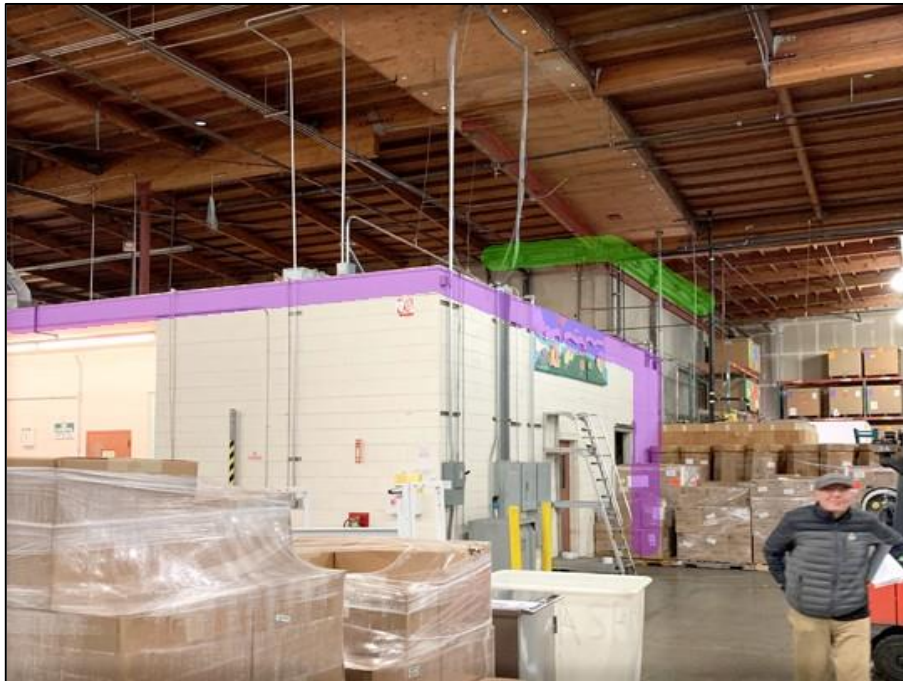
- The CMU structure has expansion anchors between the roof framing and top of CMU wall. The size, embedment and spacing of the anchors is not called out on the drawings. Additionally, the horizontal reinforcement is not called out of the drawings. The connections between the roof framing and the wall may not be adequate to

transfer seismic forces from the wall into the diaphragm. Additionally, where anchorage at the top of the wall is not sufficient, seismic forces could transfer through horizontal spanning of the walls to perpendicular walls. However, since horizontal reinforcement was not specified on the original drawings, this load path could not be verified.

- The CMU structure connection to the slab on grade is through a post installed adhesive dowel. The lap length of the dowel with the vertical wall reinforcement is 9 inches, which is less than the required code minimum.

Additional verification of the CMU structure framing and wall reinforcement is recommended.

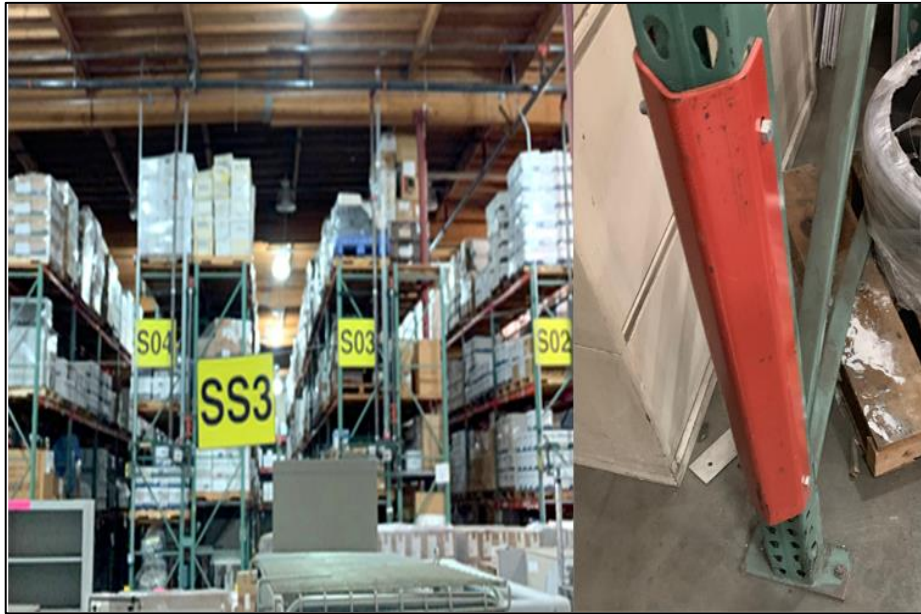
Figure 19 - Storage Rack

A large number of tall prefabricated steel storage racks are located in the building. The racks are bolted to the concrete slab-on-grade, and have a nominal lateral load system sized to accommodate operational loads of placing and removing heavily loaded pallets. Each stanchion typically has two anchor bolts attached to the concrete floor, with some bolts not installed or missing. At some locations it was clear that the stanchions had been struck by forklifts and the anchor bolts were no longer reliable. These racks could pose a potential life safety issue or block exits if damaged in an earthquake.

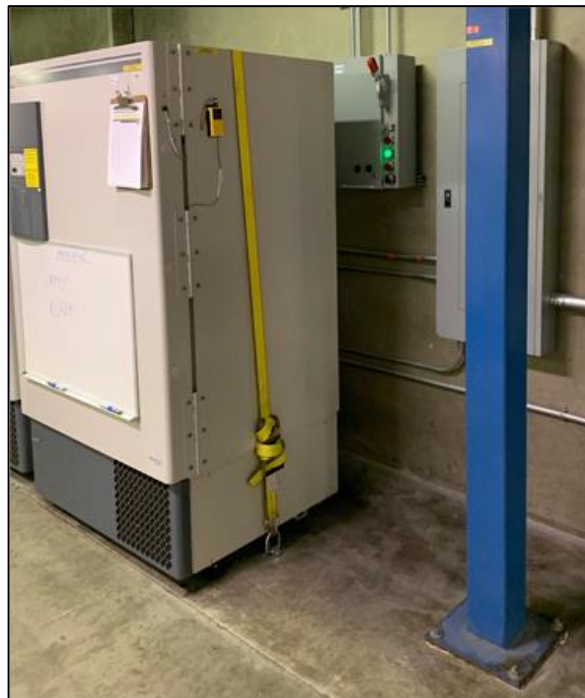
Figure 20 - Freezer Anchorage

There are many freezers on site with high value contents. The freezers are anchored with a strap over the top and anchored each side to the slab-on-grade. This connection relies on friction. No testing is known to have been conducted to validate the seismic performance of this type of restraint.

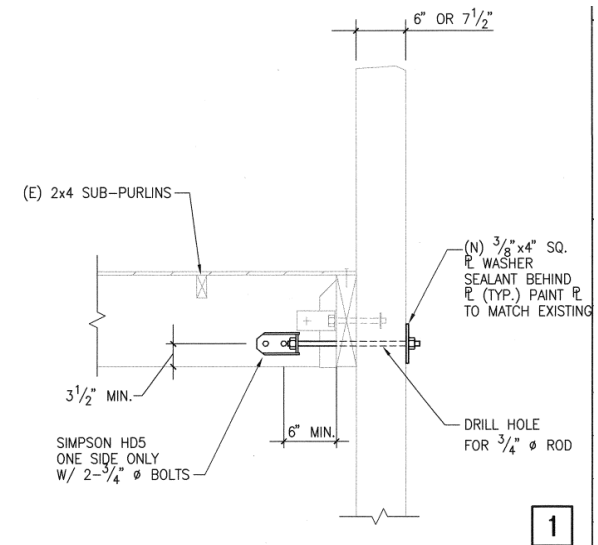
**HDU5 Capacity = 8704 lbs** 4835# (Simpson Capacity) / 1.6 \* 0.85 \* 3.32  
Capacity From FEMA P2006 (Section 4.6.5.5)

**D/C = 1.98**

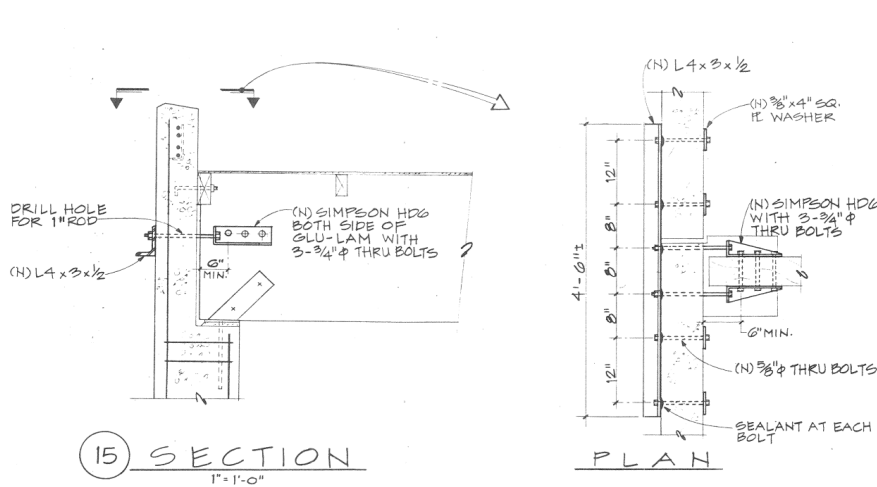
1980s Renovation - Out of Plane Wall Anchorage at Glulam

**Wall Anchorage Check (ASCE 41-17, Section 7.2.11.1) - Glulam**

**F<sub>p</sub> = 13048 lbs** (ASCE 41-17, eqn. 7-9)  
**χ = 0.9** (Collapse Prevention)  
**S<sub>xs</sub> = 2.13**  
**A<sub>p</sub> = 90.75 ft<sup>2</sup>** (24.2 ft Glulam Spacing \* (2.75 ft + 24.5/2)) / 4 Anchors  
**w<sub>p</sub> = 93.75 psf**  
**k<sub>a</sub> = 2 Max**  
**k<sub>h</sub> = 1 Flexible Diaphragm**

**HDU5 Capacity 12955 lbs** 7345# (Simpson Capacity - HD7) / 1.6 \* 0.85 \* 3.32  
 Capacity From FEMA P2006 (Section 4.6.5.5)

**D/C 1.01**
