DATE: 2019-11-18

UCSF building seismic ratings
Mount Zion Cancer Center Building H

CAAN #3004
1600 Divisadero Street, San Francisco, CA 94115
UCSF Campus: Mount Zion

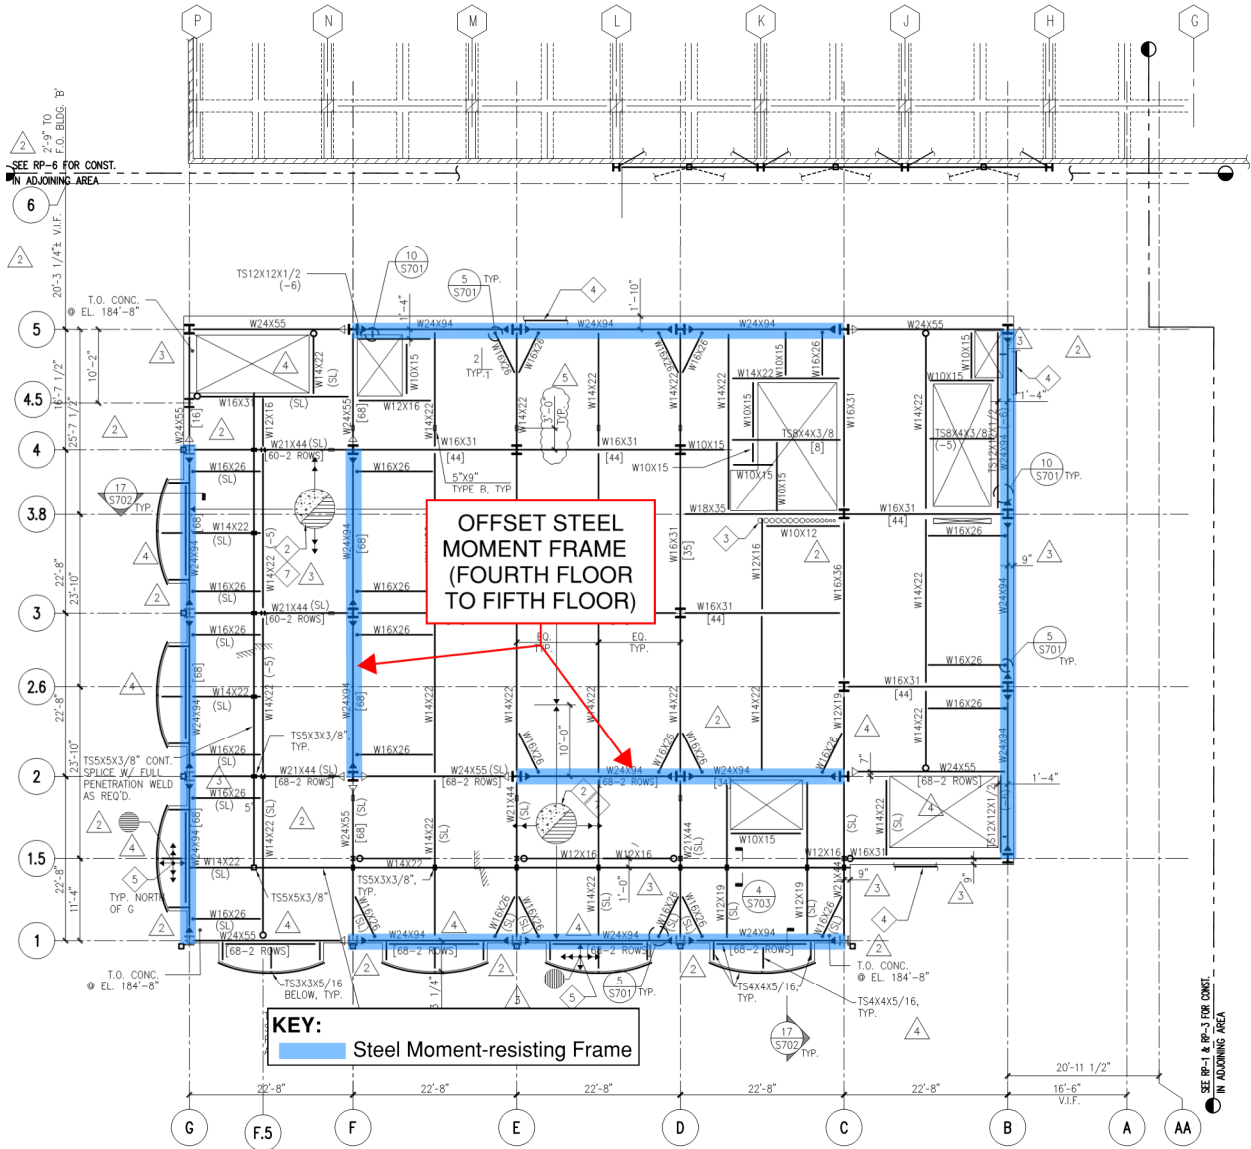
- At the fifth floor, the two-bay moment frames located on Line 2 and Line F offset horizontally to Line 1 and Line G, respectively. As such, between the fourth to fifth floor there are 8 bays of frames in each direction. In the stories below the fourth floor, there are six bays of moment frames in each direction. The shear demand-to-capacity ratio between the third to fourth floor is 67% higher than between the fourth to fifth floor. This meets the ASCE 41 Tier 1 criteria for a potential weak story. However, the structure has sufficient shear capacity to resist the shear demands from BSE-C at all stories.

G
Lateral force-resisting system at the fifth floor

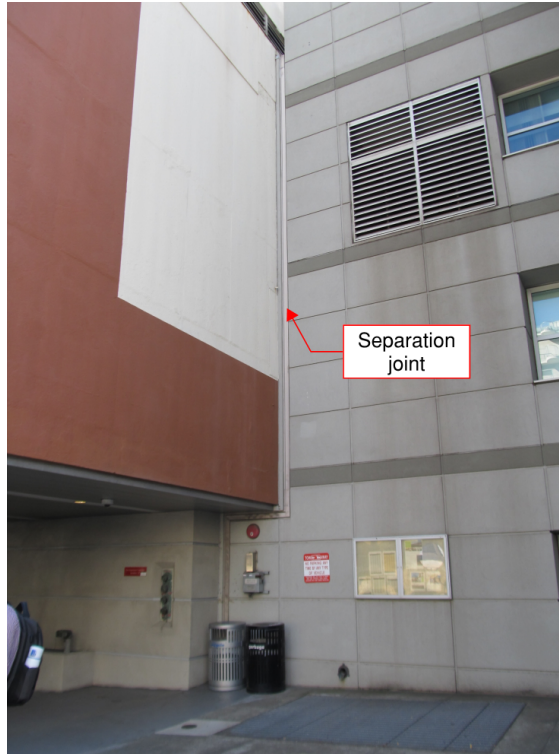
- The structure may contain inadequate seismic separation from adjacent buildings. The provided gap does not meet the ASCE 41-17 criteria of 1.5% times the story height. The provided gaps are 1", 2", 4", and 6", and the required gaps are 2", 4.14", 6.5", and 8.82" at the corresponding floor levels.

Separation joint between the Cancer Center and Building 'B'
(looking southeast)

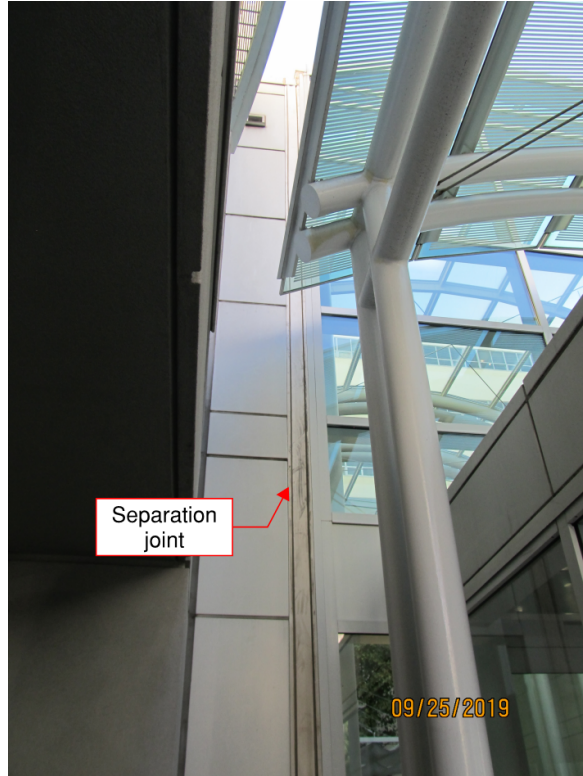
Separation joint between the Cancer Center and Building 'R'
(looking east)

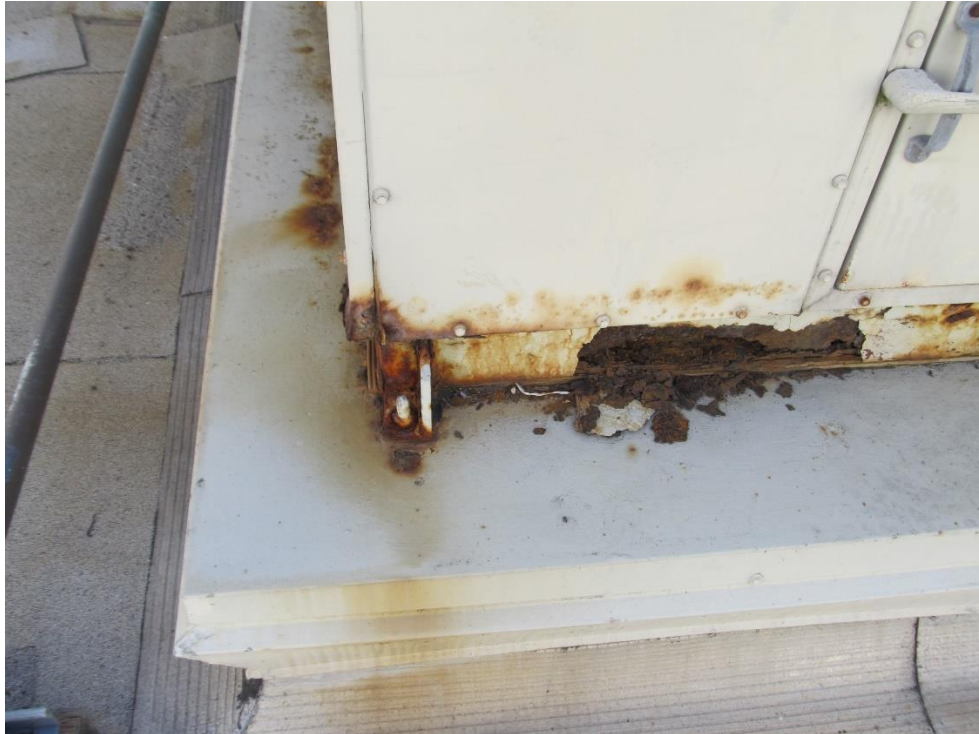
Building condition: Good. No on-going maintenance problems were noted by the building administrator. The roof and roof-top mechanical equipment are showing signs of age as some equipment housing, anchors, and skids are severely corroded.

Extensive corrosion at the base of the roof equipment

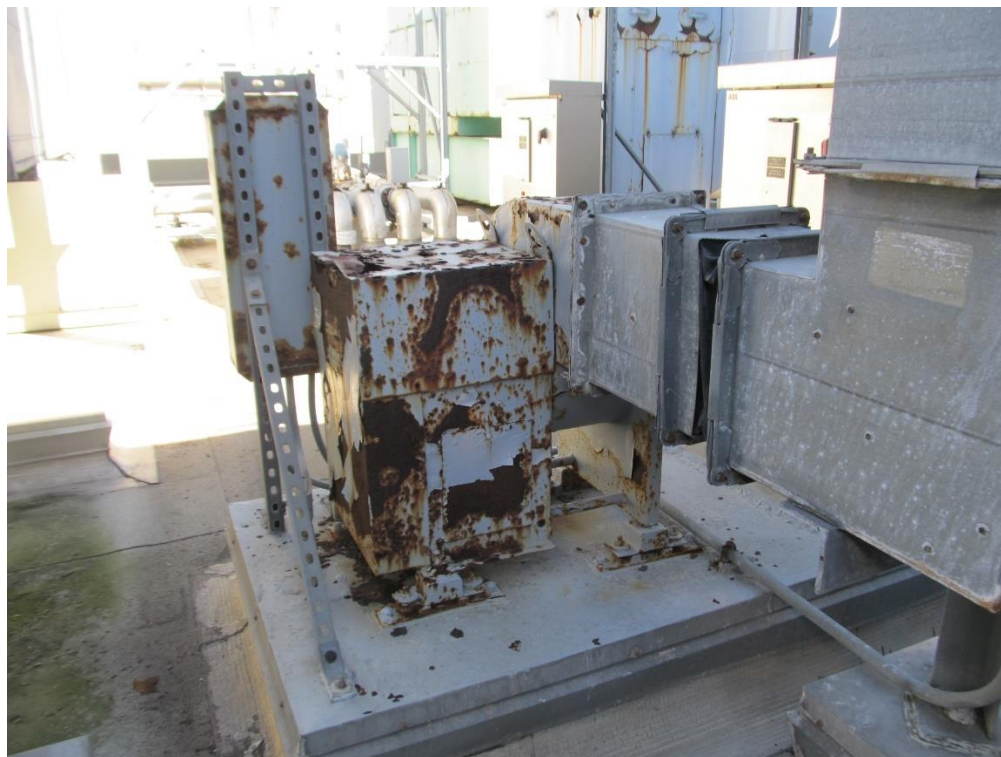
Corroding mechanical equipment at the roof

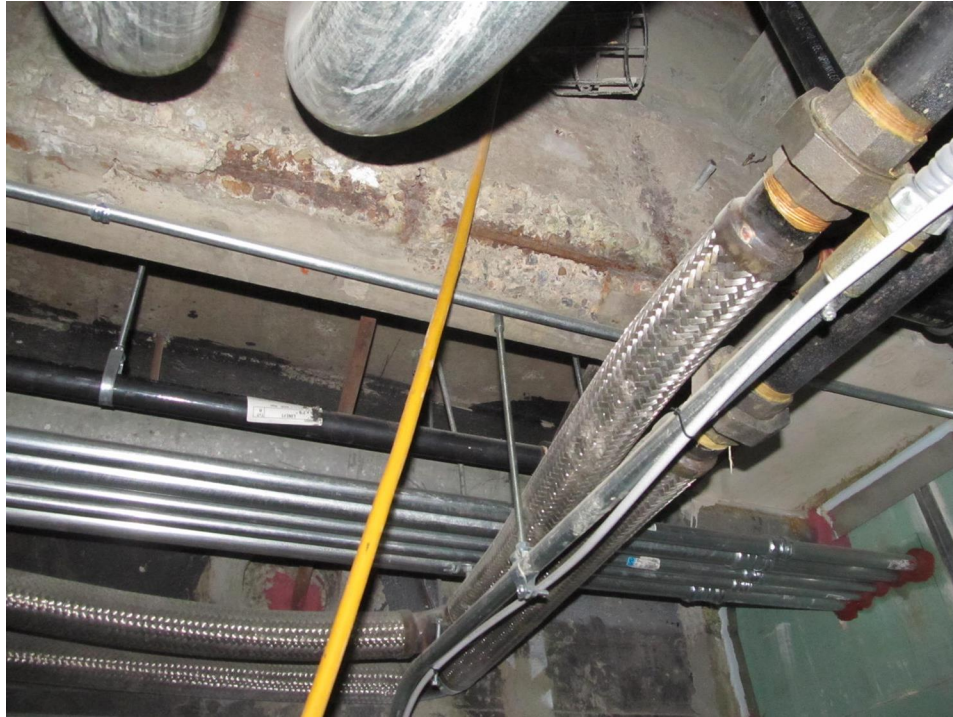
Concrete spalling in void space between Building 'B' and the Cancer Center

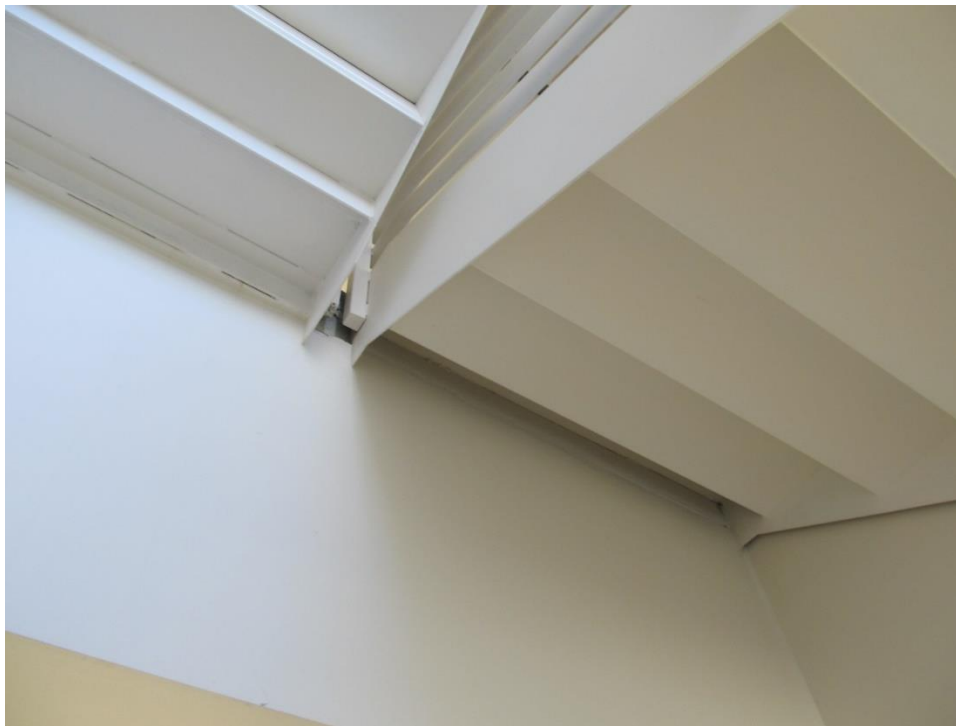
The egress stairs in the Cancer Center are constructed from steel plate stringers. No movement joints were observed at the stair landings or the floor levels. The construction documents indicate the interstory drift is 2". Given this drift, forces that exceed the capacity of the stringers and their connections may develop.

Underside of steel plate stair stringers at the intermediate landing. No slip joint was observed at the floor level or intermediate landing.
