## UCSF Building Seismic Ratings

### Central Utilities Plant, Parnassus Avenue

CAAN# 3006

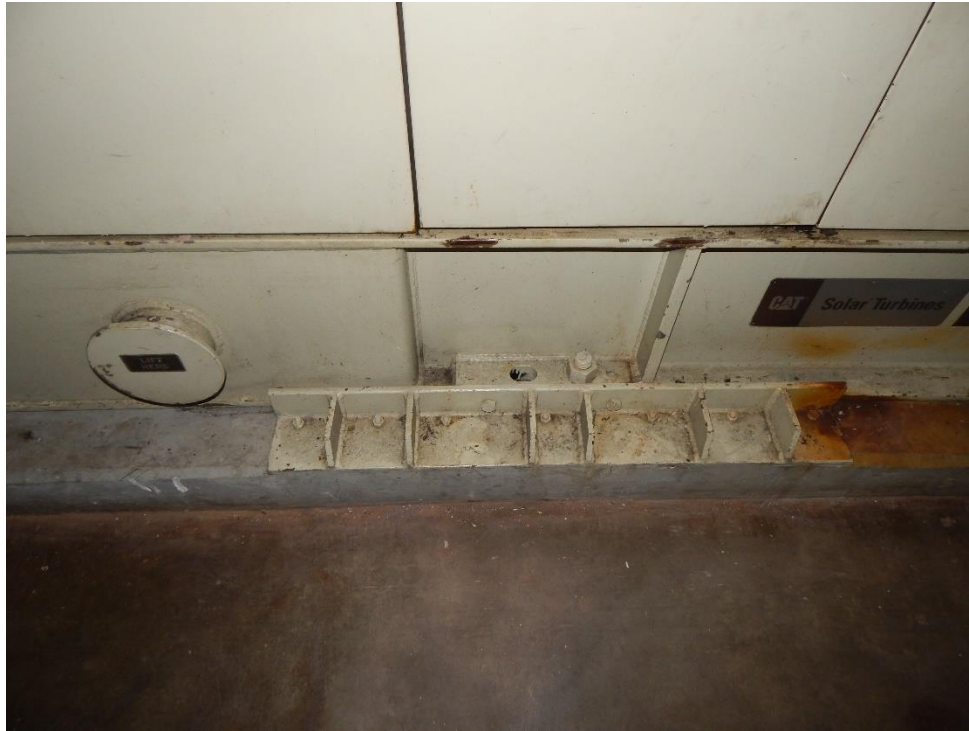
Photo 1. Gas Turbine Anchorage

A rigorous assessment of the nonstructural systems inside the building has not been performed. We observed the equipment and anchorage; no obvious deficiencies were observed. Typical equipment anchorage is shown in Appendix D.
