DATE: 2019-06-25

UCSF building seismic ratings
Buchanan Dental Center

CAAN #3010

100 Buchanan, San Francisco, CA 94102

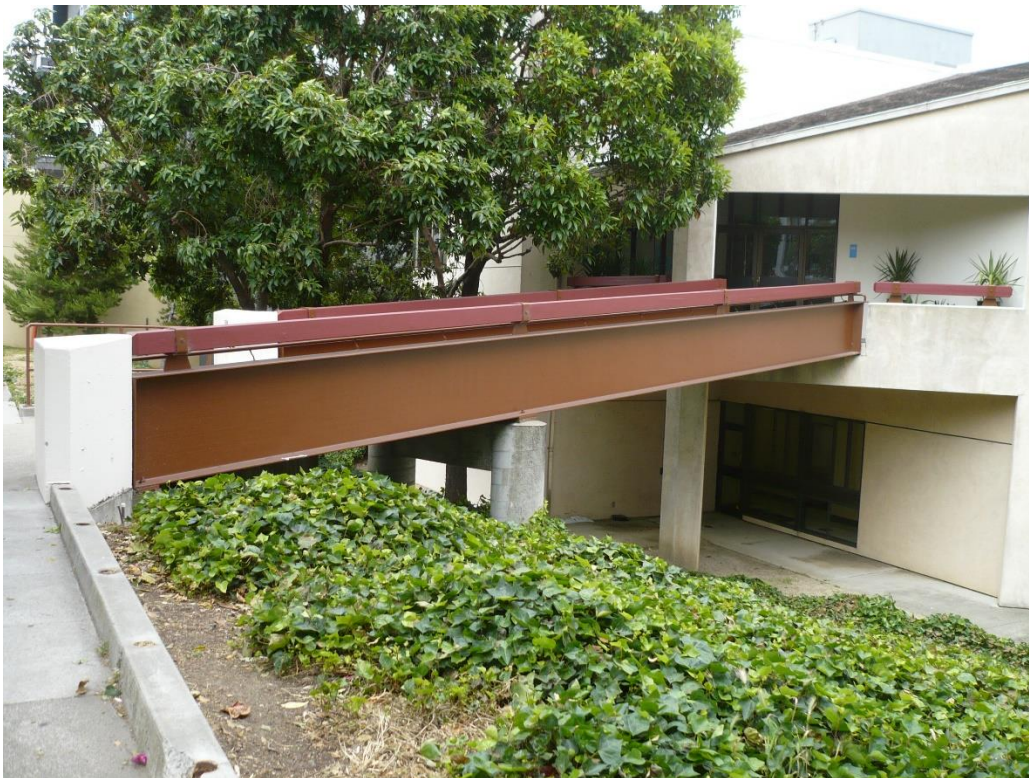
The Buchanan Street Dental Center contains a pedestrian bridge on its west elevation. The bridge is tied to the structure at its west end and has a slotted connection at its east end which allows for slip in the east-west direction. The provided joint is 1" wide. It was observed in the field that the bolt installed in the slotted hole is located at the east side of the slot so movement of the bridge to the west will be impeded.

Pedestrian bridge at main entry (looking northeast)

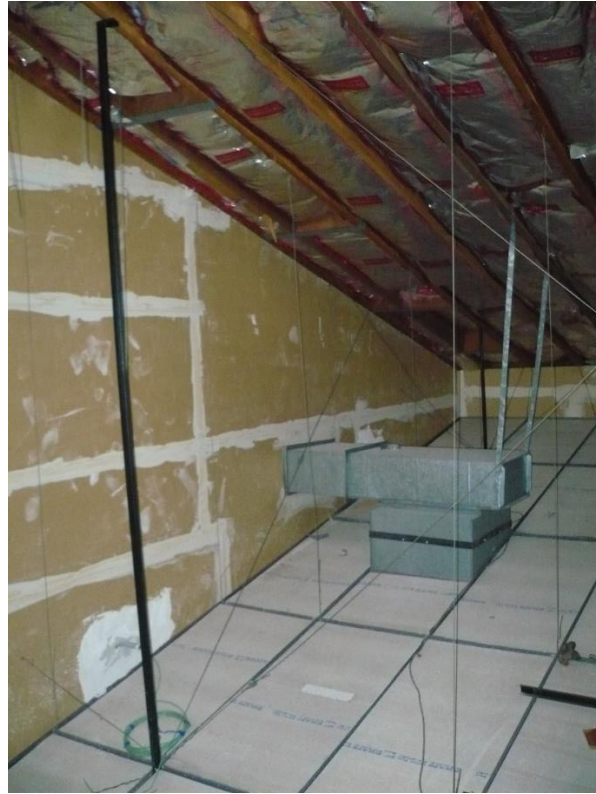
Ceiling bracing

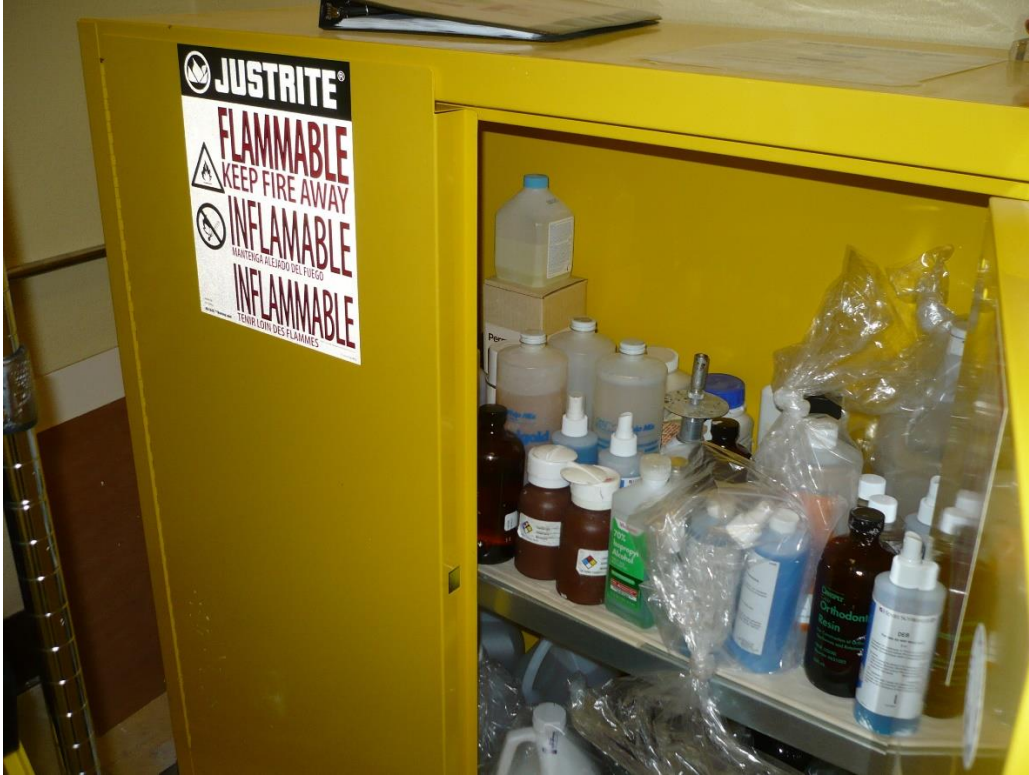
Hazardous chemical storage cabinet

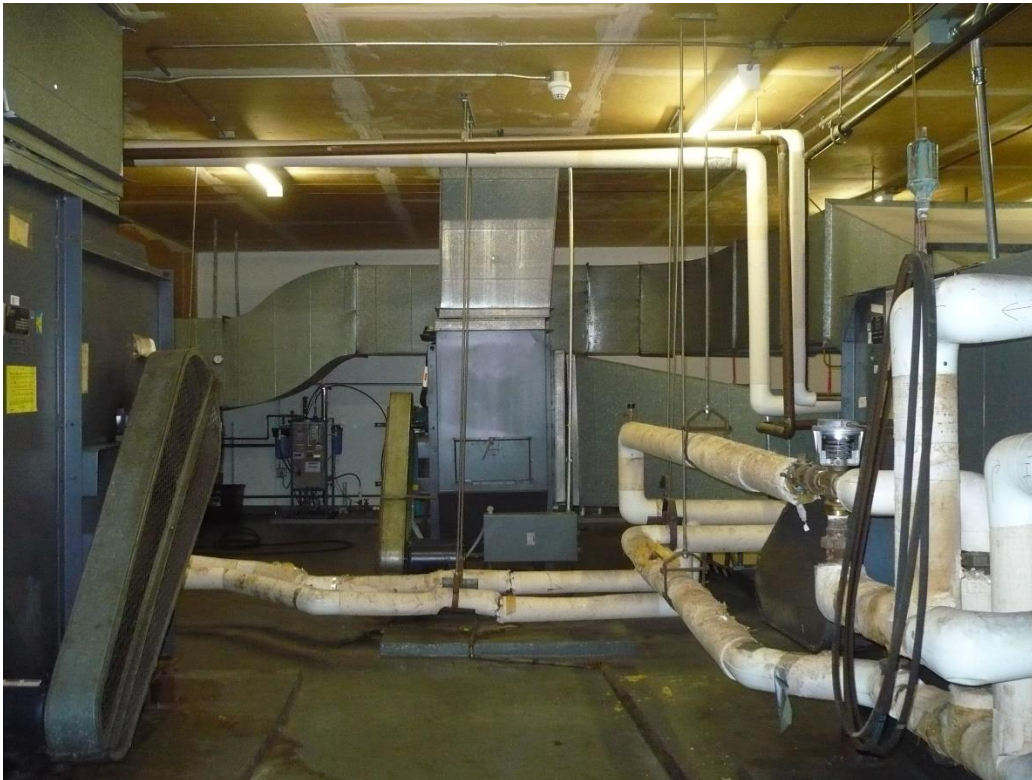
Equipment is typically anchored and/or restrained in the mechanical rooms. However, one water heater was observed to be unrestrained in the central mechanical room. Natural gas is supplied to each dental station. The bracing of the gas lines is unknown. The structure was partially renovated in 2011, and major pieces of equipment were braced at that time. Ceiling bracing was observed in the field.

Mechanical room (looking west)

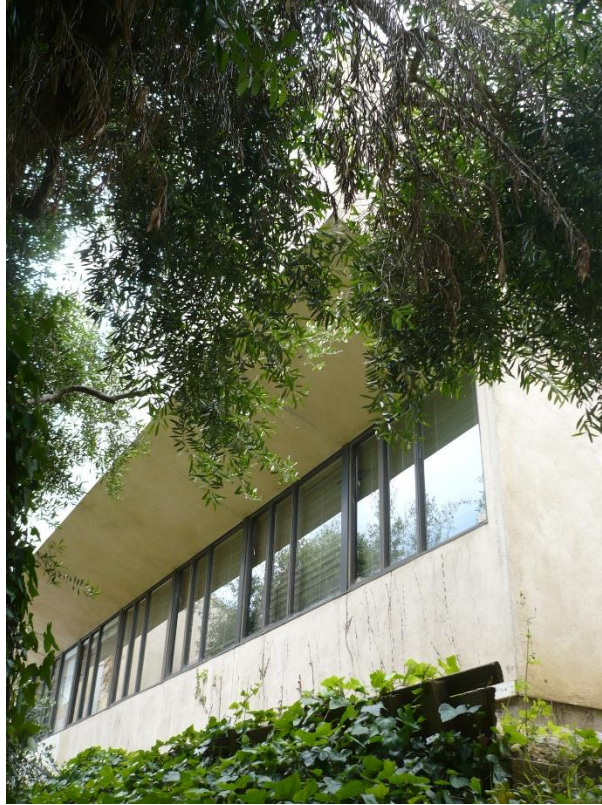
- A number of the interior shear walls are discontinuous.
- Exterior buildings walls shift inwards at the lower story on the east and south elevation.
- The pedestrian bridge contains a 1" wide expansion joint in the slab on its east end which is smaller than the 2.6" wide joint required by the Tier 1 Quick Check. However, the bridge slab aligns in elevation with the building floor level. Therefore, pounding damage is expected to be limited.

Overhang on east elevation

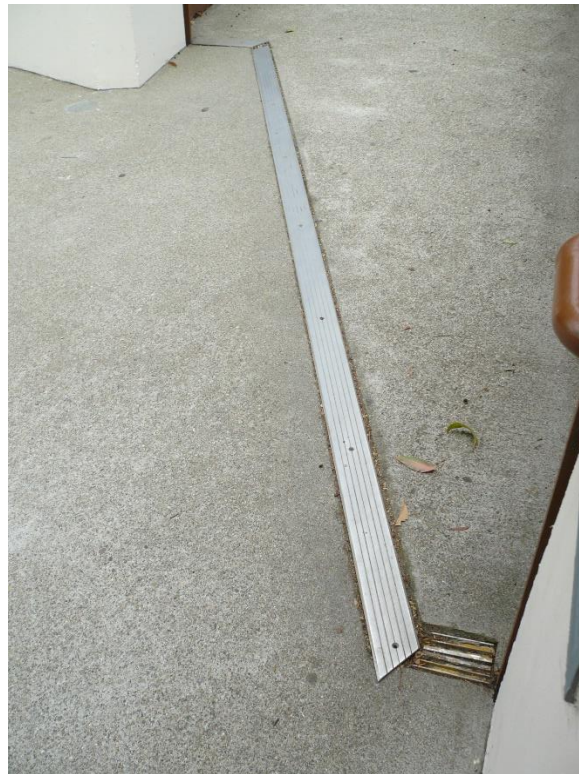
Seismic joint cover on the west end of the pedestrian bridge

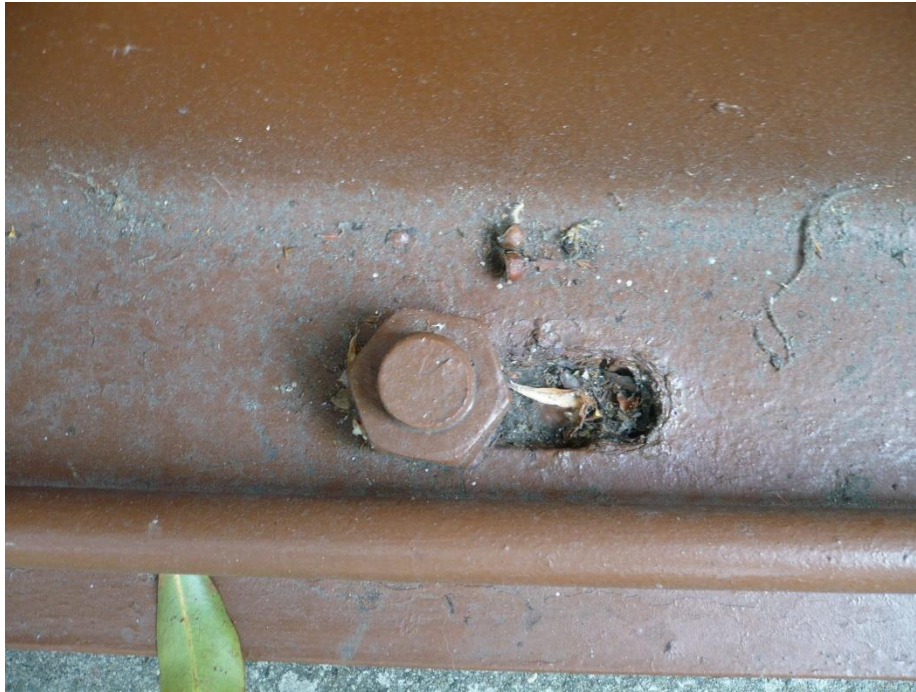
- The slip connection installed for the bridge allows for movement towards the east, but not towards the west. The bolt is incorrectly located at the east end of the horizontal slot in the steel connection plate which impedes the bridge movement in one direction. The ends of bridge girders run over the top of the support piers and are not likely to become unseated during an earthquake with up to 6" of lateral displacement which is well beyond any likely value in a major event.

Bridge connection bolt at end of slotted hole. Seismic joint is to the right (west).
