UCSF building seismic ratings

Hunters Point Research Facility

CAAN #3011

75 Crisp Road (830 & 831 Palou Avenue), San Francisco, CA 94124

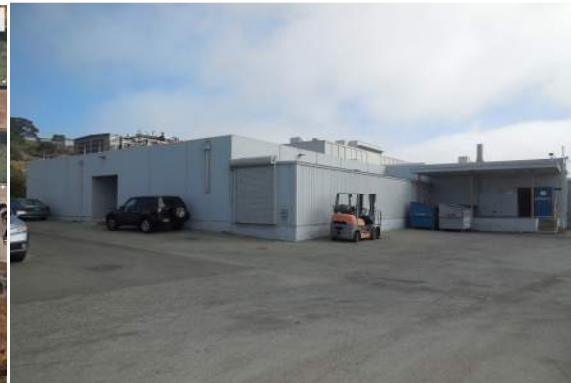
West elevation (looking northeast)

Building condition: Good. There is no evidence of settlement or on-going leaks. The building manager indicated that other than typical maintenance the structure is in good condition.

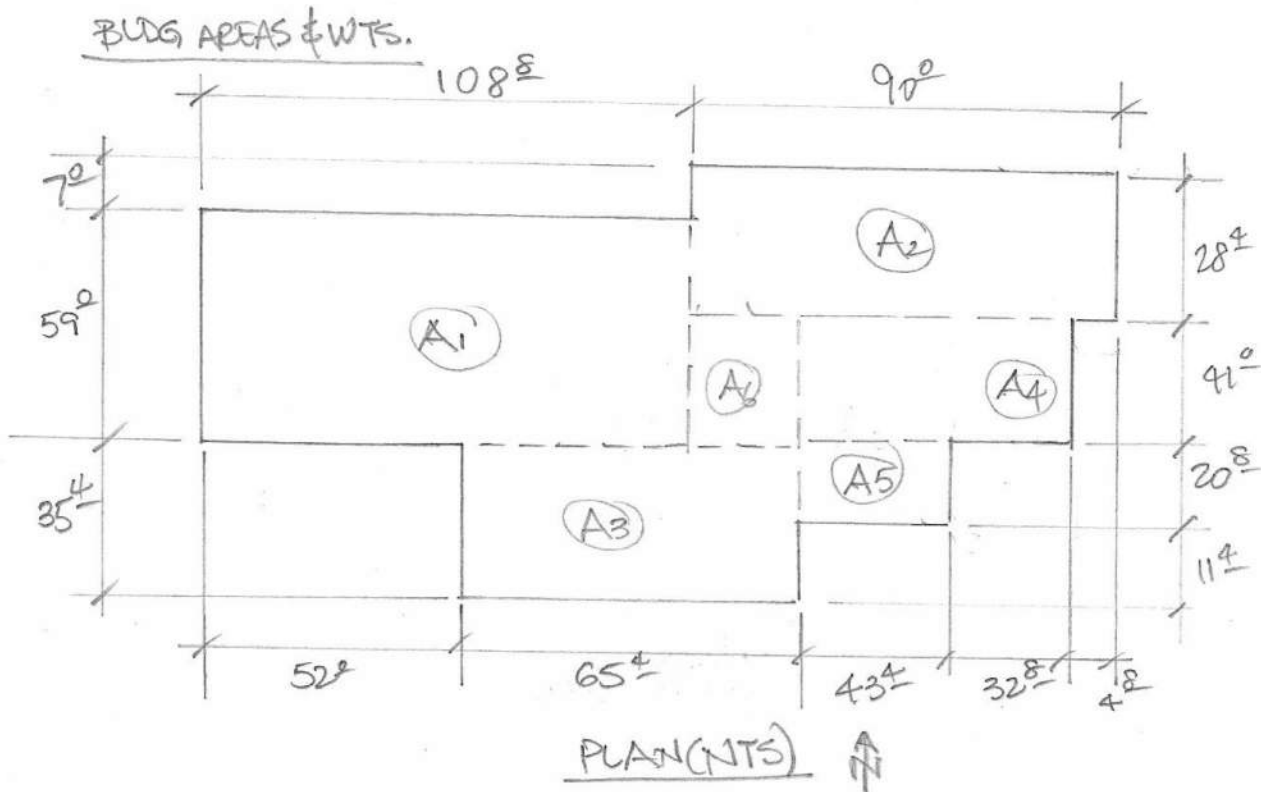
$$\begin{aligned}
 A_1 &: 59 \times 108.67 = 6412 \\
 A_2 &: 28.33 \times 90 = 2550 \\
 A_3 &: 35.33 \times 65.33 = 2308 \\
 A_4 &: 41 \times 76 = 3116 \\
 A_5 &: 20.67 \times 43.33 = 896 \\
 A_6 &: 37.67 \times 9.33 = 352 \\
 \hline
 &15,634
 \end{aligned}$$
